In situ failure test of high water content soft clay embankments reinforced by GHDs

M.Kamon
Kyoto University, Japan

ABSTRACT: To apply newly developed geosynthetic horizontal drains (GHDs) to reinforced embankment, full scale in situ failure tests were carried out. The GHDs consist of geosynthetic materials which have improved fabric parameters for permeability and reliable strength. Four kinds of GHDs were selected and a very soft clay with a high water content was used for the filling material. In this paper, the properties of GHDs used were introduced and the design procedure for the reinforced embankment including drainage by GHDs was discussed. Highly critical values for safety of the embankments were selected. The filling frame was made with sandy soil and the soft clay soil embankments was designed to be 3m high with a 1:0.5 slope angle.

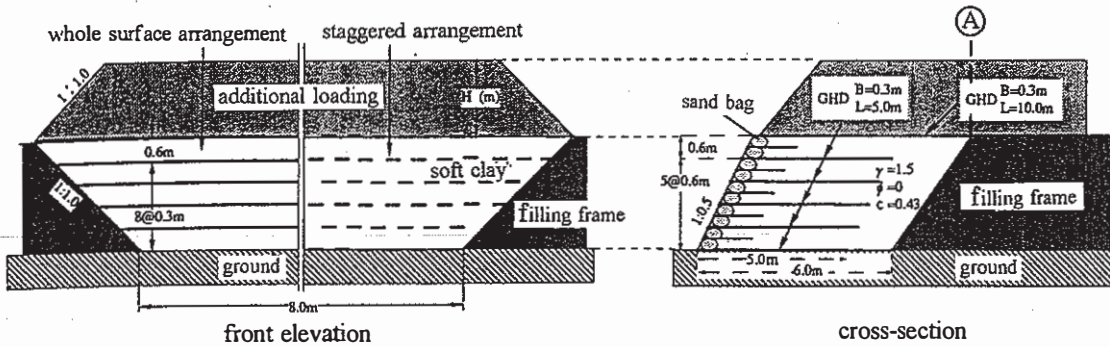
Fig. 3 Section of in situ failure test embankment

The embankments in four separated sections were 3m high with a 1:0.5 slope angle. It was too difficult to fill the embankment using ordinary methods of construction because the soil was extremely soft. Therefore, a filling frame was made with sandy soil and soft clay filling was added to the area between frames as shown in Fig. 2. Filling performed layer by layer (the thickness of each layer was 0.3m) and the surface of slope was protected by sandbags together with a nonwoven fabric (200g/m^2). To increase the strength of the soil owing to consolidation, only two layers were added each day. After the 8th layer of filling work was completed, the embankment was allowed to settle for two days, then the 9th and 10th layers were added. The embankments were left for a certain period until their degree of consolidation reached 90% or more before further loading was added. Nonwoven fabric reinforcement was laid over the whole surface of the embankment at Section 1 and 0.3m wide GHDs were placed over 50% of the embankment with staggered arrangement at Sections 2, 3 and 4 as shown in Fig. 3. For the design, it was considered that the soft clay embankment was supported by 5m long GHDs and additional loading for the failure test was supported by 10m long GHDs as indicated at the cross-section of Fig. 3. The design safety factor of the reinforced embankment was fixed at 1.0 for the filling of soft clay and 1.0 for the failure test of embankment with 1.5 meter thick additional loading modified by the Japanese design manual (1992).

material. Photos 3 and 4 show the failure patterns of test embankments in Sections 1 and 2. On the surface of the additional load in all Sections after the collapse, the main scarps appeared at cross section A as indicated in Fig. 3. The thickness of additional load and the height of the main scarp are summarized in Table 3. The deformation of 10m long GHDs which were placed on top of the 10th layer was observed in all Sections after the additional loading was removed when the failure test was completed. By this observation, it was confirmed that GHDs were broken in Sections 1, 3 and 4 at the filling frame right under position A as indicated in Fig. 3. GHDs in Section 2 were pulled out without any breakage.
