Lessons learned from a 6-year-old geosynthetic reinforced segmental retaining wall

C. S. Yoo, Sungkyunkwan University, Suwon, Kyong-Gi Do, Korea

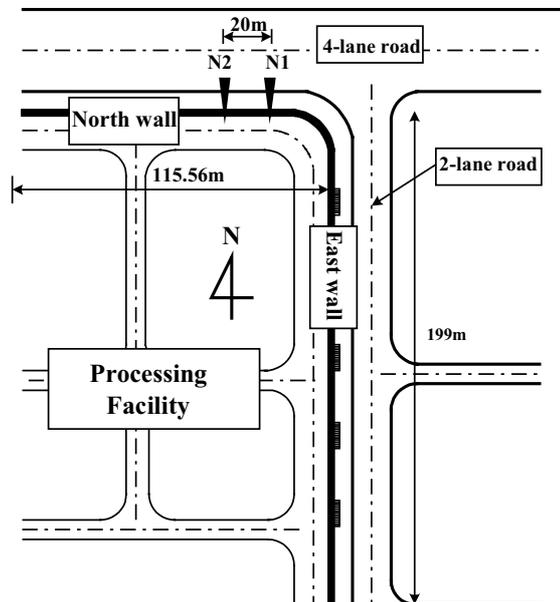
Figure 1. Plan view of site

In August 2000, several years after the wall completion, the owner noted significant wall movements along a 20-m-long section of the north wall, for which no significant problems were reported during and after construction. Two sections, N1 and N2 on the north wall shown in Figure 1, were therefore closely monitored using plum bobs. Figures 3 and 4 show the patterns of wall movements and the records of maximum wall movements with respect to time after the start of monitoring, respectively. Also shown in Figure 4 are the possible geogrid strain levels inferred from the measured wall displacements assuming that no slip between the geogrids and the backfill had occurred.

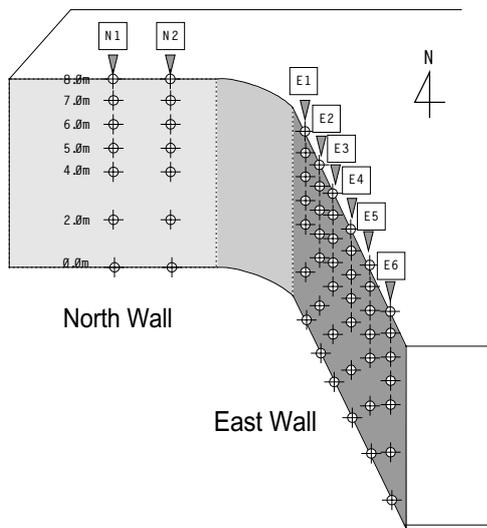
Figure 6. Schematic view of profiling program

The wall profiling was performed using a 3D total station (TOPCON Model GTS-700). Reflection targets were attached onto the wall facing units at a number of pre-selected locations. A total of 8 sections were selected for profiling; two for the north wall and six for the east wall. Figure 6 shows a schematic view of the location of the monitoring sections. For each target array, a fixed benchmark was placed at approximately 5 m away from the array and readings were taken accordingly.

The results of the wall profiling were carefully analyzed to estimate the total wall movements that had occurred during and after the wall construction. The design pre-batter angle of the wall face was a critical parameter in inferring the total wall movements from the profiling results. As mentioned previously, a pre-batter angle of 3.5 degrees was assumed based on the information available. Cumulative wall movements during and after the wall construction were then deduced from the profiling results.

most recently through the excess wall movements, moved approximately 500 mm at the top, assuming a fixed condition at the base of the wall. A maximum geogrid strain on the order of 8% would be anticipated for that magnitude of wall movements. Considering the strain at rupture of 12% for the geogrids used in the wall construction, the inferred levels of strains appear to be excessive even though possible slip between the geogrid layers and the backfill are taken into consideration.
