Long-term performance of non-woven geotextile wraparound walls

I.C. HULSE & P. PHILLIPS, Geofabrics Australasia Pty Ltd, Australia

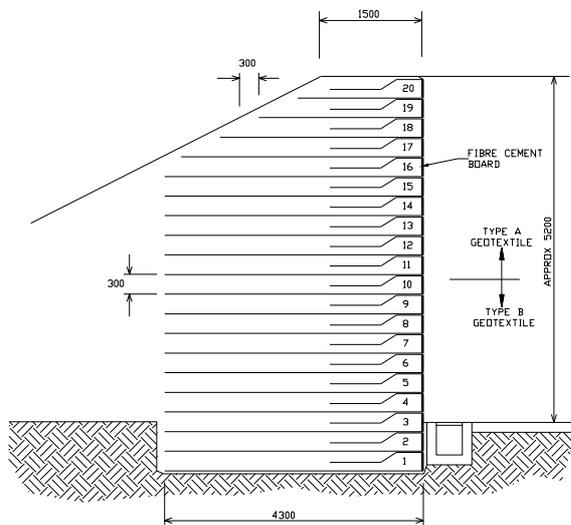
Figure 2. Perimeter wall cross section.

The profile of the wall consisted of a 1.5m wide bench at the top and then a backslope of 26°, as shown in Figure 2.

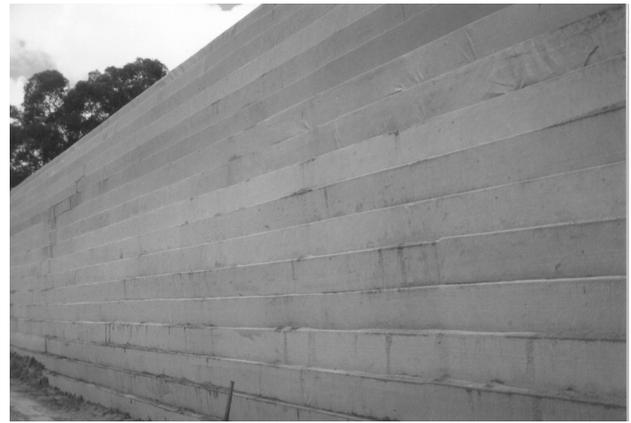
Photo 2. The "as constructed" internal wall above spray coating.

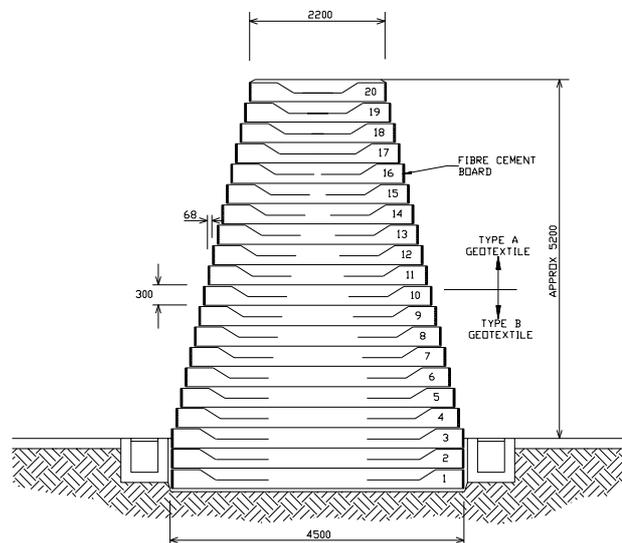
Figure 3. Internal wall cross section.

The internal wall is placed between buildings, which are connected by concrete culverts. This wall is also 6m high but was stepped back approximately 4.4 in 1 or 68mm per 300mm rise, as shown in Figure 3.

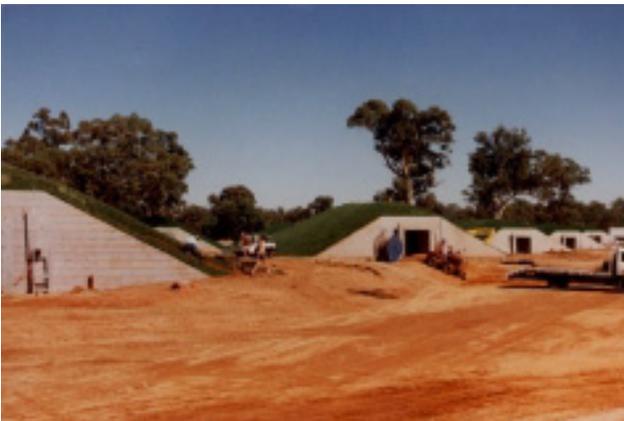
Photo 5. Storage bunkers.

As a result of the success of first the trial, and then the subsequent walls in bunker 831 and 837, ADI Mulwala have constructed several other bunker walls and blast absorbing barriers. A brief survey of these walls showed no major deformations or problems with the performance of these walls.
