# Performance of reinforced soil structures during the 1995 Hyogo-ken Nanbu Earthquake

**ABSTRACT:** The performance of a number of mechanically stabilized earth retaining walls and nailed slopes during the 1995 Hyogo-ken Nanbu earthquake is reviewed. The behaviour of the reinforced soil retaining walls is compared with that of the conventional retaining walls. Some lessons from the case histories and limitations of the current seismic design methods are discussed. Reconstruction of damaged structures by soil reinforcing techniques is also presented.

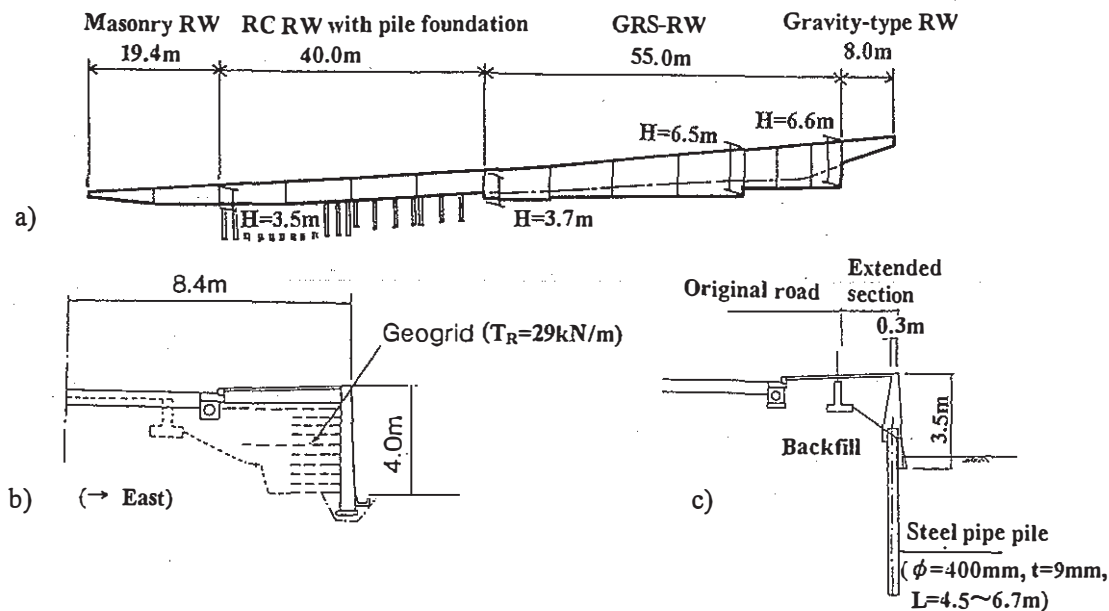
b) Maiko at Tarumi-ku, Kobe City (GR5 in Fig. 3): The wall having Blocks A and B, constructed in 1993 to expand the road immediately east of one of the approach roads to Akashi Kaikyo (Strait) Bridge. The backfill was a well-graded gravel. On the opposite side of the approach road, there exists the GRS-RW without a FHR facing described in section 3.1. Block B (Fig. 20;  $H = 4.9 - 5.1 \text{ m}$  and  $L = 60 \text{ m}$ ) was located on a steep slope facing the approach road. The facing was supported with well foundations. The wall moved outward about 2 cm at a maximum at the top of the facing. Block A (Fig. 21;  $H = 3.7 - 6.6 \text{ m}$  and  $L = 55 \text{ m}$ ), facing the

direction opposite to the approach road, moved outward about 1 cm relative to the low-height gravity type RW immediately to the right of the GRS-RW in Fig. 21a. On the left of the GRS-RW in Fig. 21a, a RC wall had been constructed, supported by steel pipe piles (Fig. 21c). Although the height of the RC wall was shorter than that of the GRS-RW, it moved outward about 2 cm relative to the GRS-RW showing a maximum depression of about 10 cm at the road face behind the RC wall. This fact indicates that RC RWs supported by piles could be less cost-effective in terms of seismic stability than GRS-RWs having FHR facings. A similar case was observed on a larger scale at Tanata, to be described later. The displacement of the masonry walls on the left end and the gravity type RW on the right end was not observed, probably due to their small height (about 2.2 m). No further displacement was observed after the earthquake in all these walls.

Fig. 21 a) Front view and b) cross-section of Tarumi GRS-RW (Block A) (GR5 in Fig. 3) and c) cross-section of the adjacent RC RW with piles.

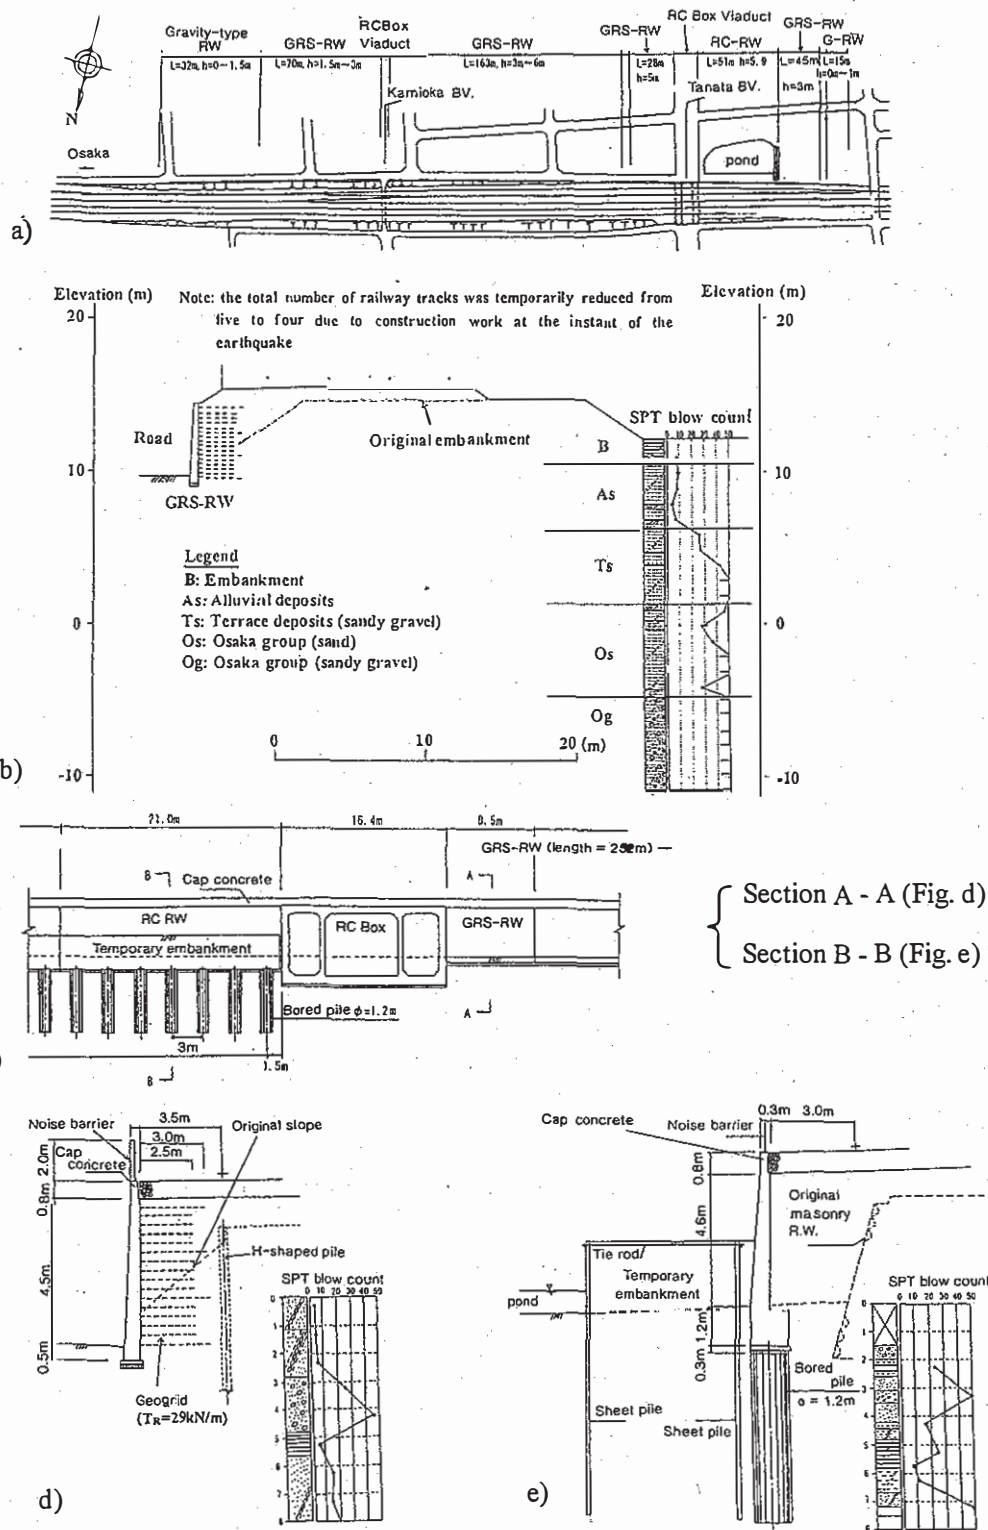
In the areas adjacent to these GRS-RWs having FHR facings, a number of wooden houses, railway and highway embankments and conventional types of RWs were seriously damaged (see Fig. 3). The degree of damage was, however, not as serious as that observed in the areas where the JMA scale was equal to seventh or higher (Fig. 4). In one of these areas, at Mori-Minami-cho 1-chome in Higashi-Nada-ku, Kobe City (the local name is Tanata), GRS-RWs having FHR facings ( $H = 1.5 \text{ m} - 6 \text{ m}$  and  $L = 305 \text{ m}$ ) were completed in February 1992 on the south slope of the embankment of JR Kobe Line (Fig. 23; GR1 in Fig. 4). The wall construction was to increase the number of railway tracks from four to five (Figs. 23a and b). The subsoil condition is relatively good (see Figs. 23d and e). In sections where the wall was higher than 1.5 m, H-shaped steel piles at a spacing of 1.5 m with temporary anchors were provided at two elevations to retain the embankment before the slope was excavated for the construction of the wall (Fig. 23d). The anchors were removed as the GRS-RWs were being constructed.

The bottom of the wall moved outward on average about 5 cm relative to the supporting foundation subsoil, pushing the subsoil in front of the wall laterally. At the highest part of the wall, which was in contact with a RC box culvert structure crossing the railway embankment, the largest outward displacement occurred, which was 26 cm at the top of the wall and 10 cm at the ground surface level (Fig. 24a).

a) At the site and in the adjacent areas, the seismic intensity was extra-ordinarily high (Fig. 4). More than 80 % of the wooden houses in front of the wall totally collapsed, but most of them were not particularly old (Fig. 25). In the areas surrounding the wall, many RC buildings and RC piers for highways were seriously damaged or totally collapsed. No doubt, this GRS-RW experienced the highest seismic load among the modern GRS-RWs.

b) On the opposite side of the RC box structure, a RC RW with a largest height of about 6 m was constructed concurrently with the GRS-RW (Fig. 23e). The wall was supported by a row of bored piles, despite the sub-surface condition was similar to that of the GRS-RW. Consequently, the con-

struction cost per wall length for the RC RW was about double to triple that for the GRS-RW. The RC RW displaced similarly to the GRS-RW; i.e., at the interface with the side of the RC box structure, the outward lateral displacement was 21.5 cm at the top and 10 cm at the ground surface level (Fig. 24b). This comparable behaviour of these two different types of RWs constructed adjacent to each other was similar to that at Maiko described above. Moreover, the GRS-RW having a FHR facing had been constructed adjacent to and to the west of the RC RW (see Fig. 23a), which was 3 m high and 45 m long. The wall did not move. In the design of RC RWs, such as the one at Tanata, seismic earth pressure calculated by the Mononobe-Okabe method using  $k_h = 0.2$  is resisted by the lateral and rotational resistance of the pile foundation, which results mainly from passive earth pressure in the subsoil in front of the pile foundation. Therefore, some lateral displacement of the pile was inevitable to mobilize the large passive earth pressure.

Fig. 23 a) Plan, b) cross-section of the embankment and c) front view from the south and cross-sections of d) GRS-RW and e) RC RW with pile (GR1 in Fig. 4), at Tanata between Ashiya and Seta-motoyama Stations, JR Kobe Line.

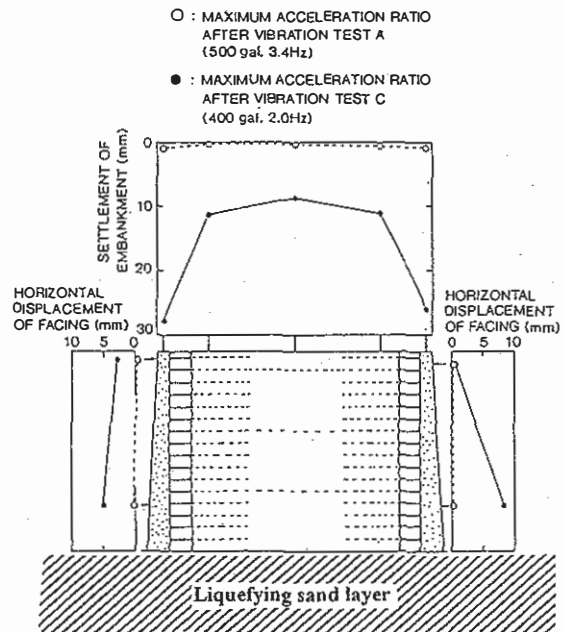
constructed on a saturated sand layer (Fig. 26). The sand zones on both the sides of the wall liquefied by the application of 360 cycles of sinusoidal loads at a frequency of 2 Hz with a peak acceleration of 400  $\text{cm}/\text{sec}^2$ . It seems that the sand zone beneath the center of the wall did not liquefy due to the weight of the wall, as seen from the excess pore water pressure recorded beneath the center of the wall. As a result, the facings settled about 2cm relative to the reinfor-

Fig. 26 Deformation of a large GRS-RW model constructed on a liquefied sand deposit (after Fig. 5 of Murata et al., 1994).

-ced backfill, but the wall maintained its integrity. This result suggests that when the foundation subsoil liquefies, a GRS-RW having a FHR facing will deform and displace more than when the subsoil does not liquefy, but may not totally collapse.

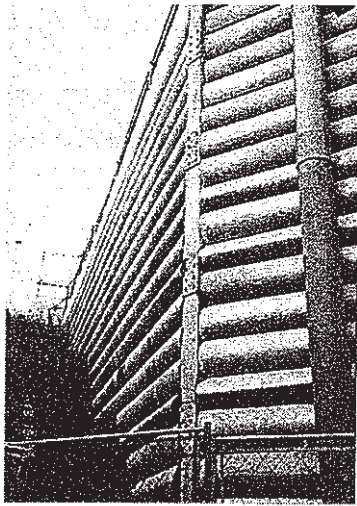
Fig. 31 Temporary Terre Armee wall at Tarumi-ku (by the courtesy of Prof. Akagi, T. of Toyo University).

There was a 6-7 m high temporary Terre Armee wall with a metal skin facing at Tarumi-ku for the construction of an approach road to Akashi Kaikyo Bridge. Some part of the facing, particularly near the bottom, was compressed noticeably (Fig. 31, TA4 in Fig. 3), inducing some outward displacement and settlement at the entire wall. As the wall did not show any sign of total collapse, only some remedy work was performed.

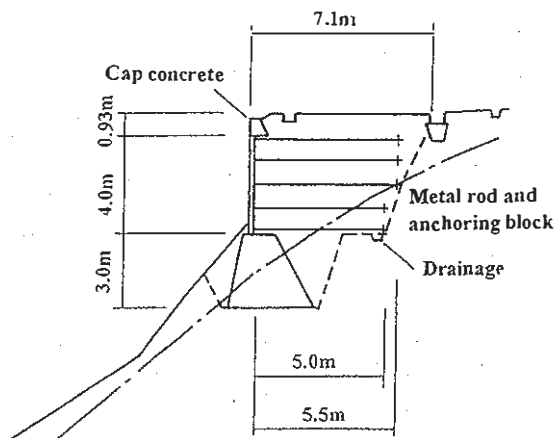
Fig. 32 Cross-section of a multiple-anchor soil RW (MA in Fig. 3).

In the mountain areas, where the seismic intensity was lower than in the areas shown in Fig. 4, some multiple-anchor soil RWs had been constructed. Precast RC panels were anchored with steel tie rods having small anchor concrete blocks at the deepest ends. The wall shown in Fig. 32 (MA in Fig. 3) had a largest wall height of 4.6 m and a total wall area of 87 m<sup>2</sup> (JMAA, 1995). No structural damage and deformation was observed at the wall face, but the cap concrete, that was not anchored, moved backward slightly.

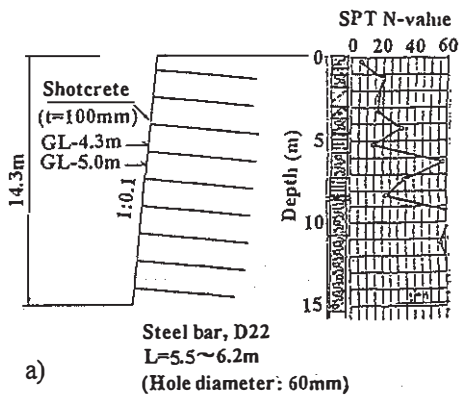
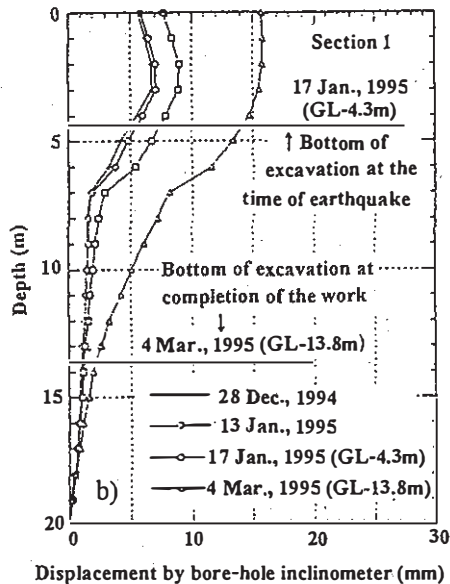
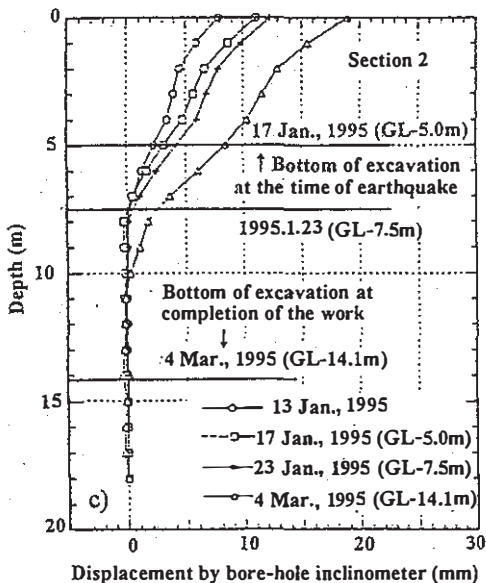
Among them, perhaps the behaviour of the nailed wall NS6 (Fig.3) was most carefully monitored at the time of the earthquake. The slope was in the process of excavation while having exhibited noticeable deformation (Fig. 34) (Fujii et al., 1996). The wall was nearly vertical while the soil was not very stiff. At the time of the earthquake, the slope had been excavated to a depth about 4.0 - 5.0 m. The wall displaced outward 1.9 mm and 3.2 mm at the largest at the measuring sections Nos. 1 and 2, showing an overturning mode as observed before and after the earthquake. No damage to the houses and other structures in the adjacent areas was observed,

because the site was a bit far away from the epicenter and the estimated PHGA was relatively low. It seems that the slope was already near the critical state at the time of the earthquake, and the slope would have not been stable without nailing during the earthquake. Despite higher PHGAs, the other slopes were more stable probably due to better soil conditions and/or larger inclination of the slopes.

Fig. 34 a) Cross-section at the end of excavation and b) displacements at the slope face of the nailed slope NS6 in Fig. 3 (Fujii et al., 1996).

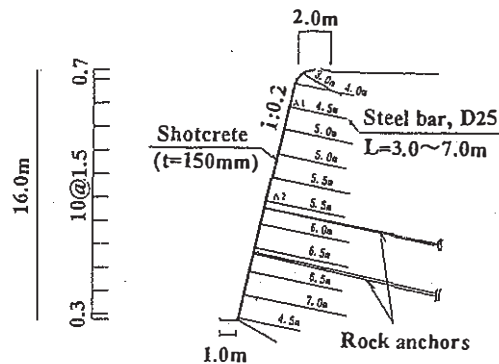
Fig. 35 Cross-section of a nailed slope in Awaji Island (NS7 in Fig. 3; Tsukuda et al., 1996).

concrete up to a depth of 9.6 m from the slope crest by the time of the earthquake. The results of pseudo-static seismic analysis performed after the earthquake for the slope with and without nailing showed that the slope had become more stable by nailing (Tsukuda et al., 1996). Although the reinforced slope was not damaged by the earthquake, a safety factor equal to 0.8 was obtained when applying  $k_h = 0.6$ , which is equal to the estimated PHGA/g, normal to the slope face. They considered that this discrepancy was due to the fact that the direction of the PHGA was largely inclined (more than 60 degrees) from the normal to the slope surface. The authors consider, however, that many other factors should be considered as well.

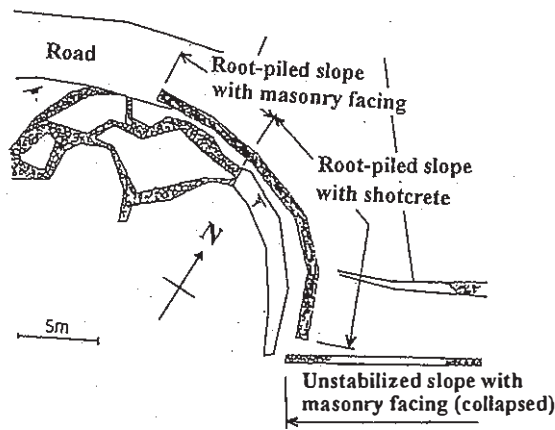
A slope located north-east of Suma-koen Station of the Sanyo Dentetsu railway (RP1; Fig. 36) (see Fig. 3) experienced an estimated PHGA of about 500 gals. A 6 - 7 m high slope had been stabilized by root piling, adjacent to a 1 - 3 m high slope that had been retained only by a masonry RW. The slope was of a residual soil, basically a gravelly sand with interbedded clay. The root-piled slope had two different facings, masonry and shotcrete. A number of hair cracks were observed on the shotcrete facing and on the road face behind the wall face, and an opening of 5 cm appeared between the masonry and shotcrete facings. However, the damage was not serious at all. The deformation of the masonry facing was smaller. Compared with the above, the masonry facing of the unstabilized slope collapsed, and several nearby wooden houses were seriously damaged.

Fig. 36 Plan of the root-piled slopes and adjacent damaged unreinforced slope near Suma-Koen (RP1 in Fig. 3; after Fujii et al., 1996).

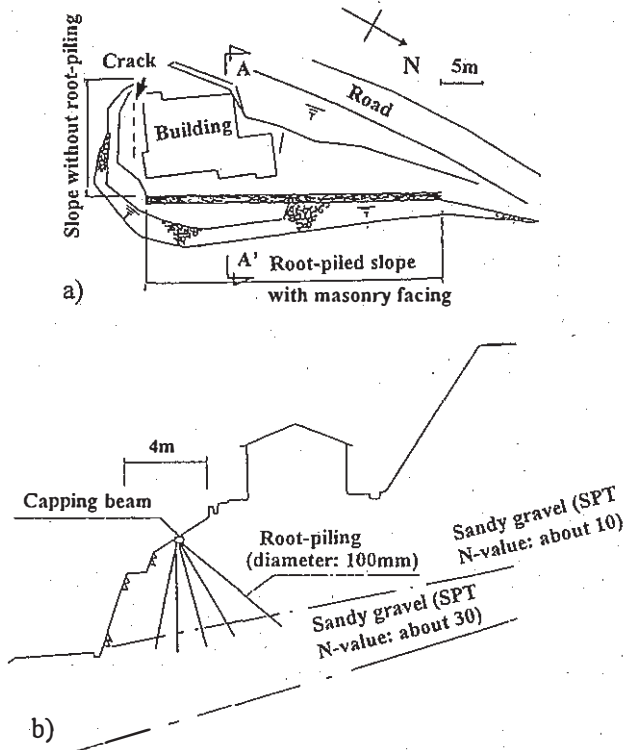
In the second case located south of JR Takarazuka Station on the right bank of Mukogawa river (RP2 in Fig. 3; Fig. 37), the estimated PHGA was about 500

Fig. 37 a) Plan of the root-piled slope and adjacent damaged unreinforced slopes and b) cross-section A-A' of the root-piled slope near Takarazuka (RP2 in Fig. 3; after Fujii et al., 1996).

gals. An about 7 m high slope having a masonry RW had been stabilized by root piling, while the adjacent slope with a height of 5.0 m at the maximum had been retained only by a masonry RW. The slope soil was basically a sandy gravel. In the root-piled slope, the soil mass between the wall face and the root piles seems to have moved slightly outward

while the root-piled zone and the soil behind it did not, judging from some small cracks and no cracks on the ground surfaces, respectively, in front of and behind the capping beam. Compared with the good performance of the root-piled slope, on the crest of the slope without root-piling, a crack with a maximum width of about 20 cm appeared immediately behind the masonry RW, associated with a 7 cm deep depression at a distance of 20 cm from the masonry RW. This fact shows that the unstabilized slope moved outward to a some extent.

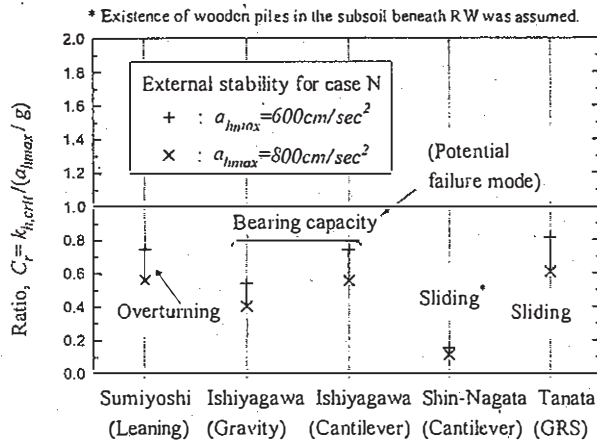
where  $k_{h,crit}$  is the critical horizontal seismic coefficient yielding a safety factor of unity. The value of PHGA was estimated as approximately 600 gal to 800 gal based on Fig. 5. For the RWs which actually failed, the values of  $k_{h,crit} = C_r \cdot (PHGA/g)$  as obtained would have under-estimated the correct values to be used in the aseismic design, because the critical PHGA at which the structures were about to fail should be equal to or smaller than the actual PHGA. The reverse is true for the RWs which did not fail.

In Fig. 40, the potential failure modes against external instability are also indicated. These failure modes were found consistent with the observed behaviour. The value of  $C_r$  against external instability for the GRS-RW at Tanata was 0.6 - 0.8, which was similar to those for the other conventional RWs excluding the cantilever-type RC RW at Shin-Nagata (CL2 in Fig. 4; see also Fig. 11). A very low value of  $C_r$  for the wall at Shin-Nagata would be due to the fact that the backfill was considerably sloped. Based on the results shown in Fig. 40 (excluding the wall at Shin-Nagata), the following conclusions could be drawn:

Fig. 40 Ratio of critical horizontal seismic coefficient to estimated PHGA for external stability of RWs (after Koseki et al., 1996).
