WANDSCHNEIDER H.P.

Reinforced Earth Company Ltd, Canada

THIBAUT P.

Reinforced earth - a case history

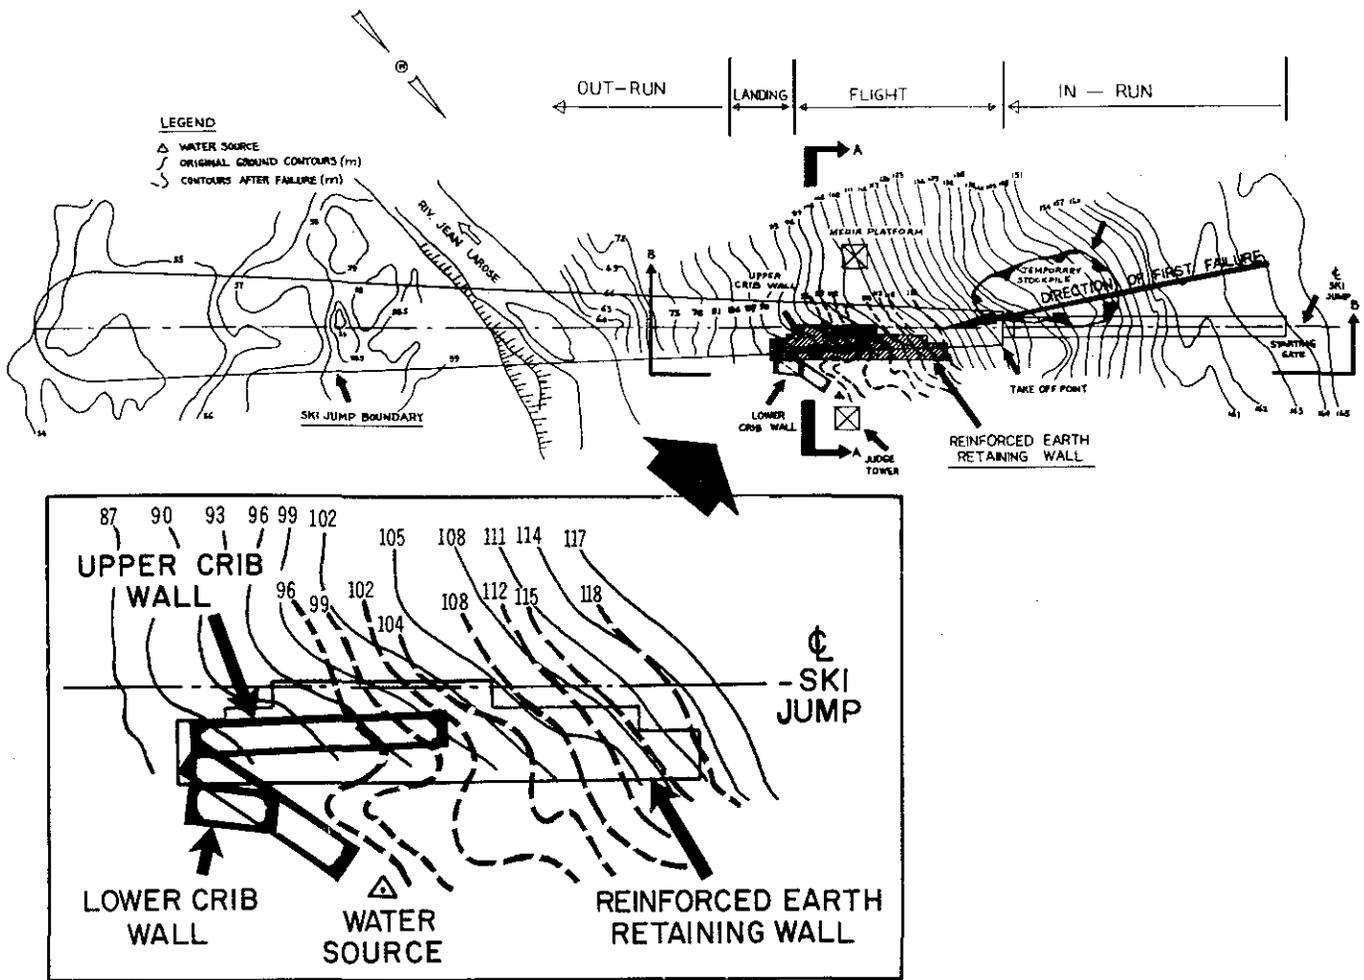
Fig. 1. Site plan of ski jump.

Fig. 1 illustrates the general outline of the area and the relative positioning of the ski jump, the judges' tower, television platform and spectator observation areas. The top of the jump is located approximately 100 m adjacent to a public highway and 10 m above it. The bottom of the jump and spectators' area are accessible only via a steep and winding roadway constructed solely for access to the spectator - ski run-out area. Retaining wall construction was required about half way between these levels or about 60 m below the top and 50 m above the run-out.

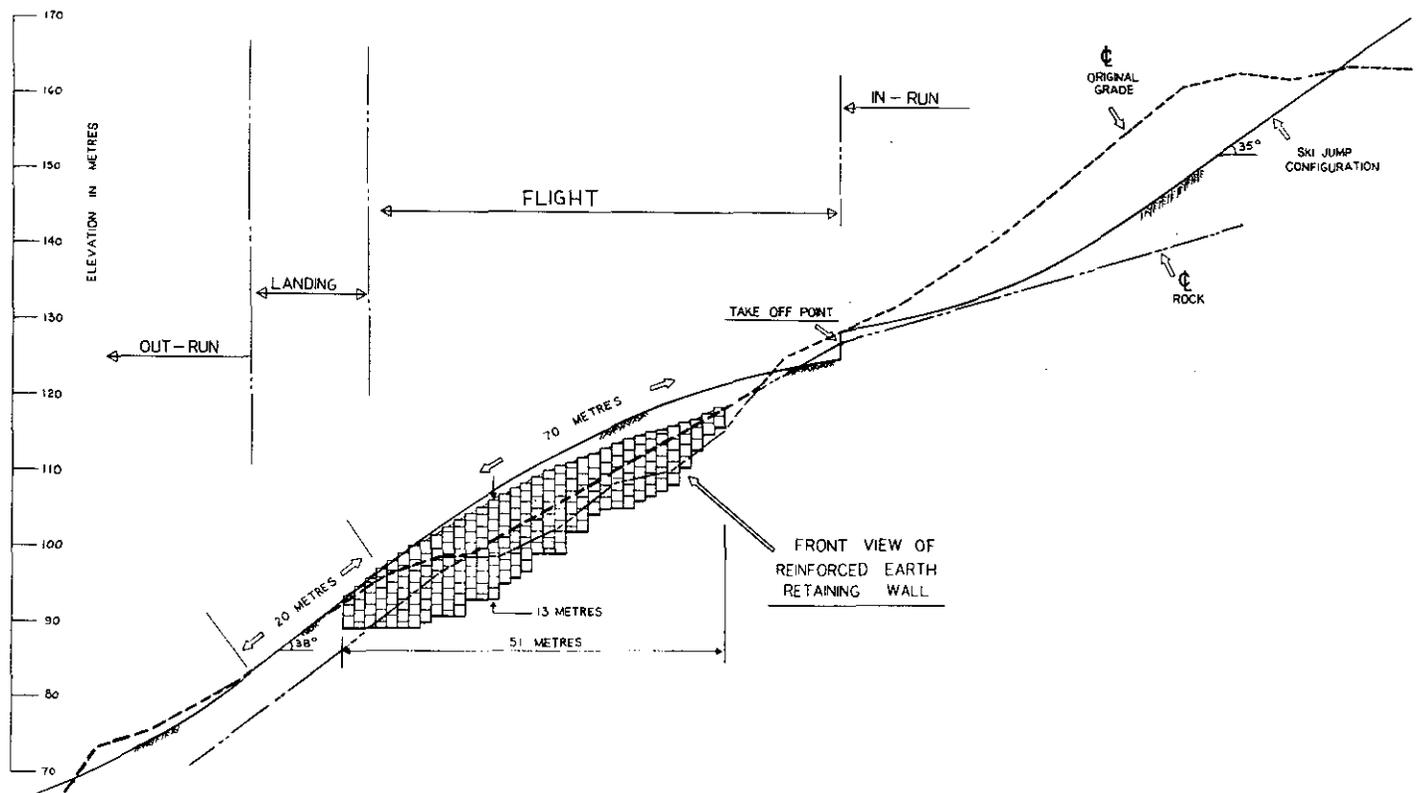
Fig. 4. Longitudinal profile (Section B-B) showing front view of the reinforced earth structure relative to the ski jump.

The relative differences in elevation, configuration of the jump and the level of the retaining wall are illustrated in Fig. 4. Due to environmental and other restraints, access to the construction area itself was available only along the slopes of the ski jump, ie, directly from the top or bottom and via slopes as steep as 1.25 horizontal to 1 vertical (1.25h:1v). To appreciate the access problems at this site fully, one needs to consider only the fact that it was necessary to erect the judges' tower with a 200 tonne crane (equipped with an 84 m boom) to obtain a lifting capacity of 4 tonnes at full reach. An alternative to the crane, which was considered, was the use of a helicopter. However, one was not available economically in the required capacity.

planes to the depth investigated. Bedding planes were found to be numerous during excavation but were favourably inclined, ie, opposite to the direction of any potential sliding plane or arc failure. The original and ground profile, soil and rock conditions are also illustrated in Fig. 4.

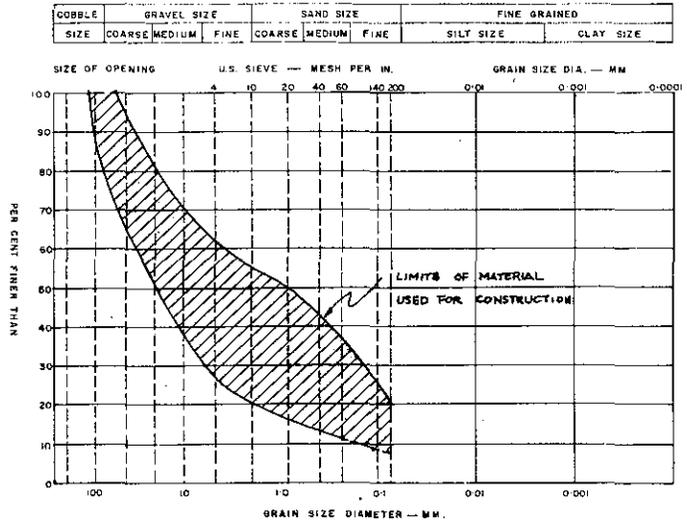
Fig. 5. Grain size distribution chart indicating the limits of material sizes used for construction.

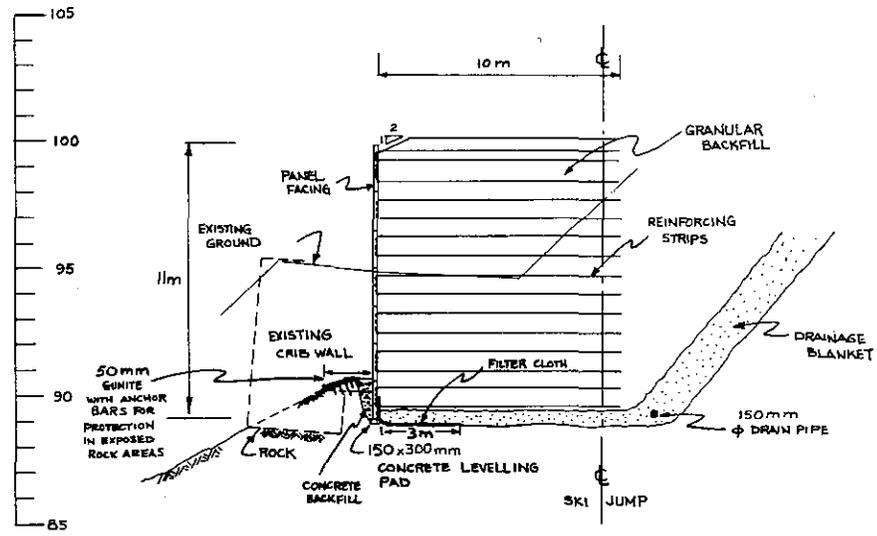
Fig. 6. Design section.

Internal design of the RE mass utilized the parameters determined from laboratory tests carried out by others. The results all fell within the usual requirements of the Reinforced Earth Company. In this regard it was realized that compaction would be achieved only by the movement of the backhoe, tamping with its bucket and the action of a very small bulldozer. Also, the cover in front of the wall could be maintained at the usual configuration with the exception of one area where the lower and undamaged part of the crib could serve as berm because of insufficient space. A typical design section is shown in Fig. 6. The total surface area of the wall facing was 500 m² and its average height was about 10 m.

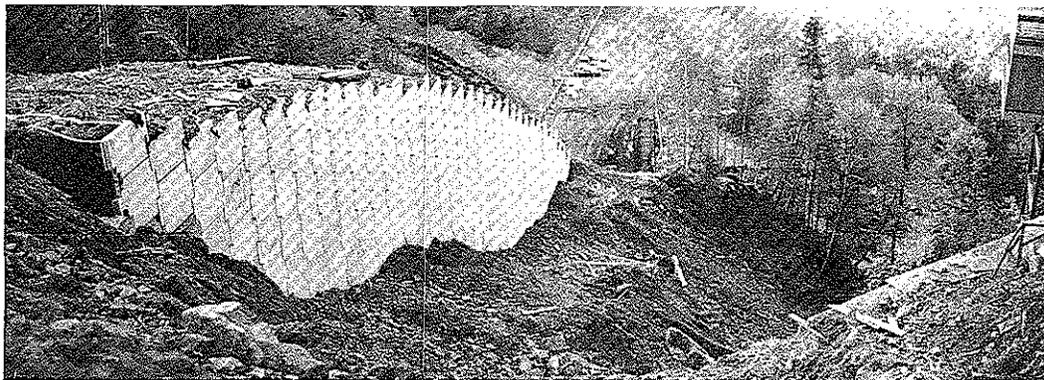
Fig. 8. Reinforced earth wall nearing completion.

Initial delays due to poor weather, slow excavation, the refusal to truck the panels down the mountain etc. appeared to delay the scheduled completion at first, but subsequent good weather and reduced handling of fill improved the rate of wall erection to the point where it was completed ahead of schedule. the average rate of wall construction was, in fact, about 20m² of face area per day with the maximum recorded at about 35 m² per day, a very satisfactory rate of construction under the difficult circumstances. Fig. 8 shows
