# Slope stabilization with woven geogrids in San Bernardo Hill

**ABSTRACT:** As a result of the rains that occurred during the summer of 2008 in Salta city, an important stretch of the access road to the top of San Bernardo hill was affected by debris sliding which produced an important landslide of the road in one part and the destruction of it in another. Although the importance of this road, because of being the only vehicular access to one of the most important and most visited touristic places in Salta, it had to be closed for security reasons and the impossibility of circulation for larger vehicles, causing major economic losses and important trouble to tourism. The developed project allows solving a serious problem of slope stabilization with a very low cost, even lower than any other conventional solution, with a very important advantage, specially for this moments, that is to build up a low environmental impact wall using the non-conventional bagged stone wall alternative, with soil reinforcement elements made with double twist hexagonal mesh and additional reinforcement. In this case we use woven geogrids fabricated with polyester yarns, in the range of 40-60 KN/m ultima

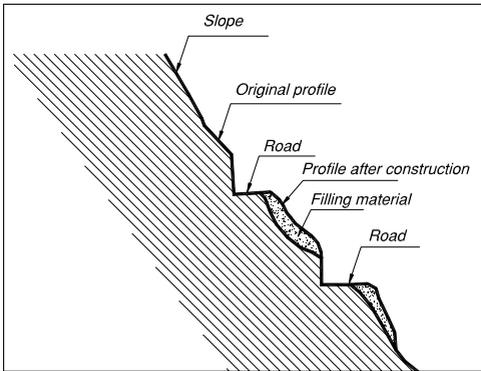
Figure 2. Profile after construction

As a result briefly above, in February 2008 due to intense rainfall (70 mm in one hour) maintained after several days, there were two landslides (D1 y D2) that hit the slopes and part of the asphalt surface in the access road to San Bernardo hill (D1 and D2).
