Use of reinforced earth walls in canals**Utilisation de murs en terre armée pour des canaux**

Kakrapar weir scheme in Gujarat has the Ukai right bank main canal off-taking from Kakrapar right bank canal as shown in Figure 1. Design for the canal is made for 45 cumecs at its head and after its run for a distance of 35 km. Kosamba branch off-takes from this canal and the capacity gets reduced to 22.6 cumecs. Typical problem of stability of slopes for this canal was noted in its range from 35.05 km. to 37.65 km. wherein the canal has a maximum depth of cutting of 12 m. The dimensions of the canal for this reach reveal bed width of 8m. and initial side slopes of 2:1 changing to 1.5 : 1 above the berm. Canal gradient is 1:6000 with $n = 0.0225$ and full supply depth of 2.8m. Borehole details at the site revealed top 1.5m. black layer of silty clay, layers of silty sands, silty clays and sandy silts. Typical details for the site bore hole are shown in Figure 2 and the shear characteristics of a few selected soil samples are given in Table I.

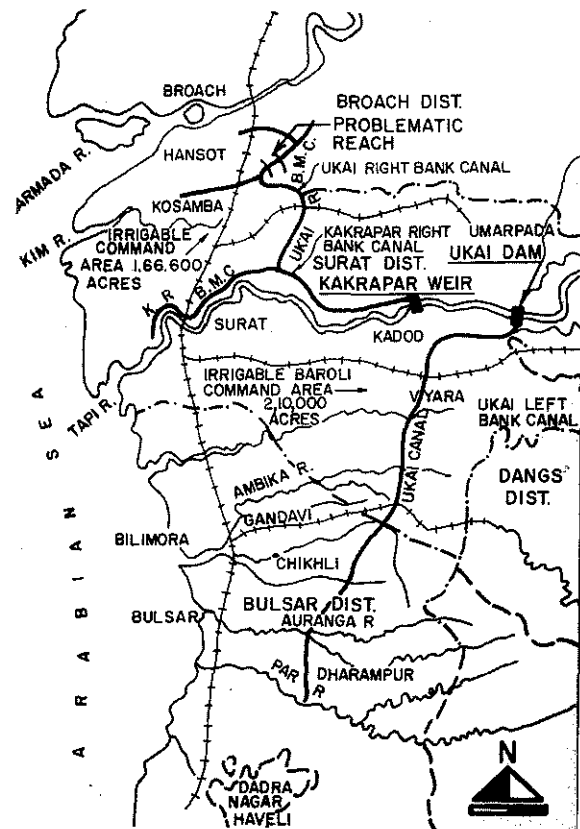
were observed at number of places. Failure patterns for the slopes in this reach of the canal as observed on 21st July 1972 are shown in Figures 3-5. Canal section details before and after the formation of the slip are shown in Figure 6.

of the canal wherein the edge of slip was observed at a distance of about 71m from the centre line of the canal and extending right upto the spoil bank as shown in Figure 7-8.

Detailed investigations carried for the problematic stretch of the canal revealed that severe fissurisation and loss of shear strength under hydrostatic pressures or on partial drying due to time lag in construction programme seem to have contributed for the formation of slips. Failure arising out of strain incompatibility between the different horizons of the soil profile with

Additional points which deserve attention in analysing the formation of the slips will now be presented. The initial slopes adopted for the construction work of the canal can be considered as steep as the final slopes observed after the formation of slip were of the order of 4:1 to 5:1.

Excavated material dumped in the spoil banks very near to the top of the slopes further aided in actuation of slips. Fissured clay on exposure lost its strength and thereby increased the instability of slopes.

The present proposition hence consists of providing on both the banks of the canal reinforced earth walls with water proofing linings for the problematic reach extending from 35.06 km to 37.65 km of the Ukai right bank canal. An appropriate drainage system can also be provided to relieve the hydrostatic pressures for these reinforced earth walls. Figure 9 reveals the section for the reinforced earth walls to be adopted for the canal. Details for an optimal design are worked out taking into consideration the soils met with on the canal banks for steel plate sizes and their spacings (3,1977). This project when visualised with the proposition of reinforced earth walls on both the banks of the canal help reducing the expenditure.
