Geosynthetics for natural disaster prevention and mitigation -Japanese challenge-

ABSTRACT: Japan is a country of a variety of serious natural hazards. It is composed of many islands and has long coastlines. The islands are mostly mountainous with volcanos. As Japan is located on the four earth's crusts, there are numerous active faults which cause unstable natural slopes and, of course, strong earth-quakes. Japan has been repeatedly hit by earthquakes, some of which induced tsunamis. Japan often suffers heavy rains caused by weather fronts, typhoons and their combinations. Due probably to the global warming, the number of sudden downpours is increasing. Japan is affected by about 10 typhoons annually, which cause not only heavy rains but also high waves causing damage of coastlines. Application of geosynthetic technology has increased in Japan because of its high strength and durability. This report intro-duces Japanese challenges to utilize geosynthetic technologies to mitigate natural disasters. It covers reinforced embankments resisting overtopping caused by tsunami and river flood, geotubes for coastal protection especially for Japanese severe environment such as high waves,

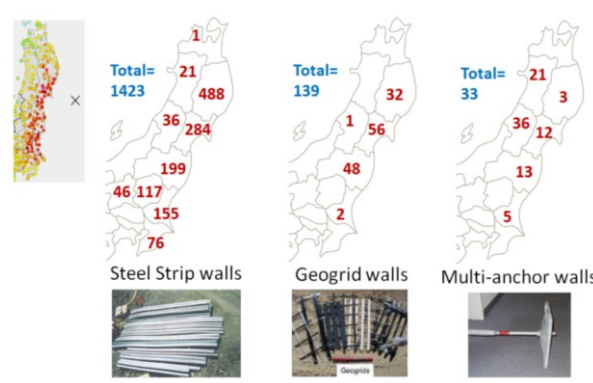
Figure 1. Site investigation of earthquake damage to reinforced soil wall in the 2011 Tohoku earthquake (Miyata, 2012, Kuwano et al., 2014).

Japan is a country of a variety of serious natural hazards. It is composed of many islands and has long coastlines. The islands are mostly mountainous with volcanos. As Japan is located on the four earth's crusts, there are numerous active faults which cause unstable natural slopes and, of course, strong earthquakes. Japan has been repeatedly hit by earthquakes, some of which induced tsunamis. The 2011 off the Pacific coast of Tohoku Earthquake (The 2011 Tohoku Earthquake) of $M_w=9.0$ with a huge source region of about 450 km by 200 km occurred on March 11, 2011. It is the largest earthquake ever recorded in Japan and the fourth largest in the world after 1900 (USGS, 2012). Wide area in the Tohoku and Kanto regions were strongly shaken by the earthquake. At some locations, very high accelerations of more than 1000 gal, or even more than 2000 gal at particular sites, were recorded. Large settlement, sliding failure, and collapsing of conventional type retaining wall of unreinforced soil structure, such as road and railway embankments, earth dams and housing sites, occurred by the earthquake. Almost 20,000 people are dead or missing by the 2011 Tohoku earthquake. Tsunami was the most serious impact of the earthquake. Inundation height and run-up height were as high as about 40 m (Tsunami Joint Survey Group, 2012). It killed thousands of lives and caused extensive damage of various structures such as seawalls and bridges. Many seawalls and river dikes were washed out by the tsunami. However, many reinforced soil walls survived the tsunami impact, though they were partly or fully submerged. With respect to the performances of reinforced soil walls, various teams went to the wall sites and the damage was reported in Kuwano et al. (2012, 2014) as shown in Figure 1 and Table 1. The damage of reinforced soil walls, i.e. steel strip walls (Terre Armee), multi-anchor walls and geogrid walls, was classified into four levels, namely, ultimate limit state, restorability limit state, serviceability limit state. The ultimate limit state is only less than 1% of investigated walls for all the three types. More than 90% of the walls show no

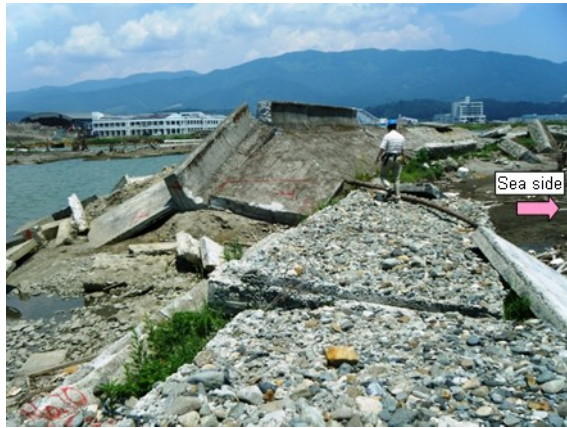
Figure 3. Destroyed seawall at Takata-matsubara (Kuвано et al., 2012, 2014).

Tsunami was the most serious impact of the earthquake as mentioned before. Inundation height and run-up height were as high as about 40 m (Tsunami Joint Survey Group, 2012). Many seawalls and river dikes were washed out by the tsunami as shown in Figure 3. However, many reinforced soil walls survived the tsunami impact, though they were partly or fully submerged. There are numbers of reinforced soil walls in Tohoku region. Miyata (2012) reported the damage of the walls by the direct impact of the earthquake (shaking) and summarized that just less than 1% of the walls were seriously damaged but more than 90% of the walls did not show any damage. Most of the reinforced soil walls were constructed without considering effects of water. However, some of them were exposed to the direct

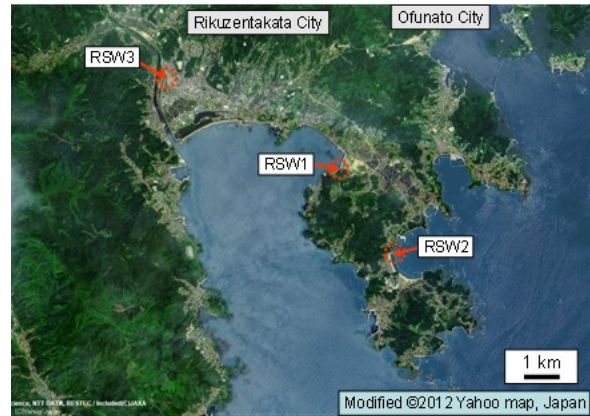
Figure 4. Reinforced soil walls in Rikuzentakata City (Kuвано et al., 2012, 2014).

Steel strip wall (Terre Armee wall), indicated as RSW1 in Figure 4, with the maximum wall height of 6 m was constructed at the junction of Hirota reclamation dike and the road embankment on the slope. The area was hit and fully submerged by the tsunami with the estimated run-up height of 17 m. Most of the about 500 m long reclamation dike was washed out by the tsunami except the small part which is near the RSW1 side end where the floodgate was located. Figure 5 is the front view of the damaged RSW1. It is seen that the only a part of the wall near the dike is seriously damaged. Figure 6 is a close-up view of the wall. The upper part of the wall collapsed. Many facing panels fell down and the backfill of the wall was lost. Though it is not clearly seen in this figure, the lower part of the wall was also damaged due to the scouring at the footing. Some of the footing members were brought out and part of soil was lost. Figure 7 is a typical cross section of the wall. Although the cross section is ordinary, the depth of embedment was probably about 40 to 50 cm and a bit too small as a coastal structure. It resulted in the damage of the lower part of the wall as mentioned above. However, it is to be pointed out that the most of the damaged part of the RSW1 was covered with the soil of reclamation dike before the earthquake, and probably therefore the footing depth was thought to be enough when the wall was designed. Another and more serious problem with the RSW1 was that the wall was not constructed continuously from the sea side to the land side. It was interrupted at the junction of the wall and the reclamation dike. The soil of the dike was probably washed out by the tsunami first. Then the backfill of the wall was eroded from the interruption of the wall toward the back of facing panels of the reinforced soil wall as seen in Figure 8. Once the backfill was lost, the facing panels and reinforcing members, which used to support the backfill, were not supported by the backfill and the panels fell down. If the wall was constructed continuously without any interruption, damage of the wall is thought to have been much less.

Although the steel strip wall (Terre Armeé wall), RSW1, was seriously damaged by the tsunami as mentioned above, it is probably not fair to conclude that Terre Armeé does not resist tsunami impact. Another Terre Armeé wall, RSW2, was located on the east side of the peninsula opposite to RSW1 as shown in Figure 4. The tsunami hit the peninsula from both east and west sides. The RSW2 was constructed on the beach to support the road as shown in Figure 9. The maximum wall height of RSW2 is 10.5 m. The wall was submerged in the tsunami with the estimated run-up height of 14.9 m. However, in contrast to the RSW1, the damage of the RSW2 was negligibly small as seen in Figure 10. There could be two possible primary factors of the small damage. The first one is that the depth of embedment is more than 1.5 m, much bigger than that of the RSW1. Therefore, the backfill of the RSW2 was not lost from the bottom of the wall. The second factor is that the backfill of the reinforced soil wall was fully covered with rigid concrete panels without interruption as seen in the RSW1 which was seriously damaged by the tsunami.

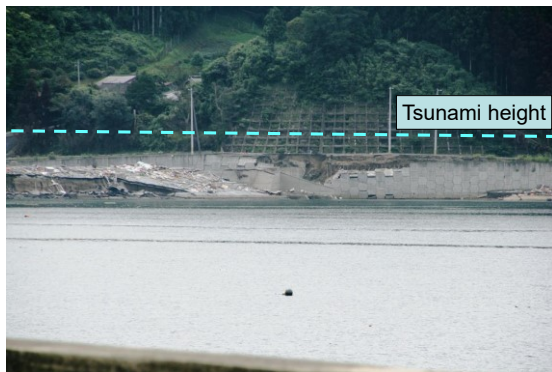
Figure 5. Front view of RSW1 (Kuвано et al., 2012, 2014).

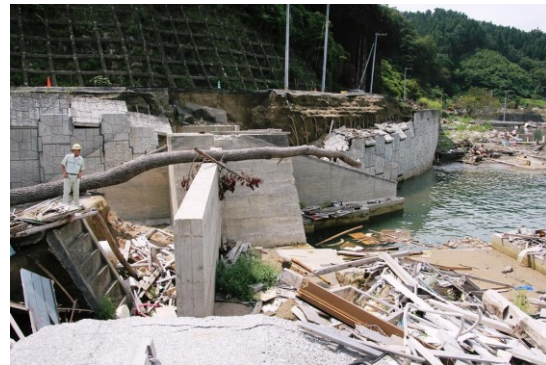
Figure 6. Close-up view of damaged RSW1 (Kuвано et al., 2012, 2014).

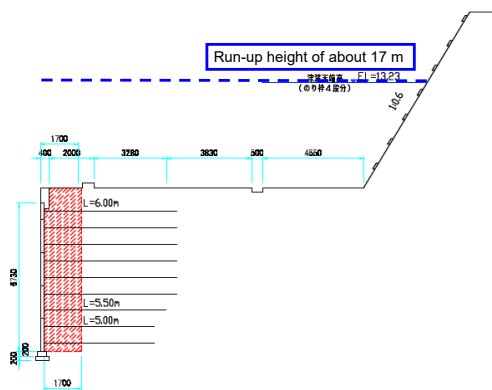
Figure 7 Cross section of RSW1 (courtesy of Dr. Otani, Hirose Corp.) (Kuвано et al., 2012, 2014).

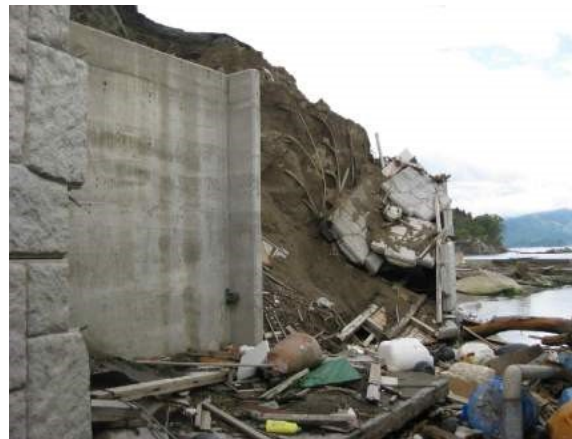
Figure 8 Erosion of the backfill of damaged RSW1 (courtesy of Dr. Otani, Hirose Corp.) (Kuвано et al., 2012, 2014).

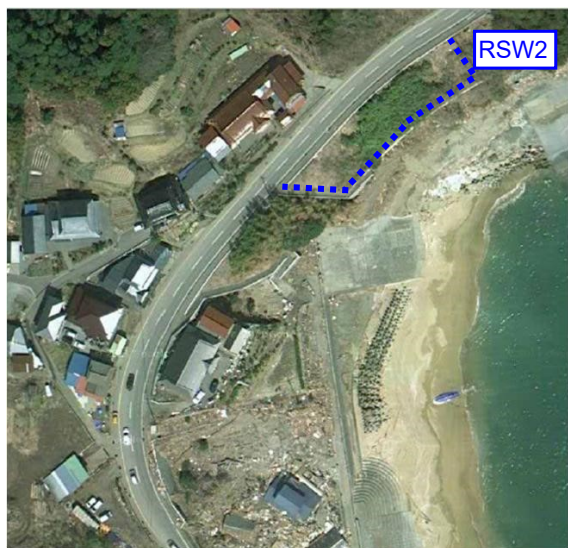
Figure 9 Location of RSW2 (courtesy of Dr. Otani, Hirose Corp.)
(Kuwano et al., 2012, 2014).

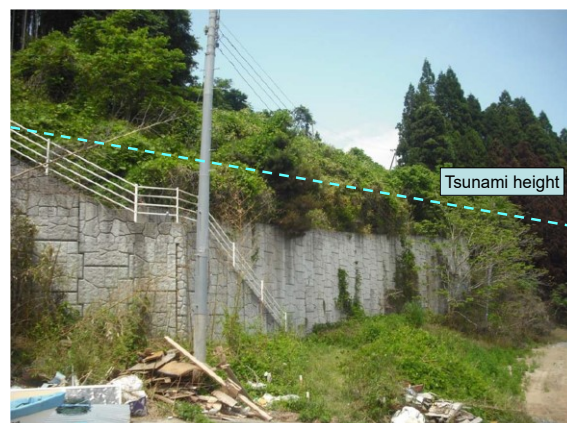
Figure 10 Close-up view of RSW2 (courtesy of Dr. Otani, Hirose Corp.)
(Kuwano et al., 2012, 2014).

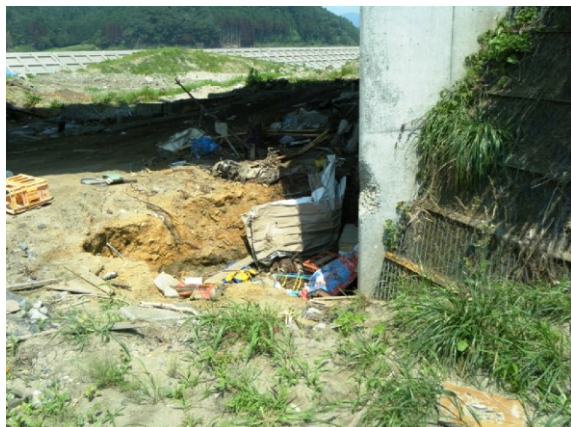
Figure 11 Scouring at the abutment of the Nanakiri overpass (Kuwano et al., 2012, 2014).

In the downtown area of Rikuzentakata City, Nanakura overpass of Route 340 across the Ofunato railway line was located near the Kesen River, along which the tsunami went upstream besides the invasion from the coastline. As the handrails of the bridge were bent down toward the river, the overpass was fully submerged and the power of tsunami was more from the sea side than the river side. Four reinforced soil walls with the height of about 7.7 m were constructed at the abutments of the bridge. It has expanded metal mesh facing units with layers of geogrids for reinforcement and geotextiles for horizontal drain. Scouring was found at the foundation of the abutment as shown in Figure 11. This scouring and the damage of handrails indicate huge impact of the tsunami on the bridge. However, damage of the walls was very limited, e.g. a small scoop of backfill as seen in Figure 12. Thin vegetation sheets behind the wire mesh facing panels probably protected backfill from erosion by the tsunami.

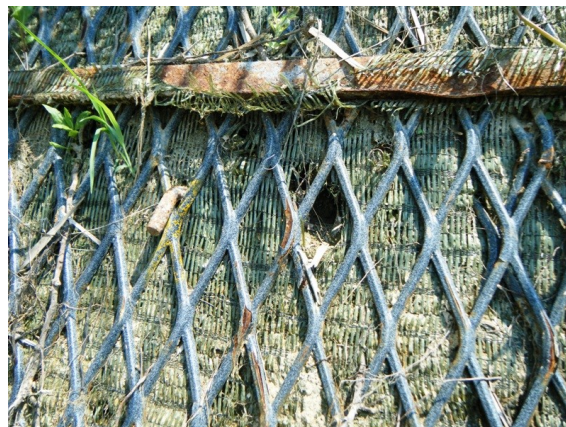
Figure 12 Slight damage at the expanded metal mesh facing of RSW3 (Kuwano et al., 2014).

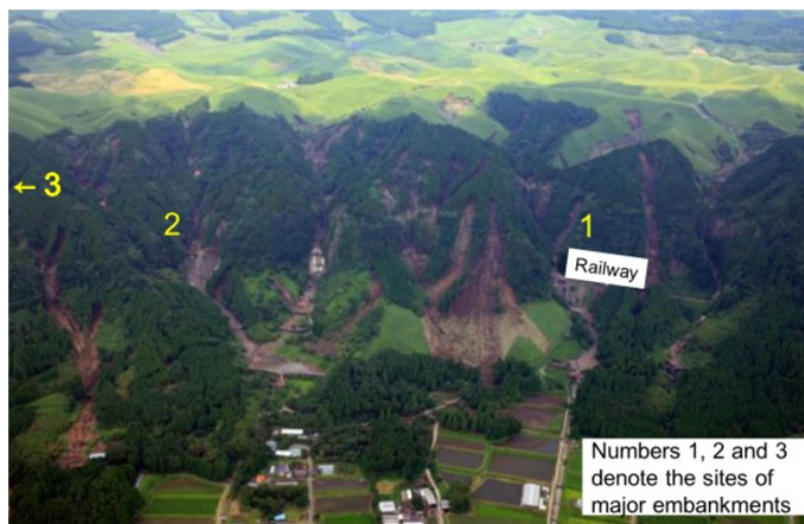
Figure 17. Aerial photograph of Ho-hi Line immediately after the 2012 heavy rain (Tatsuoka et al., 2007).

To arrange a 3 m-diameter drain corrugate pipe crossing the embankment, a nearly vertical GRS RW with FHR facing was constructed at the downstream toe of each embankment. From 12th to 14th July 2012, 23 years after the first event described above, another, more severe rainfall attacked these sites (Figure 17). The total precipitation during a period from early morning 12 July till evening 14 July reached 816.5 mm with a peak of 500 mm in 5 hours and 106 mm/hour, which was much more intense than the 1989 heavy rainfall with a total precipitation of 650 mm and a peak of 67 mm/hour. A number of embankments that did not collapse by the 1989 heavy rainfall were seriously damaged or totally collapsed by scouring, erosion by over-topping flood and seepage flow of rain water likely with a loss of suction followed by the development of positive pore water pressure. The three major geosynthetic-reinforced (GR) embankments that were reconstructed in 1991 were attacked by over-topping flood due to clogging of the 3 m-diameter corrugate drain pipes by mudflow from the upper reach. However, the main body of these GR embankments survived having been only partially eroded, despite that they were not designed against such over-topping flood. At the site 2 in Figures 15 and 17, the left-hand part (Oh-ita side) of the embankment located between two tunnel exits was unreinforced backfill that survived the 1989 flood and remained unchanged. This part was severely eroded by the overtopping flood of the 2012 rainfall (Figure 18). Figures 18c shows the eroded part of the unreinforced embankment after having been excavated to some extent for restoration works. On the other hand, the right-hand part (Kumamoto side) of the embankment seen in Figure 18a is located at the deepest place of the valley. This part was fully eroded by the 1989 flood and reconstructed with a GRS structure (Figure 16). The exposed cross-section of the GR

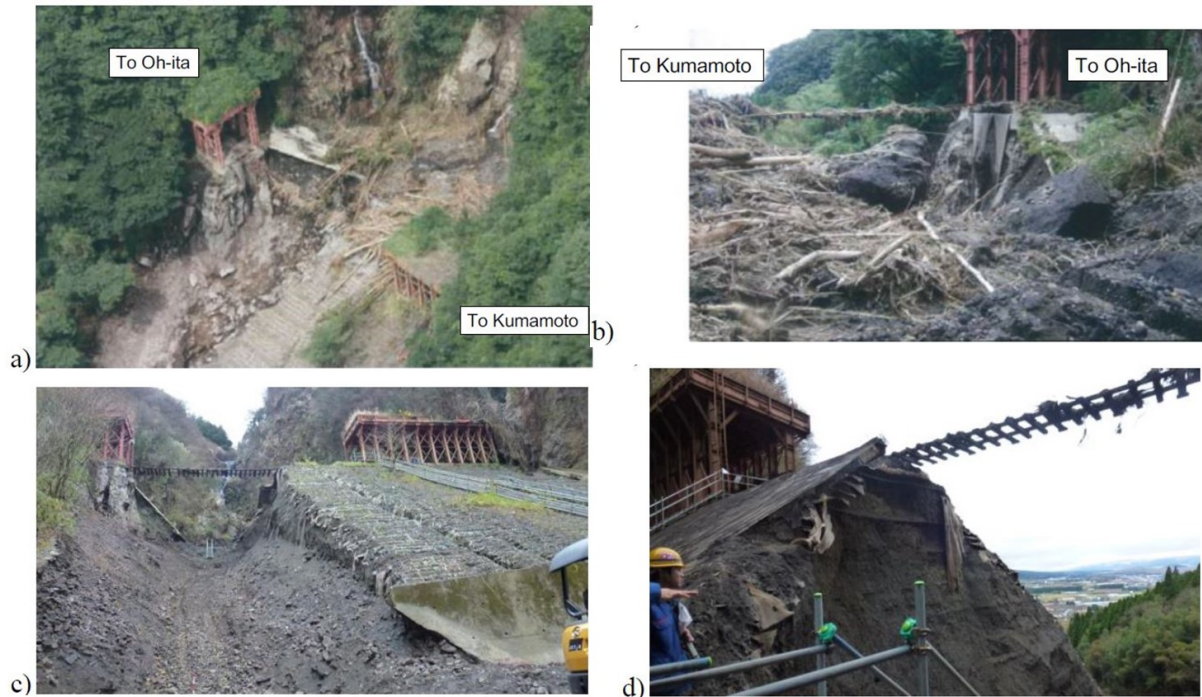
Figure 18. a) Aerial photograph; and b) a close view from upstream (a & b: immediately after the 2012 heavy rainfall, by the courtesy of JR Kyushu); and c) a view from the downstream; and d) exposed cross-section of geosynthetic-reinforced section (c & d: taken 26 November 2012). Site 2 of Ho-hi Line, JR Kyushu (Tatsuoka et al., 2007).

embankment is shown in Figure 18d. This part of GR embankment performed very well during the 2012 heavy rainfall: i.e., it may be seen from Figure 18c that only some surface layer of the downstream slope of GR embankment was eroded. Although relatively deep gullies were formed in the unprotected downstream slope of the GR embankment, these gullies did not further develop due likely to the resistance of geogrid layers against erosion.

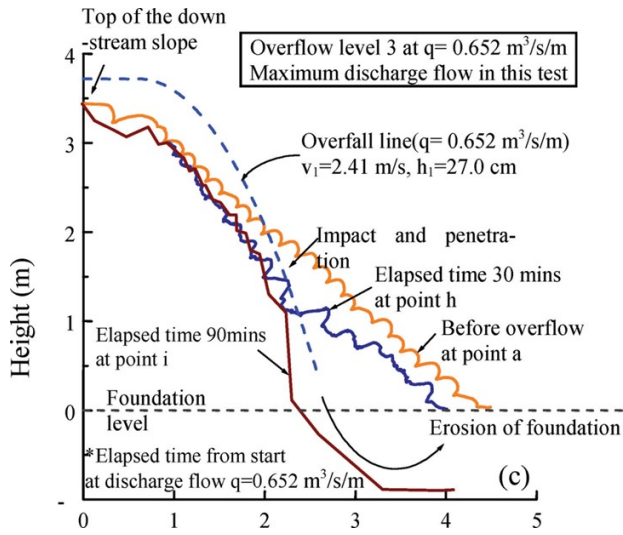
Figure 26. Lateral displacement of soil bag surface after overflowing tests (Mohri et al., 2007).

The flow rate was gradually increased from Step 1 to Step 7. Overflow water with a low flow rate went along the surface of the soil bag and was basically in the state of nappe flow, however, a small hydraulic jump occurred on each soil bag steps. In Steps 2 and 3, the overflow ran down the downstream slope of the embankment with the strong entrainment of air and entered a state of skimming flow. As a result, the running water started to separate from each soil bag surface, resulting in more sand being sucked from the soil bags. From Step 4, the water’s flow velocity increased more, causing a hydraulic jump at the crest. Figure 26 shows the lateral displacement of soil bag surface after overflowing tests.

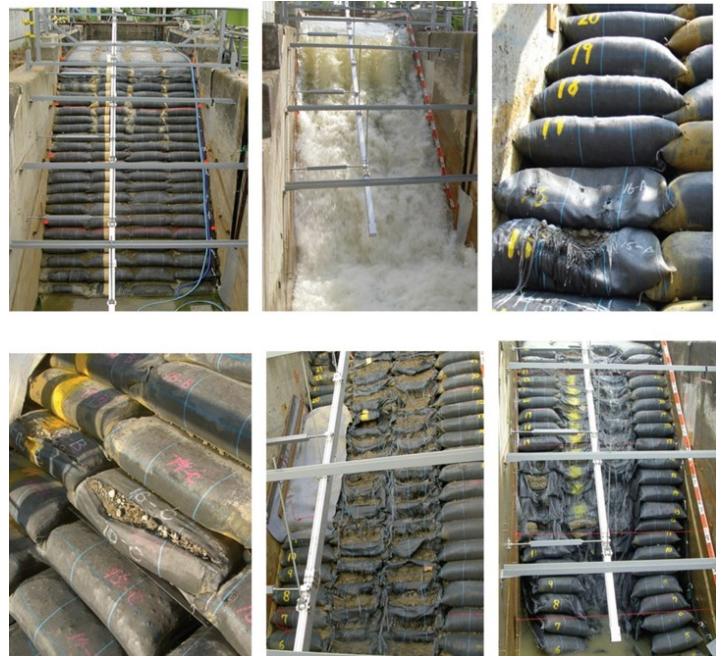
Figure 27. Eroded surface of Soil bags

In Steps 1, 2 and 3 with a low flow rate, only limited amount of soil leaked from the soil bags. In Steps 4 and 5, as shown in Figure 27, fill materials in the soil bags were discharged, so their surface sank. This phenomenon of washout occurred uniformly across the downstream slope of the embankment, but it was centered in the area where overflow water jumped from the crest landed. For Step 6, considering damage and deterioration of soil bag materials, artificial damage was given to the soil bags at the interface between the soil bags' surface and running water to continue this test. As the damage expanded, some of the fill materials were discharged. Thereafter, however, the bag materials covered the upper fill materials again and adhered tightly to the whole surface of the embankment, so the overflow water did not erode the embankment's materials directly, resulting in no overall collapse of the dam. In Step 7 (1.5m³/s), where water with a higher flow rate flowed continuously, a soil bag on which the overflow water landed directly broke, causing the successive destruction of lower soil bags. However, the lower part of the embankment did not deform further, and destruction of the whole dam did not occur. Based on these findings, it was demonstrated that GSET-dam had great resistance to piping and suction and remained stable without complete collapse against large overflow. In addition, it is effective to place materials such as soil-cement and vegetation on the surface of the soil bags to ensure the durability of small earth-fill dams.

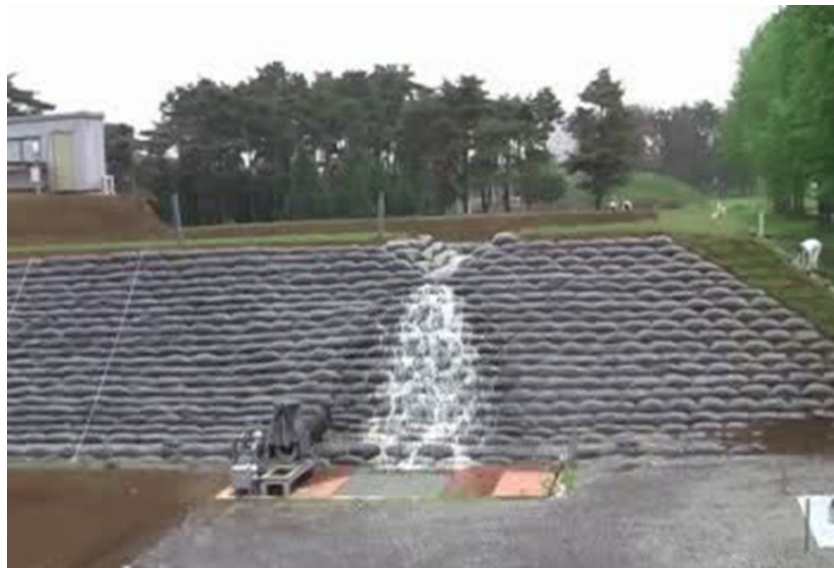
Figure 29. Overflow test of spillway of the full-scale field model earth-fill dam.

NARO constructed a full-scale earth-fill embankment using GSET as shown in Figure 28, examined its construction performance, observed its behavior during and after the construction and conducted a test to evaluate the long-term durability of the model. For this demonstration test, an embankment with a height of 3.2m, an upstream slope of V:H=1:1.5, a downstream slope of V:H=1:1.2 and a body width of 21m, in which 10 m of embankment was constructed with soil bags containing recycled crushed rock (RC-40), and 11 m was constructed with soil bags containing Kanto loam. In this field model test, the embankment was overlaid with soil-cement and vegetation to confirm the effectiveness of these methods of preventing UV deterioration of soil bags in the final stage. Overflow test of spillway of the full-scale field model earth-fill dam was carried out as shown in Figure 29 and proved high resistance of GSET-dam to overflow.

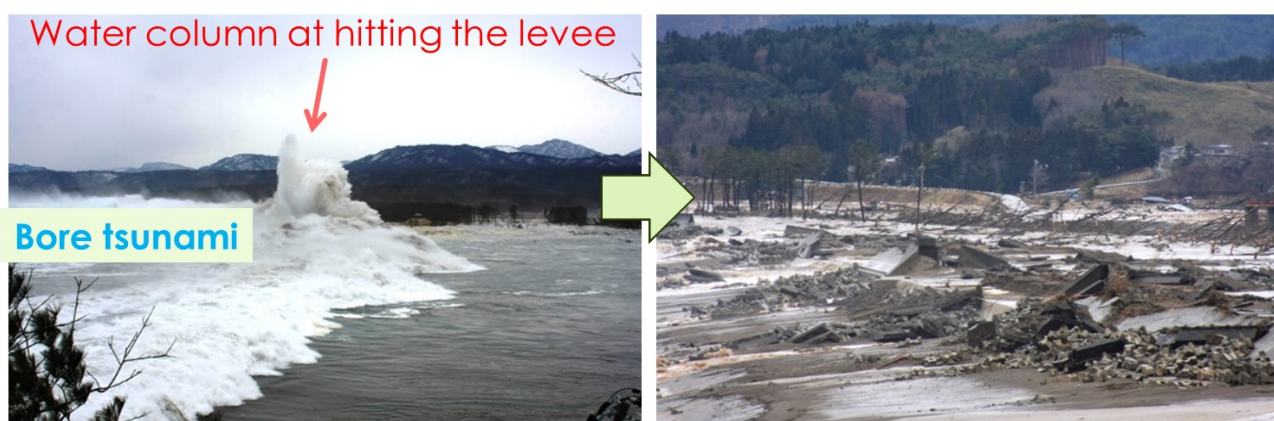
Figure 30. Tsunami and damage of coastal dike at Tofugaura in Iwate Prefecture.

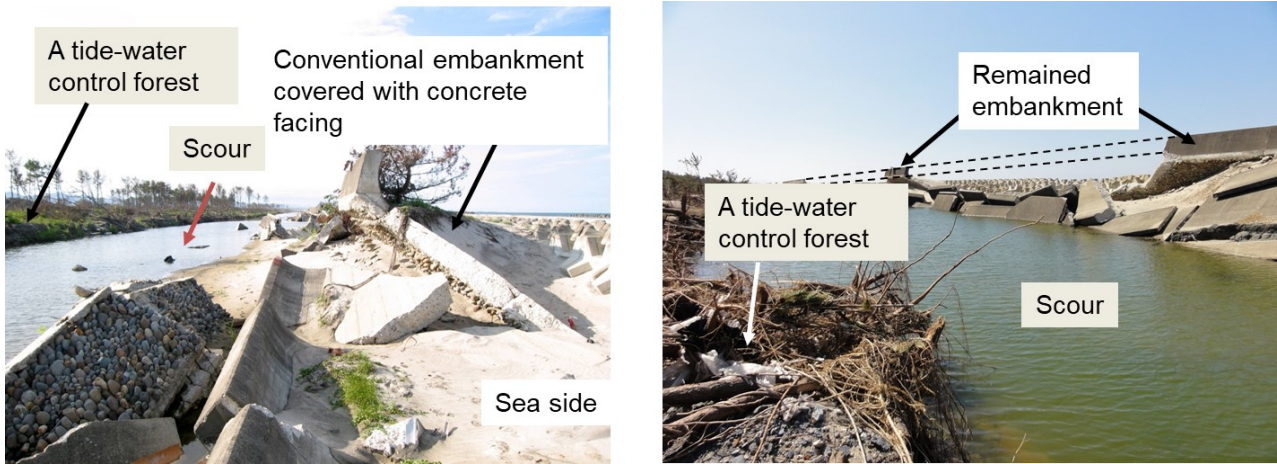
Figure 31. Damage of coastal dike and its surroundings.

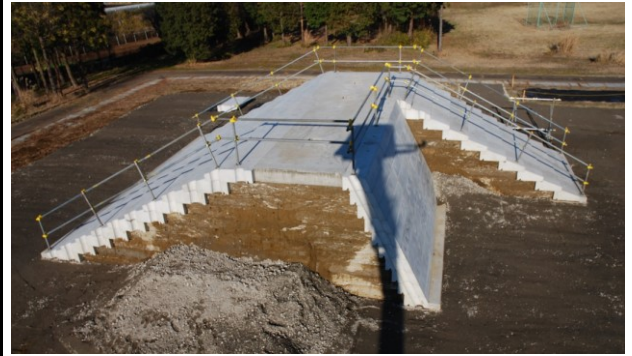
Figure 36. Construction of model GR-levees of gentle slope type and steep slope type.

Figure 35 shows example of GR-levee (seawall). Cement treated soil is used at the surface of soil embankment to reduce the erosion. Facing blocks are connected tight with reinforcing bars to prevent facings from being detached. Whole the components of GR-levee are combined with layers of geotextiles. As the GR-levee can make a steeper slope, 1:0.5 for example, as compared to the gentle slope of conventional dike, 1:2.0 for example. It means the GR-levee can be higher than the conventional type coastal dike for the same land width. Model GR-levees of gentle slope type and steep slope type were constructed successfully as shown in Figure 36.

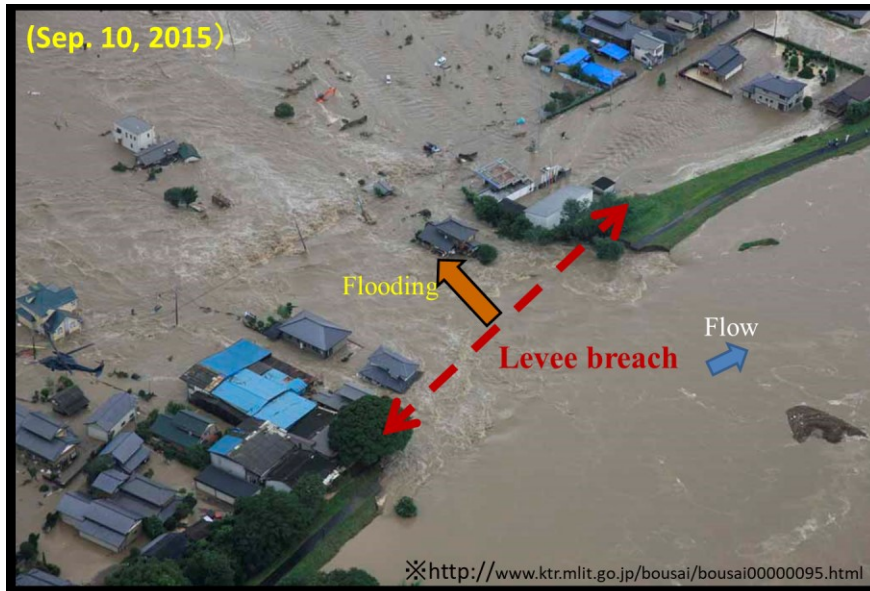
Figure 38. Levee breach in Kinugawa River was caused by extreme flood due to typhoon No. 18.

levee breach in Kinugawa River, Japan as shown in Figure 38. This breach was mainly due to overflow and resulted in extensive flood damage in Joso City, Ibaraki Prefecture. Levee failures have occurred in a number of places globally and have caused severe damage along rivers. River levees are generally designed to protect against scour, infiltration, and earthquakes for water levels below the designated high water level (HWL), and hence overflows exceeding the HWL are not generally considered for the design of river levees. Earthen levees made up of sediments, including sand and clay, are typically found in the world because river levees are originally semi-natural structures made of sediments transported from upstream regions of the river. However, earthen levees have the potential to fail due to overtopping flows. Armored levees, which are covered with concrete panels, have been introduced to reinforce the levee against overflow erosion, though such levees can still collapse due to overflow erosion when the panels are swept away by the current created by a flood. The development of a new reinforcement technology for a river levee to withstand floods and earthquakes is needed.
