Geomembrane liner failure: modelling of its influence on contaminant transfer

V. Nosko

N. Touze-Foltz

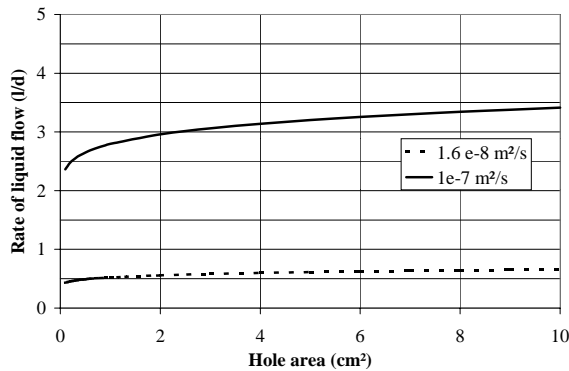
Figure 3: Evolution of the rate of liquid flow with the hole area, for the two values of hydraulic transmissivities adopted for the axi-symmetric case

Figure 3 Shows the evolution of the rate of liquid flow obtained for a single hole for both values of hydraulic transmissivities adopted. The hydraulic head on top of the composite liner was equal to 0.3m for the calculations performed. One can notice that the hole size is not the influent parameter on the rate of liquid flow, whatever the value of hydraulic transmissivity. As shown on Figure 3 the hydraulic head is a much more important parameter. Indeed, the rate of liquid flow is nearly proportional to the hydraulic head applied on top of the composite liner. As a result, it seems that as far as circular holes are concerned, it is much more important to perfectly know their location than their size in order to adequately estimate the rate of liquid flow through the composite liner.

One can notice as well on Figures 3 and 4 that an increase in the hydraulic transmissivity by a factor close to 5 results in an increase in the rate of liquid flow by nearly the same factor. As a consequence, the use of a geotextile in the transmissive layer resulting in an increase of the hydraulic transmissivity may not be a convenient practice as it will significantly contribute to increase the rate of liquid flow. More research is needed to clarify this point and especially to quantify the hydraulic transmissivity of the transmissive layer at field scale.

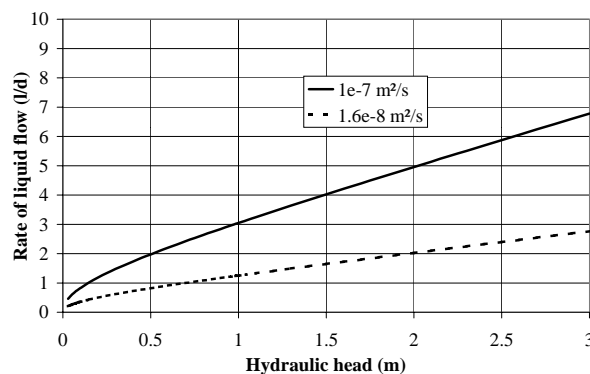
Figure 5: Evolution of the rate of liquid flow with the hydraulic head, for the two values of hydraulic transmissivities adopted for the two-dimensional case

For calculations performed assuming a damaged wrinkle in the geomembrane, the width of wrinkle adopted was 0.2 m. Figure 5 shows the rates of liquid flow obtained as a function of the hydraulic head applied on top of the composite liner. The evolution of the rate of liquid flow (given here for a meter of wrinkle) with the hydraulic head is nearly linear, especially for hydraulic heads greater than 0.5 m. The rate of liquid flow is less sensitive to an increase in the hydraulic transmissivity than in the axi-symmetric case. Indeed, the increase from a value of θ equal to $1.6 \times 10^{-8} \text{ m}^2 \text{ s}^{-1}$ to a value of θ equal to $1.6 \times 10^{-8} \text{ m}^2 \text{ s}^{-1}$ results in an increase by a factor 2.5 of the rate of liquid flow.
