HEIKINHEIMO, R., IPT Foundation Consultants Ltd., Finland

**THE USE OF GEOTEXTILES FOR EMBANKMENT REINFORCEMENT IN TURKU HARBOUR**  
**UTILISATION DE GEOTEXTILES POUR LE RENFORCEMENT DES RAMBLAIS DANS LE PORT DE TURKU**  
**ANWENDUNG VON GEOTEXILIEN BEI DER VERSTÄRKUNG DER BÖSCHUNGEN DES**  
**TURKUER BOOTSHAFENS**

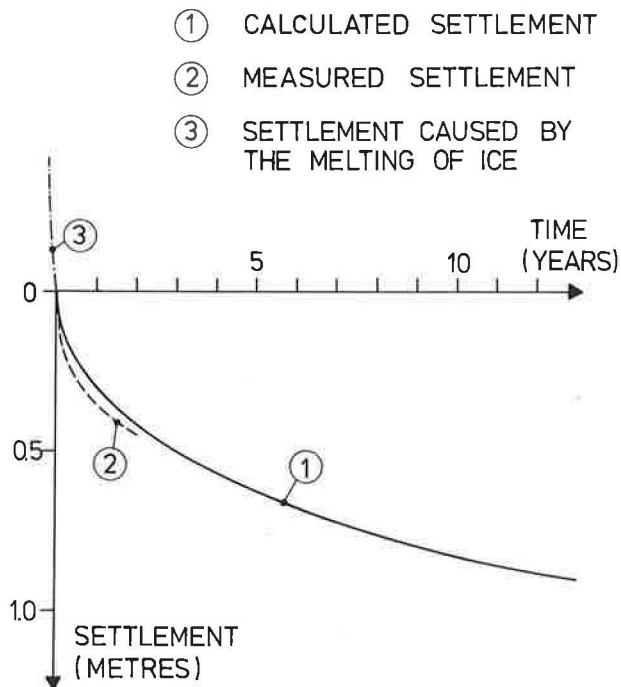
Figure 4 The estimated and measured settlements of the embankment

The total settlement in the long-term has been calculated to be of the order of 3.0 metres after a consolidation period of hundreds of years. According to the oedometer test data obtained, the settlement of the embankment will reach a value of ca. 0.8 metre in the first ten years (Fig.4).

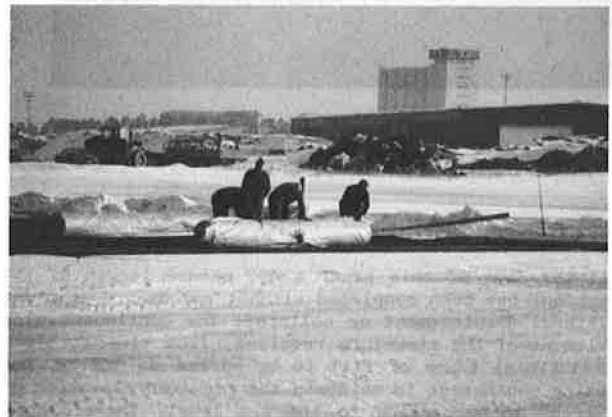
Figure 5 Spreading out of the geotextile on ice

The strips of reinforcing fabric were spread out across the embankment area in the winter time on top of the ice, stitched together and then covered with a protective layer of sand (Fig.5 and 6). In the spring, after the thaw, when the fabric with its cover of sand had sunk down to the sea bed, the successive structural layers of embankment bulk material were built up in due course (Fig.7).

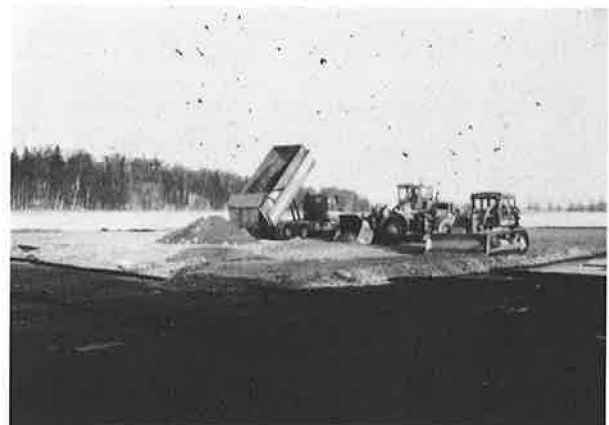
Figure 6 Laying of a protective layer of sand to cover the geotextile

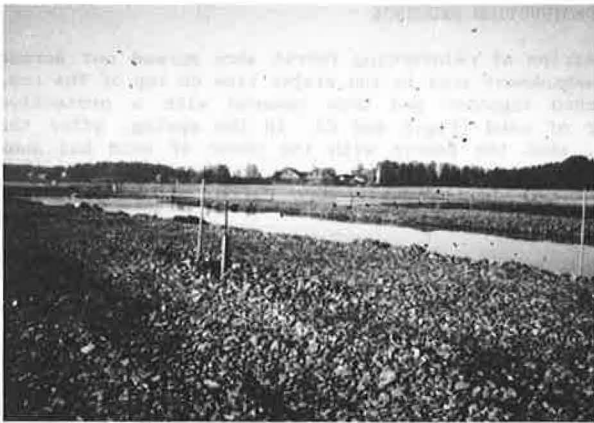
Figure 7 Summer 1984. Ice cap melted. Bordering embankments filled in.
