Geotextile structures used for the reconstruction of the Motorway Munich–Salzburg

G. Bräu

R. Floss

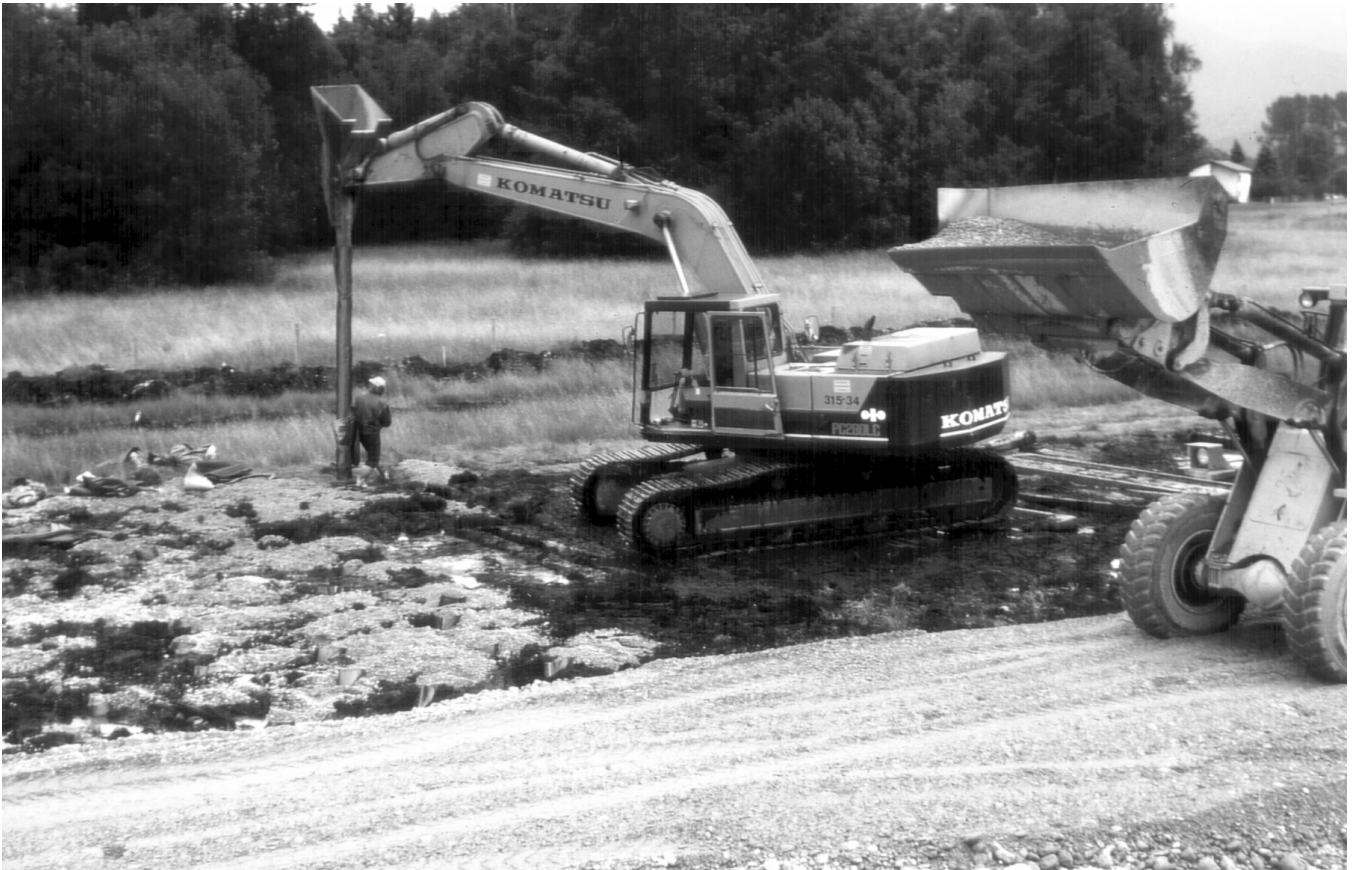
Figure 1: Installation of geotextile coated gravel columns

Geotextile coated gravel columns consist of a hose from a high-strength woven fabric with a diameter of approx. 20 cm sewn at the foot. This is pulled over a steel tube installed at an excavator, filled with gravel or splitt (fig. 1) with a granulation 8/16 mm and then pressed into the soil. A raster of the insertion points of approx. 1.5 m in the triangle was used. The maximum length of the columns is limited by the arm construction of the excavator and is usually within 5 - 6 m. The installation process lasts only few minutes for one column, so that daily performances of approx. 150 gravel columns are usual.

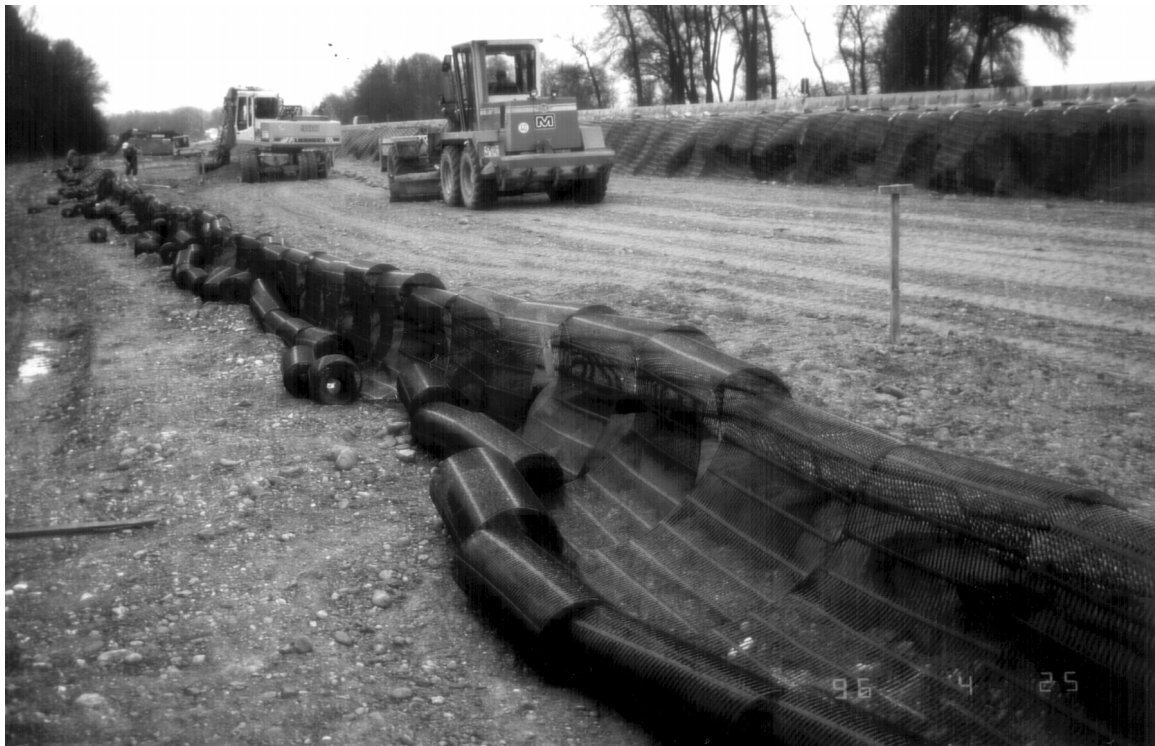
For this at the edges of the section to be covered an auxiliary formwork is set up, the lower part of the geosynthetic layer is inserted and the gravel fill is applied in a height from approx. 40 to 50 cm. After compacting this soil layer the excess lengths of the geosynthetic from the lower position are turned up and connected over the gravel fill for direct force transmission. When using woven fabrics as reinforcing elements this could be achieved by sewing with a appropriate site hand sewing machine. For geogrids bars, rods or cable straps could be used.

Figure 4: Installation of “gravel mattress” within former pond

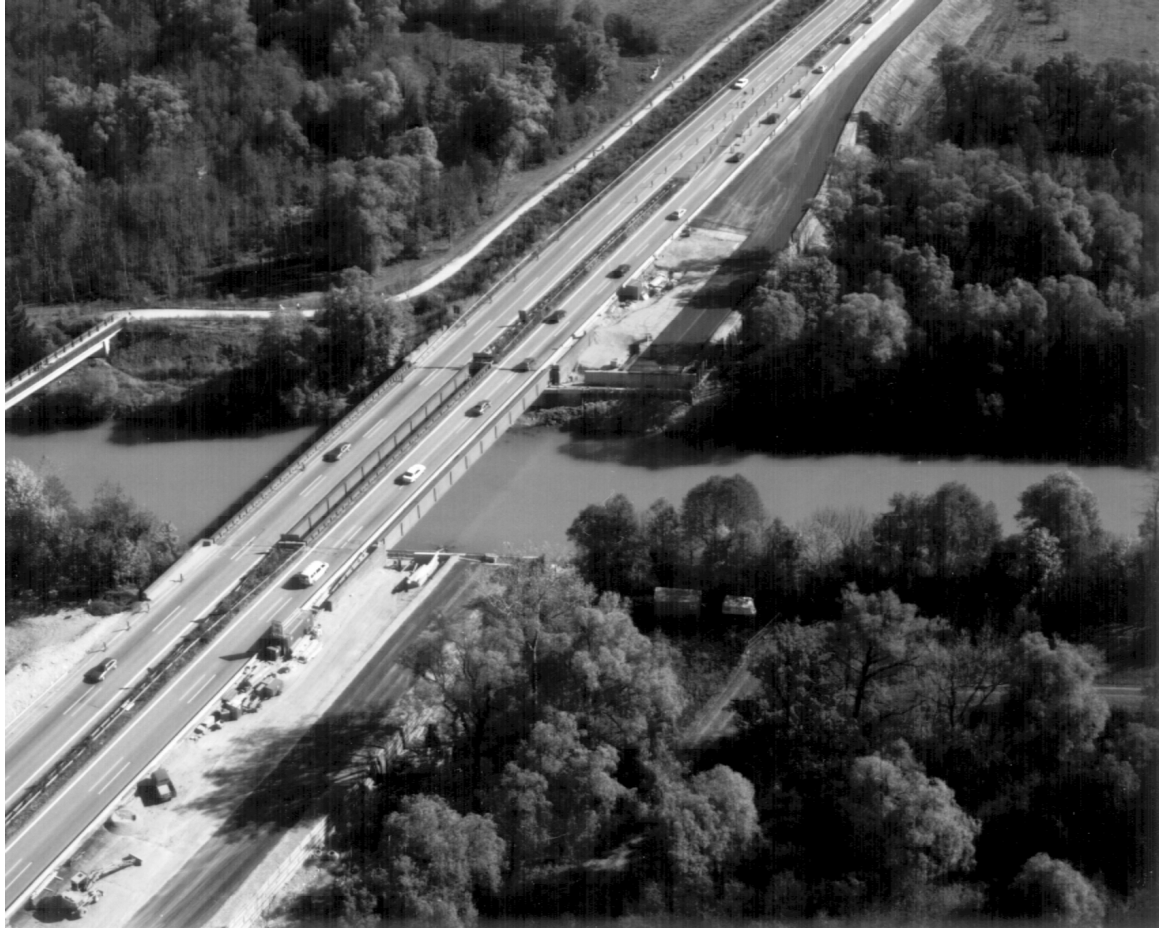
Figure 5: Location for temporary reinforced slopes at river “Tiroler Ache” within nature reserve areas

Due to expected great absolute and differential settlements within this area a flexible, geotextile reinforced steep slope was designated for this temporary building. On a length of approx. 300 m two walls with a height up to 5 m were established. The design and calculations were oriented at the actual german regulations (FGSV 1994, DGGT 1997).

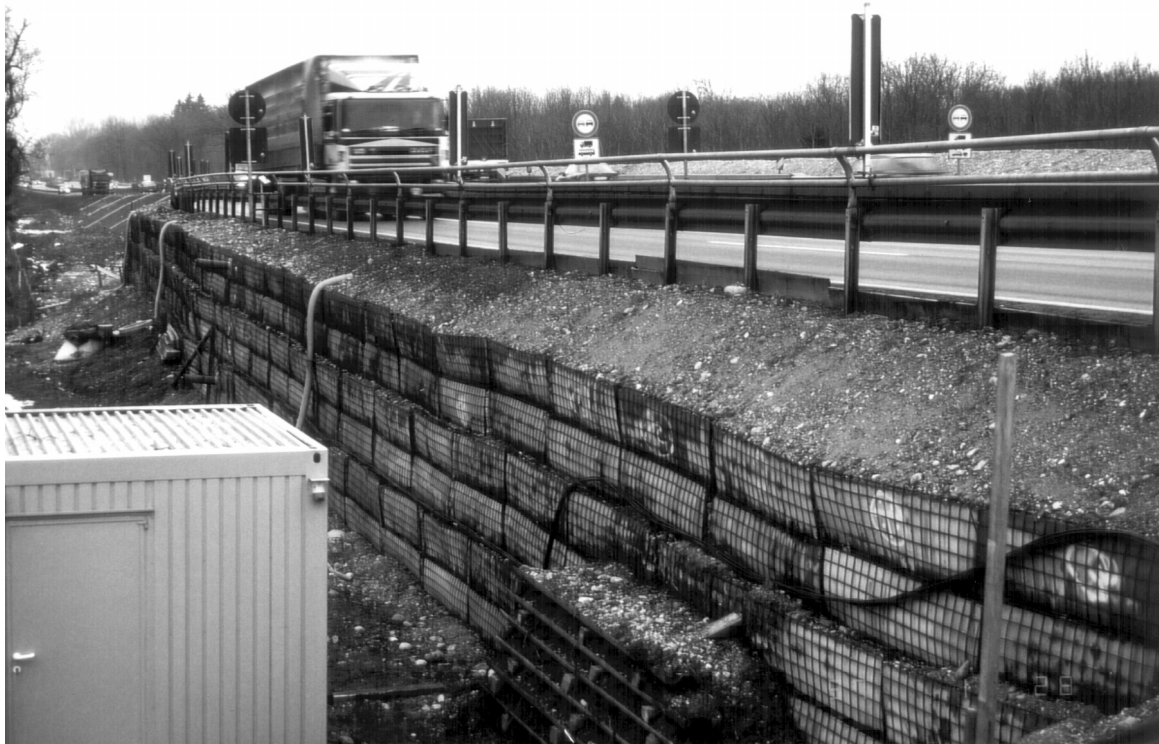
For the front formation "steel grid elements" consisting of a preformed structural steel fabric were used, which served with an inserted wooden plate as lost formwork.

Figure 6: Temporary reinforced slope under heavy motorway traffic

As the walls were directly under heavy motorway traffic and no experience existed for this special topic in Germany, an extensive measuring program was installed. This program was also necessary due to the highly compressible and strongly changeable subsoil conditions with resulting large settlements. Both, vertical and horizontal extensometers, bowden cable displacement gauges as well as earth pressure and pore water pressure transducers were inserted in the wall and in the backfill. The results are tied up over extensive geodetic measurement.

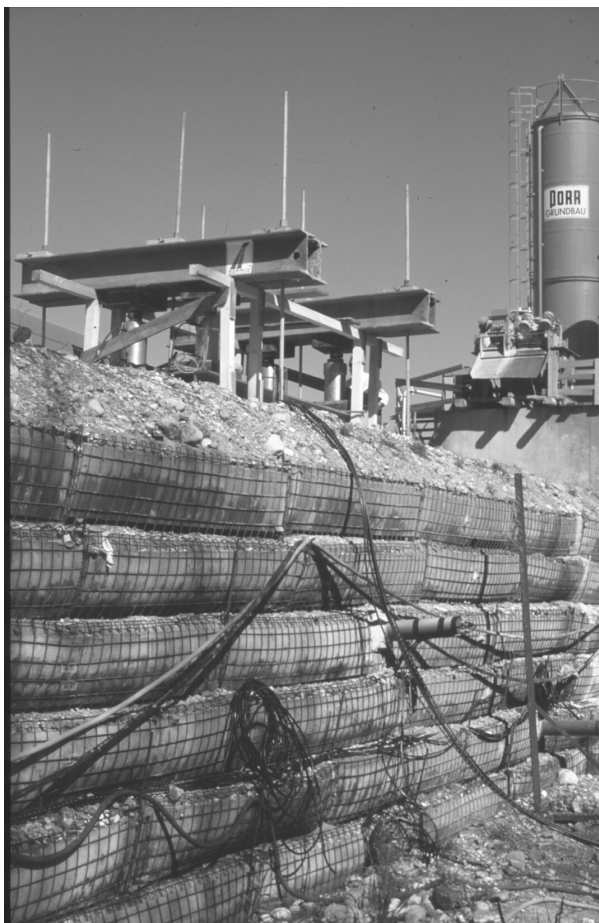
Figure 7: Cross section with loading system

As dead loads were expected to be not sufficient to stress the walls, 6 ground anchors with length of 15 m each were installed for each of the two walls. Between this 6 anchors used as abutment a loading system was built with a loaded area of 2 m x 2.5 m. With 4 hydraulic pistons a maximum load of 4000 kN was possible. The maximum pressure reached during the test was 800 kPa for the wall with material A and 600 kPa for the wall with material B. This resulted only from failures of the ground anchors (pull-out resistance and reaching the yield point of the steel).

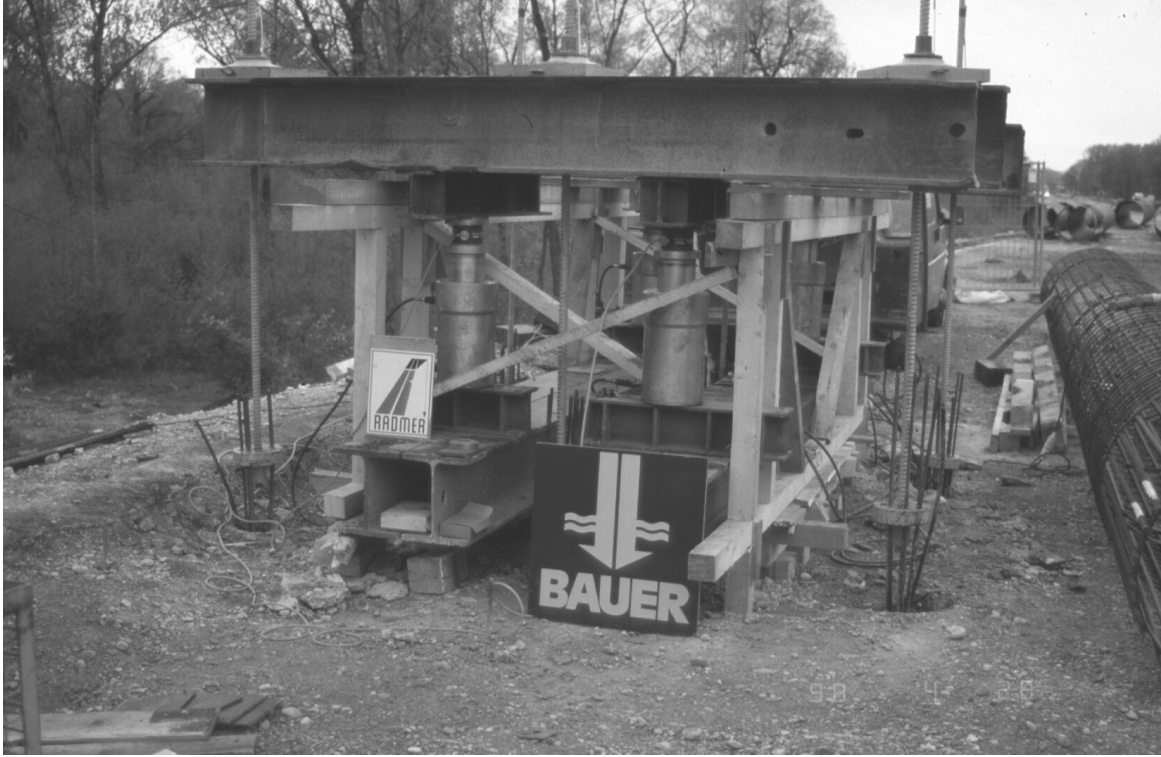
Figure 8: Ground anchors as abutment for test loading of the reinforced slope

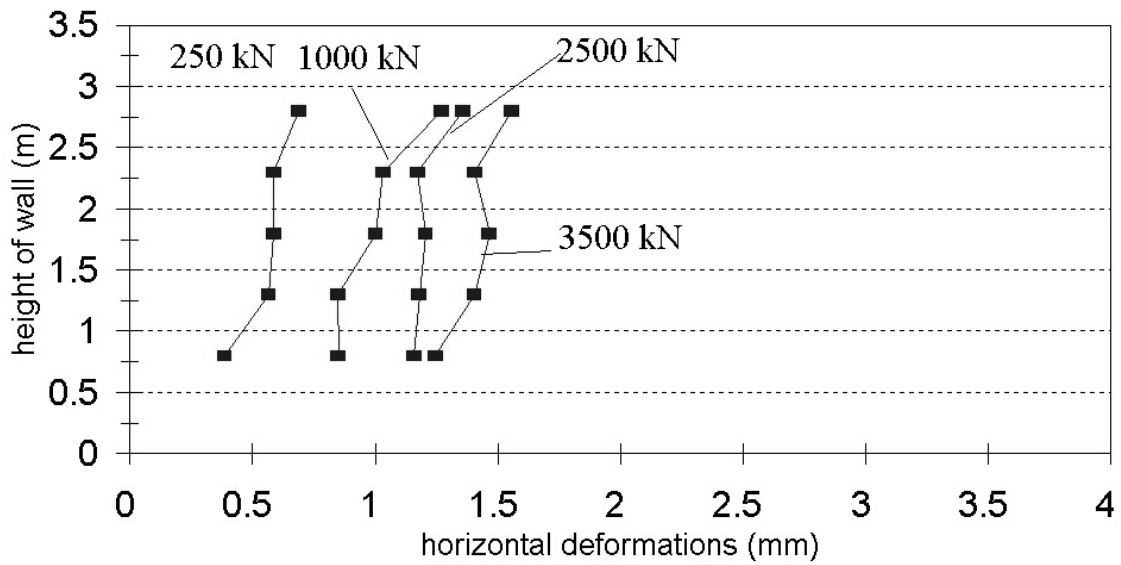
Figure 9: Horizontal deformations of wall 1 during test loading (geogrid reinforcement)

The observed horizontal and vertical deformations are shown in figure 9 and 10 and demonstrate the good performance of the constructions. There was no sign of failure anyway. As the walls were calculated due to the actual standards with only the necessary factors of safety and a traffic load of $p = 33.3 \text{ kPa}$, the surcharge of 20 to 25 times the design value shows the reserves of the systems bearing capacity or the possibilities for optimizing the calculation methods.

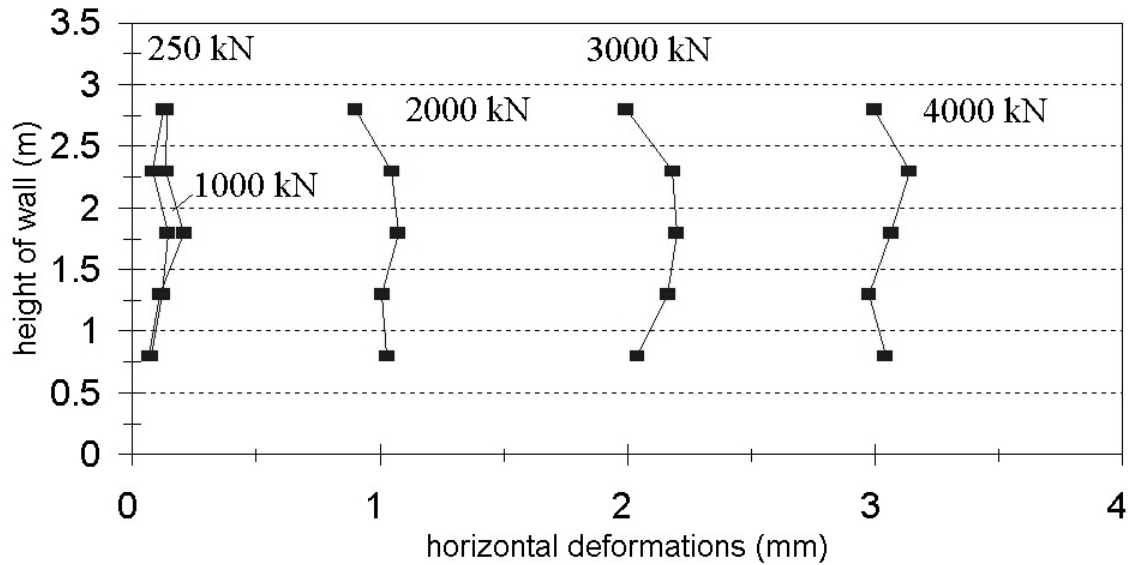
Figure 10: Horizontal deformations of wall 2 during test loading (composite reinforcement)
