Walls over compressible soils and unstable slopes. Examples

A. Ramirez, F. Valero & C. Perez
Tierra Armada S.A., Madrid, CAM, Spain

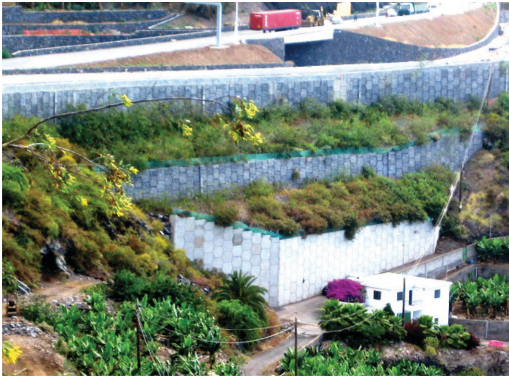
Figure 2. Tiered walls at Icod de los Vinos (Tenerife, Spain).

The contribution of the two walls to the increase of stability was not equal: it was the intermediate one who more effectively contributed to the slope stabilization. That wall was designed using a trapezoidal cross section, but the longer reinforcements were placed at the lower block instead of on the upper, as these walls are typically projected. (Figs. 1–2)

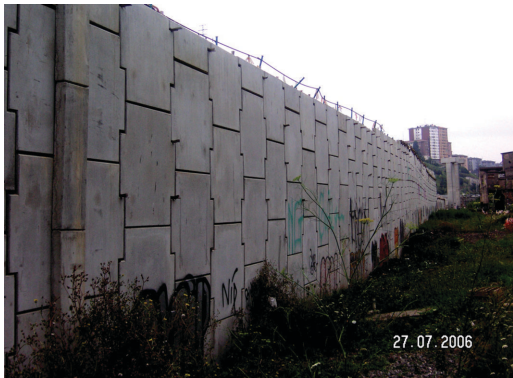
Figure 5. Huge settlements (0.5 m–0.75 m) suffered along the wall's facing with no cracked panels reported at all. See the horizontal joint's deflection.

Because of this, big settlements were observed; although some settlement was already expected, it was not in the same amount as it was observed. The wall suffered from a maximum settlement of nearly 0.75 m (Fig. 5). In spite of this settlement, the structure showed no disruption along its length. This behaviour was to be expected and, as the wall was built in several construction stages, some added measures were considered.

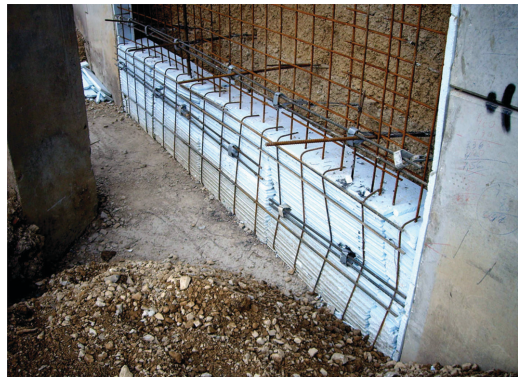
Figure 6. Repairing jobs. Elastic joint of expanded polystyrene placed at the footing.

Once the settlement of the foundation soil started, the backfill followed this movement, while the facing started cracking because of the vertical displacement restraint. As a consequence, some of the ties that linked the reinforcement to the facing panels broke. It was necessary to repair the facing and to make an EPS' elastic joint at the footing in order to reduce the remaining settlement (Fig. 6).
