# Earthen channel lining trials

Keywords: earthen channels, geomembranes, geosynthetic clay liners, trials

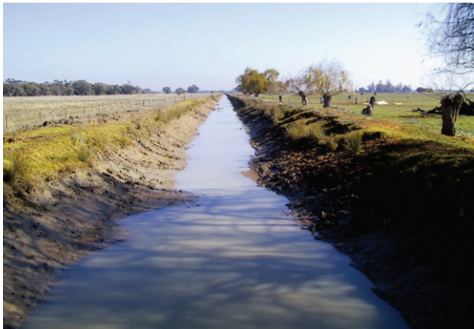
Figure 1. Typical unlined channel.

The unlined channels were typically rough and unevenly shaped with ponded water, animal tracks and burrows and occasional tree roots. They were prepared for liner installation by removal of standing water, minimal reshaping and tree root removal by an excavator and excavation of anchor trenches as required.

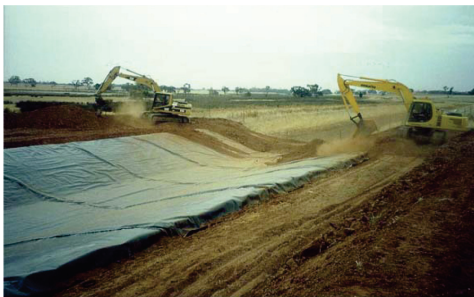
This section of channel was approximately 20 m wide and 1200 m long and this was a much larger trial than the other installations. The liner was fully welded and QC tested as per normal practice. The soil cover was material previously overexcavated from the channel bed and stockpiled to each side. It was placed and spread by backblading with excavators.

Figure 2. Soil cover installation over 0.75 mm HDPE.

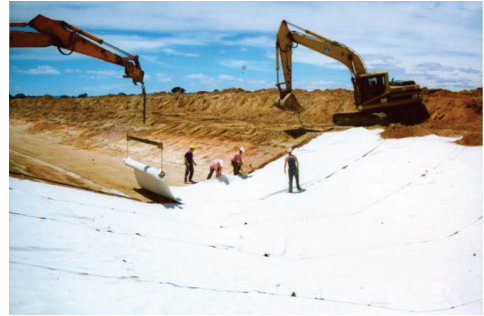
The GCL liner was installed at Tooloondo channel in 2002. Preparation for the GCL also required overexcavation to provide the final soil cover which

Figure 3. GCL installation.

was again placed and spread by excavators. It is to be noted that the soil cover must be placed before the GCL becomes wet as unconfined or premature hydration can permanently damage the GCL. The GCL seams are overlaps with supplementary bentonite.

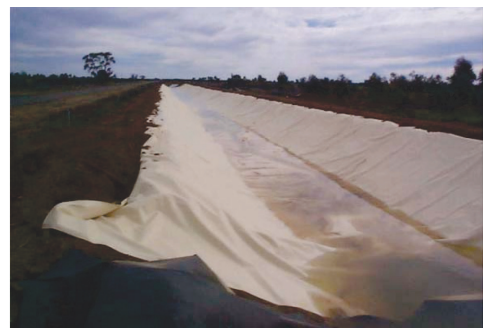
Figure 4. Reinforced PP a1.1 mm.

The major advantages expected of reinforced PP are in the form of better thermal stability and hence less thermal expansion/contraction and the potential for better resistance to puncturing by hooved animals. It was installed at the Finley Main Channel in 2001.

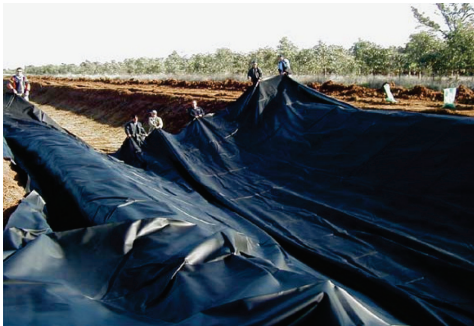
The major feature of 0.75 mm PP is that it is able to be prefabricated into large panels such that the trial installation was entirely prefabricated. This does require good advance information on the channel size and profile. It was installed at the Finley Main Channel in 2001.

Figure 5. Unreinforced PP 0.75 mm (Note large crew size).

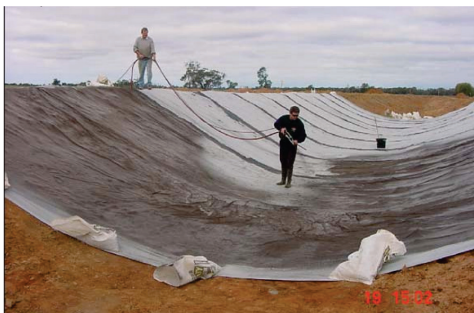
The product used was a rubberised bitumen emulsion in a water based carrier. It was applied cold in multiple coatings over a geotextile carrier. Some UV deterioration is expected and a periodic overcoat is recommended for exposed portions every 2-3 years.

Figure 6. Rubberised bitumen emulsion.

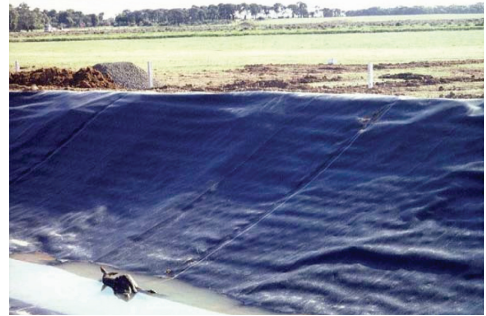
HDPE 1.5 mm is the most common grade of HDPE and this was installed in the normal way with cross seams. One of the hazards for these installations is the local wildlife and this was well illustrated by the discovery of a dead kangaroo one morning when the installation was almost complete. The surface is extremely slippery and the animals cannot get out.

Figure 7. HDPE 1.5 mm (note dead kangaroo).
