Bench-type wall with flat slabs and steel bars

ABSTRACT: This paper describes test results of a bench-type reinforced soil wall with the combination of concrete slabs and steel bars. A steel bar with a piece of steel plate was inserted from outside through a hole in the slab. Backfill soil expanded horizontally, and the bars resisted expansion of the soil. The backside slope of the backfill was 45° in inclination. Panel-type earth pressure gages were placed there, to measure normal and tangential components of earth pressure. Both horizontal and vertical movements of several points in the backfill were measured. Therefore, relative displacement between bars and soil, and stress distribution in the backfill, could be clarified to some extent. Deformation was observed in early spring due to percolation of melting snow, but no sign of rupture was seen. The state of unequal settlement of soil layers in the backfill was recorded by the deformation of bars.

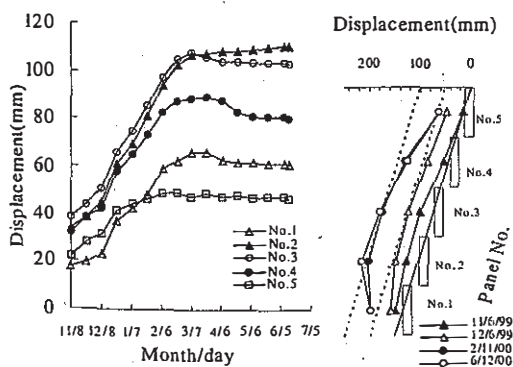
Figure 2. Horizontal displacement of the front panels.

The front panel moved both horizontally and vertically. Figure 2 shows the displacement of panels during and after the construction. Large displacement occurred after the construction. The three months from December to February are winter, and the temperature drops to below zero (coldest: -18° C), and snow falls. This is the cause of large displacement. Displacements of steps 2 and 3 were larger than those of other steps. The base of the front wall moved both horizontally and vertically. Therefore, inclination of the front face did not change very much. The original inclination was 16.7°, and the final inclination was 16.7+1.7=18.4°. The predicted value of displacement was 75mm, which is 1.4° in

inclination. This value is very close to the measured value of 1.7°.

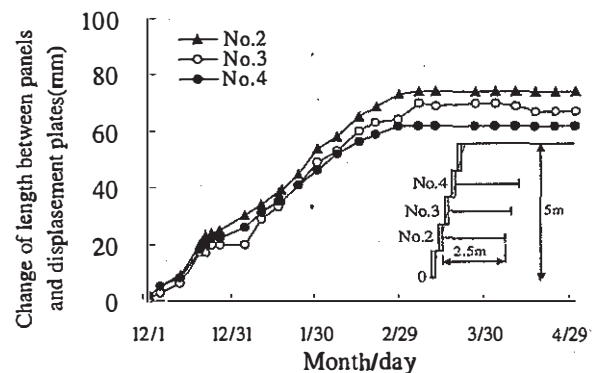
Figure 3. A change of length between front panels and the horizontal displacement plates with the passage of time.

Five plates were buried in the backfill. Two plates were placed near the back slope, to measure displacement of the backfill there. It was found that the back slope did not move. Three plates were buried at points about 2.5m from the face panel. These plates moved only 2-3mm. This shows that the backfill between the plates and the back slope elongated very little. The backfill between the front wall and the 3 horizontal displacement plates elongated largely, and the front panels moved forward as shown in Figure 2. Figure 3 shows a change of length between the front panels and the horizontal displacement plates with the passage of time. An increase in length was found only during winter. As for friction between soil and bars, bars near the wall face work to prevent forward movement of soil and the rest part of the bars work as an anchor.

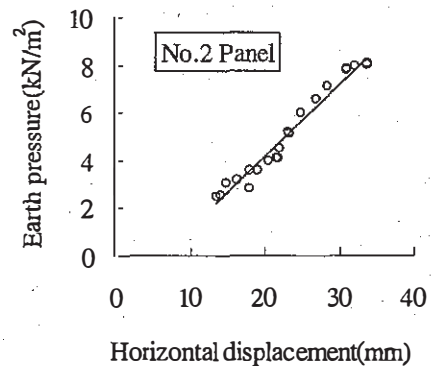
Figure 8. Horizontal displacement versus earth pressure for Panel 2 during construction

The coefficient of linear deformation $E=3.3$ MPa was obtained by taking the following data.

- Horizontal earth pressure $\sigma_h=8.5\text{kN/m}^2$,
- Vertical earth pressure $\sigma_v=18.47\times 3.5=57.6\text{kN/m}^2$,
- Horizontal displacement $\Delta l=0.034\text{m}$,
- Horizontal length of the soil layer $l=6\text{m}$,
- Poisson's ratio $l/m=1/3$.
