EARTHQUAKE PERFORMANCE OF TWO STEEL TANKS ON GEOTEXTILE REINFORCED EARTH

M. Incecik, R. Iyisan

Istanbul Technical University, Civil Eng. Faculty, Geotechnical Engineering Department, Turkey

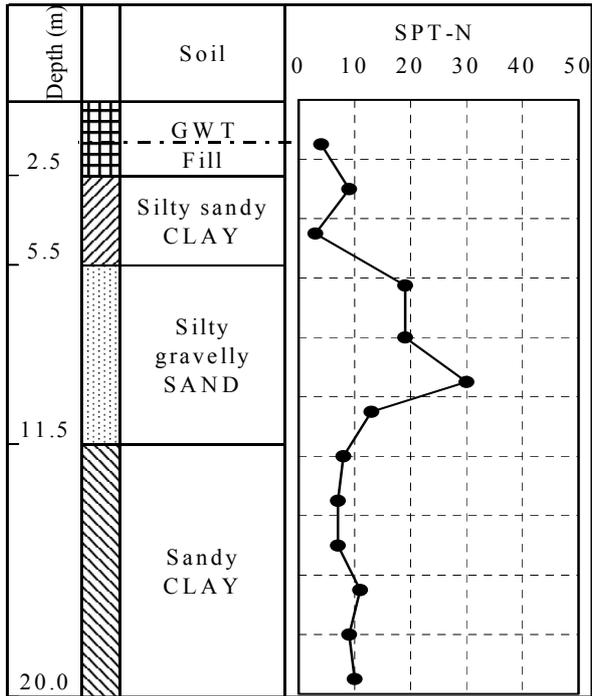
Soil profile obtained from the borings consists of a fill with thickness of about 2.5 m, underlain by a medium to stiff silty sandy and low plasticity clay with thickness of

about 3 m, underlain by a medium to dense silty gravelly sand layer between the depths of 5.5 and 11.5 m. Under this layer, a stiff sandy clay layer is located down to the end of borehole. A typical soil profile, including the SPT-N values based on subsurface borings is given in Figure 2.

Figure 2 A typical soil profile based on the subsurface borings

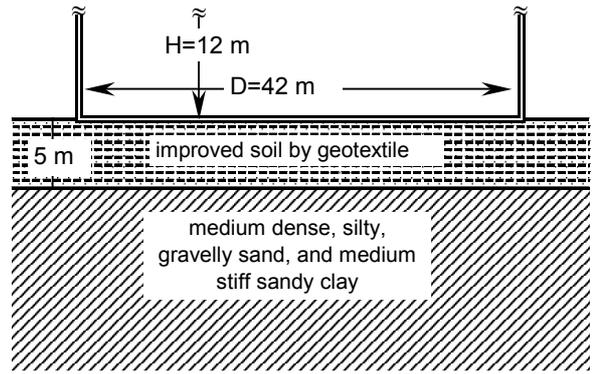
During the foundation design, it is found out that the shallow foundation placed on the existing subsoil profile at the site does not have enough bearing safety. Therefore, use of geotextile to reinforce earth has been suggested to improve the bearing capacity of foundation soil. For this purpose the ground was excavated to a depth of 5.5 m and woven polypropylene geotextiles were placed on compacted fill material in every 50 cm. Figure 3 shows schematically the cross section of the tank and improved soil at the site.

Figure 3 Tank on the geotextile reinforced soil (no scale)

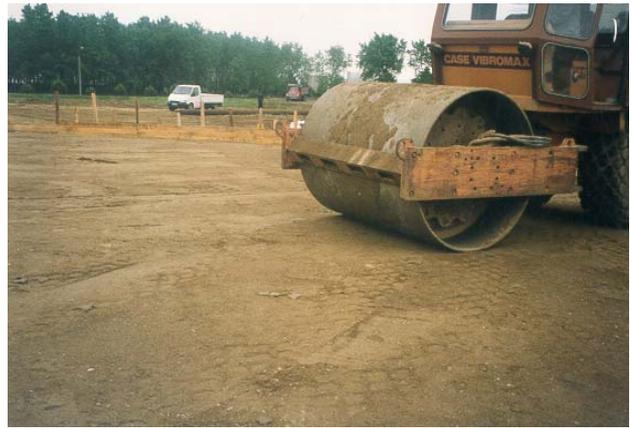
For improving the soil at the site, the existing uncontrolled fill at the top and the underlying clay layer were excavated to 5.5 m depth and a fill layer with thickness of 5 m at the base of excavation was formed with well-graded gravel compacted by a vibrated compactor of 35 tons (Figure 4).

Figure 4 Compaction of the fill material by a vibrated compactor

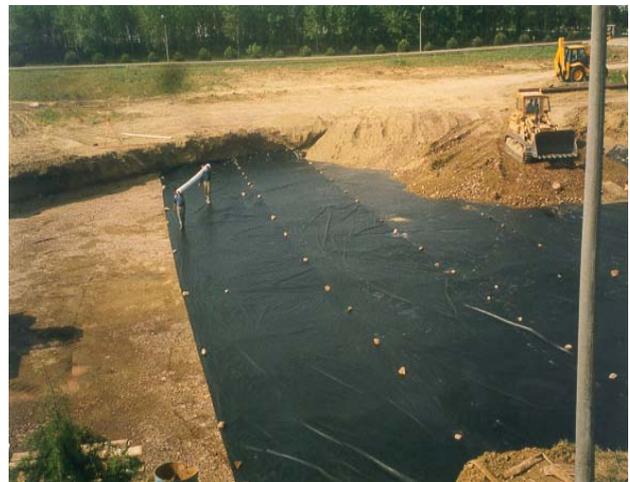
The degree of compaction was almost 100% in the fill and insitu density tests were carried out to verify the field compaction. Geotextiles were placed on this layer as nine-layer line with 50 cm fill materials (Figure 5 and 6). The nominal tensile strength of the selected geotextile is 25 kN/m (Geolon 25), and its permeability is 0.005 m/sec. The mass unit per unit area and the thickness under a pressure of 2 kN/m² are 100 g/m² and 0.5 mm, respectively. The tanks were seated on an asphalt cover with a thickness of 6 cm. Figure 7 shows the preparation of the formwork of the ring beam of the steel tanks after the soil compaction.

Figure 5 Placing of the geotextiles on the surface of excavation

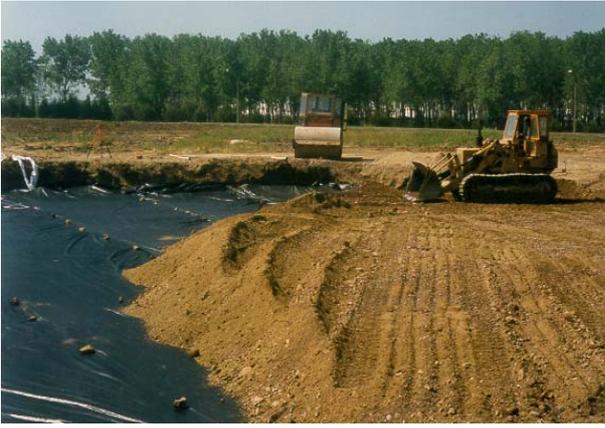
Figure 6 Forming of the filling on the geotextiles

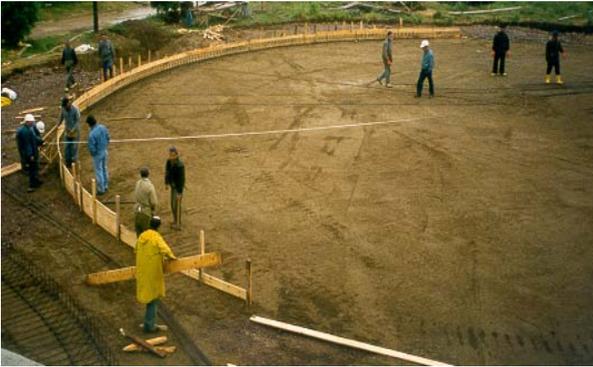
Figure 7 Preparation of the formwork of the ring beam of the steel tanks after the soil compaction

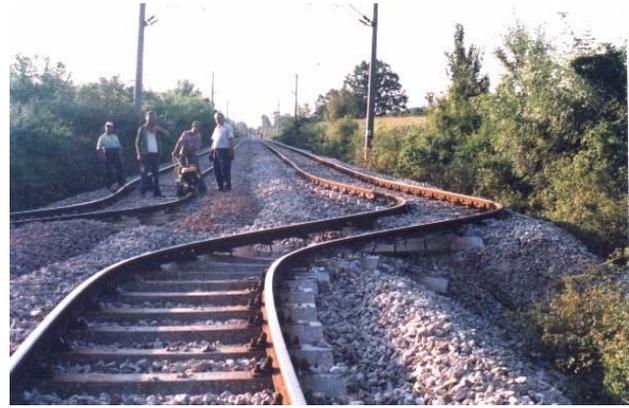
The focal depth was estimated as about 17 km. The length of the surface rupture was about 125 km and the average displacement along the surface was about 3 m (right lateral strike slip) (Figure 8).

Figure 8 Lateral displacement of the railway between Istanbul and Ankara (Barka,1999)

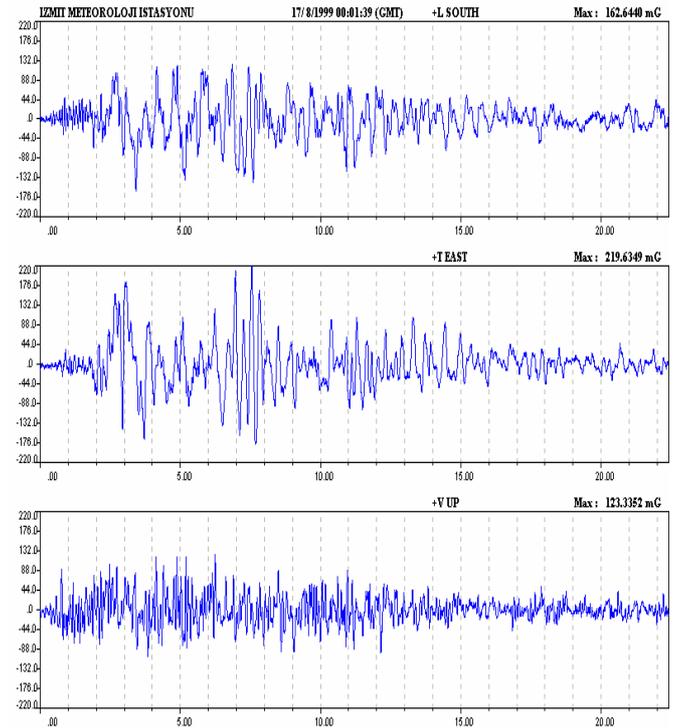
The recorded peak accelerations were in the range of 26-480 gals in the earthquake area (Figure 9). The earthquake caused a large number of structural damages, fatalities and injuries in the densely built urban areas such as Izmit, Golcuk, Adapazari and Yalova. According to official surveys approximately 17000 persons lost their lives, 24000 persons were injured and 600000 persons were homeless in the earthquake region (Figure 10).

Figure 9 3-D Strong ground motion recorded at Izmit Meteorological Station

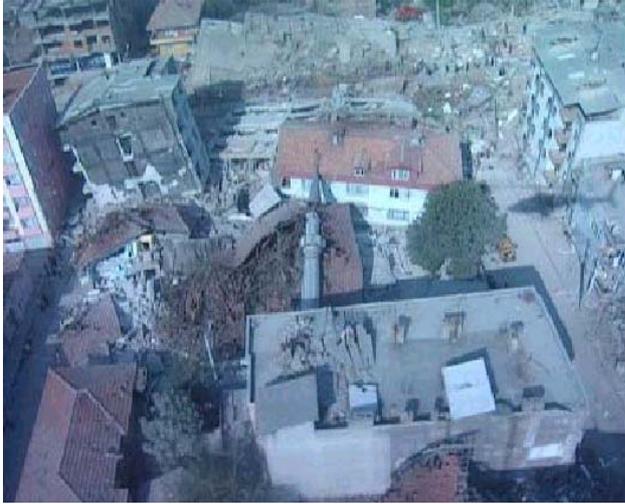
Figure 10 An example of the structural damage from the earthquake region. (www.sakarya.edu.tr/deprem/res_adp.html)
