# Case study on engineering behaviors of the Simajiri mudstone for dam construction - slope reinforcement in dam reservoir

**ABSTRACT:** "K" dam was constructed with large excavation of Shimajiri group mudstone (Shimajiri mudstone) deposited in Tertiary. This mudstone is low in strength (soft rock), weak consolidation and especially poor in slaking-durability, consequently it is easy to deteriorate and become muddy. The design and performance considering the characteristics of the mudstone were carefully studied for the dam construction and cut-slope in the dam reservoir. In this study, the rebound phenomenon accompanying with the excavation was observed by highly precise extensometer in the dam reservoir bed, and was related to the decrease of strength of the Shimajiri mudstone by laboratory tests. On the contrary, the decrease of strength was not observed in the cut slope countermeasured by concrete frame with a tie-back. These results indicate that this reinforcement method is highly effective to deterioration of Shimajiri mudstone and may be better consideration to solve the problems of the similar works in Shimajiri mudstone.

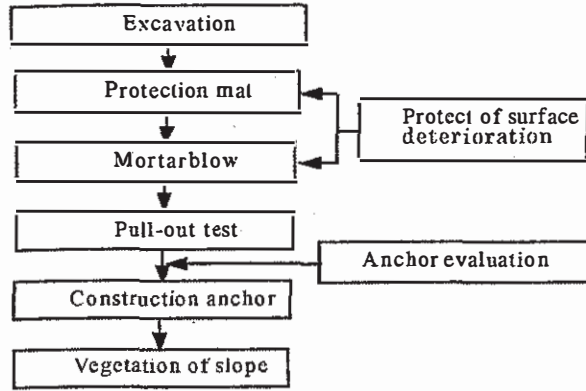
Figure 6. Procedure of slope protection.

The performance procedure of the slope protection is shown in Figure 6.

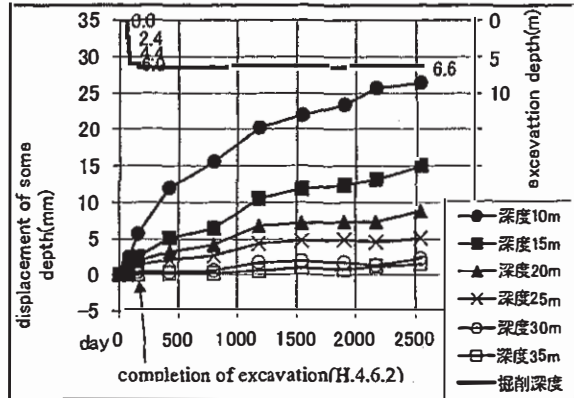
Figure 8. Measurement result of dam reservoir bed.

Field measurements were performed at the central part of the dam reservoir to observe the deformation behavior caused by the excavation. The results obtained by using highly precise extensometer (sliding micrometer) are shown in Figure 8.

The upheaval deformation of the ground occurred from the ground surface to the depth of 30m. Especially, the deformation in the surface of excavation site is larger, and it occurs immediately after excavation and continues for a long time. But at the part of the cut slope reinforced by a tie-back and cast in-situ slurry wall, obvious deformation was not observed.

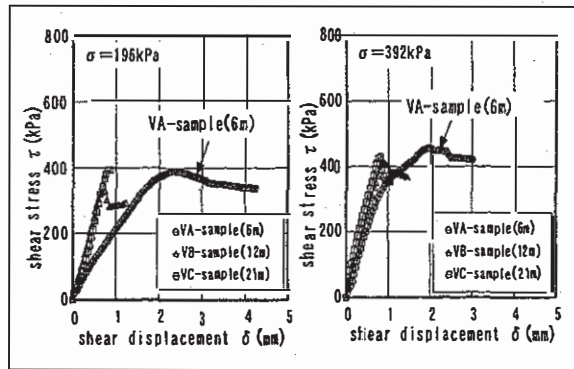
Figure 9. Deformation properties of dam reservoir.

(6m, 12m, 21m) with boring core specimens of the dam reservoir bed to compare the rebound quantities with excavation depths. On the other hand, boring core specimens of the 5m depth in the cut slope were tested. The results of the specimens in the dam reservoir bed are shown in Figure 9 and Figure 10 respectively. The shear modulus of the specimen at the 6m depth is much smaller than the others, but it recovers easily, as the confining pressure gets larger.

Peak strength of the shallow depth specimen (6m) is much smaller than that of the deeper points (12m, 21m). From the above mentions, it was cleared out that the strength and deformation properties of the Shimajiri mudstone must be strongly influenced by the rebound behavior due to excavation.
