Displacement and failure characteristics of model geogrid-reinforced structure subjected to impact load

N. Yasufuku, H. Ochiai, K. Omine & T. Kobayashi
Kyushu University, Fukuoka, Japan

ABSTRACT: In order to clarify the failure mechanism of geogrid-reinforced structure affected by earthquake, the failure mode of reinforced structures are carefully investigated when it was subjected to the impact load, based on the pictures shot by the high speed camera. It is observed that as the acceleration increases, the sliding surface of the geogrid reinforced structure first appears from the back of the sliding surface predicted by Coulomb's active earth pressure. The fixing length of reinforcement is important to improve the deformation characteristics of the reinforced structure during the impact load.

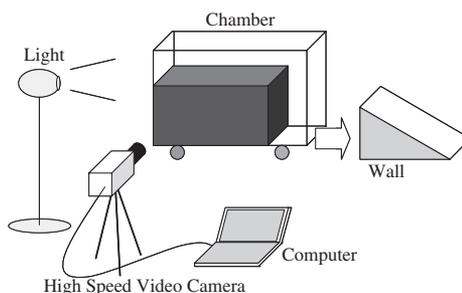
Figure 1. Outline of experimental system.

A model chamber with casters is used, where an impact load is applied by manually dashing the chamber against a wall. The model ground consists of the length with 41.5 cm, the height with 20 cm and the width with 10 cm, in which its side is made of an acryl plate to observe the movement of the ground during the test using a high speed digital video camera as schematically shown in Figure 1. This camera (Phantom V4.2; Vision research co. Ltd.) can take 2024 scenes for 2 seconds with 512*512 pixel. A typical model reinforced ground is shown in Figure 2, together with the photo.

An impact load is applied to the model ground by using an inertia force mobilized when the chamber strikes against a fixed wall (see Figure 1). The deformation and failure pattern of the ground are carefully observed by high speed video camera and then analyzed by PIV method through the test. The magnitude of the impact loads are relatively evaluated by the values of an acceleration sensor. The measured acceleration varies widely, and thus two or three tests were conducted under the same initial test conditions. Test cases conducted are summarized in Table 1, where the earth reinforcement materials with three layers are installed in the Cases from 1 to 3, whose differences are the length of the materials. On the other hand, for comparison, Case 4 is prepared, which treats the ground without any earth reinforcement materials. Figure 3 indicates a typical acceleration time history obtained.

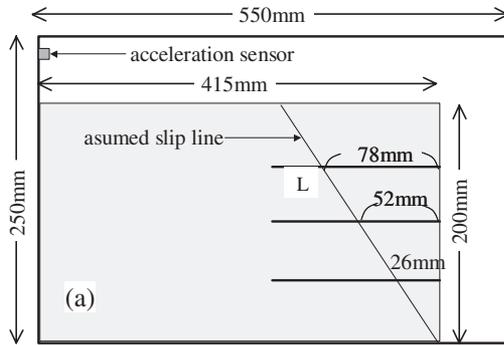
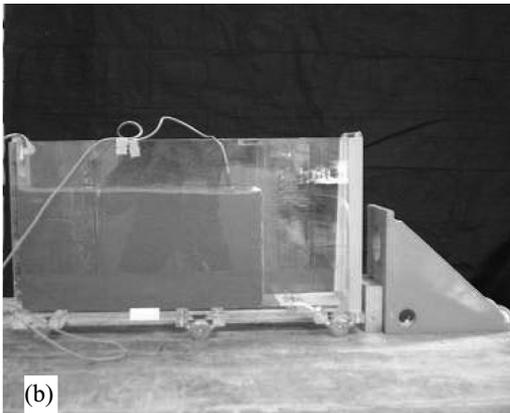
Figure 2. Earth reinforcement mode ground.

The magnitude of the impact load was evaluated by the acceleration sensor mounted in the top part of the chamber. As shown in this figure, each reinforcement material was horizontally laid in the ground with an equal vertical space. Length of the reinforcement material was determined based on the expected slip surface from the Coulomb's active earth pressure theory. In this study, three different embodiment lengths of the earth reinforcement materials were prepared, whose lengths were 67 mm and 33.5 mm longer, and 10 mm shorter than the length from the front of the ground to the slip line shown in Figure 2, where ΔL is the embodiment length defined.

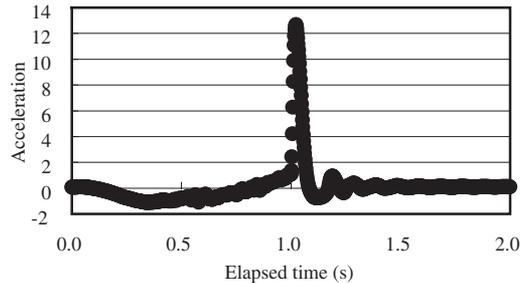
Figure 3. Typical acceleration time history.

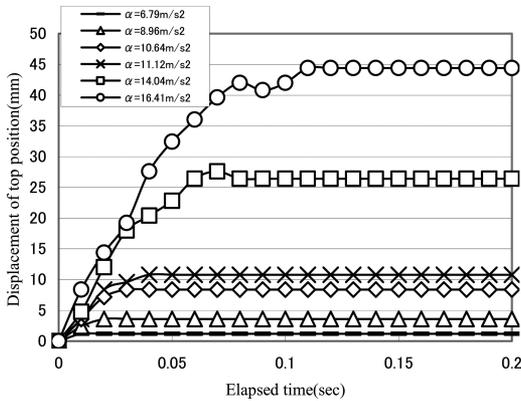
Figure 4. Displacement of earth reinforcement at top position against elapsed time.

Figure 4 shows the displacements of the top of the ground in Case 1 against the elapsed times under the various acceleration conditions. The displacement begins to occur at the moment once an impact load is applied and proportionally increases with the increasing elapsed time. After that, the displacement for each case converges to a certain value being dependent on the magnitude of acceleration. Figure 5 indicates the relationship between the residual displacements at the top of the ground and the acceleration values in Case 1. It is found that the residual displacement begins to occur when the acceleration becomes greater than around 6.3 m/s^2 in this model earth reinforcement ground and then increases with the increasing acceleration. When the acceleration exceeds a certain value, it is observed that even if the inside of the earth reinforcement area has no damage, there is a case the

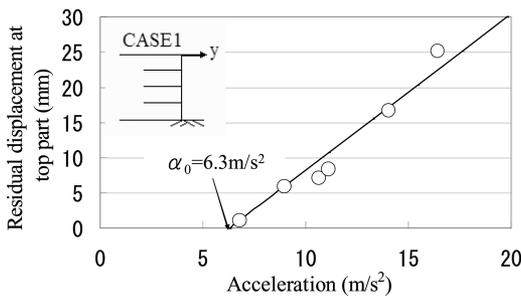
Figure 5. Residual displacement at top part of the ground against accelerations.

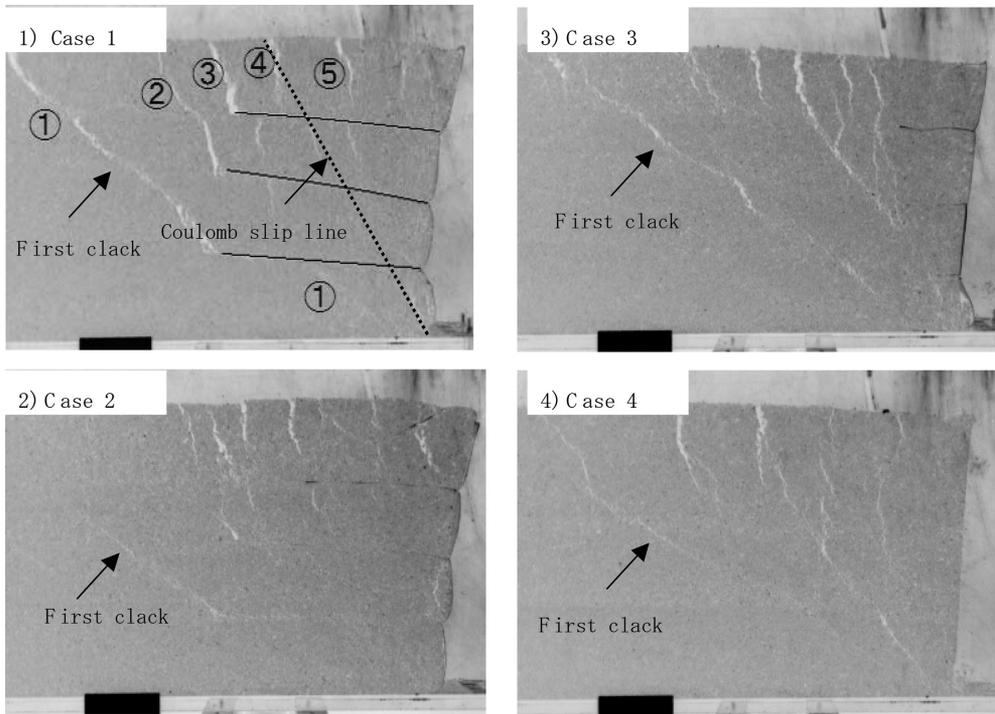
Figure 6. Typical failure patterns of each case at 0.1 seconds after subjected to an impact load.

slip layer can be formed behind the reinforcement area and the ground often reaches the failure. Therefore, the embodiment length of the earth reinforcement material seems to be important to increase the potential safety of the reinforcement ground. Figure 6 shows the typical failure patterns from Case 1 to Case 4 under the acceleration around 14.5 m/s^2 when the elapsed time reaches to 0.1 seconds. From the high speed video observation, the following behaviours can be seen. In Case 4 without any earth reinforcement and Case 3 in which there is no sufficient embodiment length for all the earth reinforcement materials, a clear clack such as a slip line first appears behind a Coulomb's slip surface. Many clacks inside of soil mass within the clear slip line are then presented and the length of clacks becomes longer and longer with the elapsed times. Finally the embankment in both cases reaches to a catastrophic failure. On the other hand, in Case 1, which has a sufficient embodiment length for all the earth reinforcement materials, a clear crack first appears which seems to be similar to the Case 1. After that, although the soil mass ahead of the clack moves forward, a catastrophic failure does not occur due to the earth reinforcement effects. The number in Case 1 (see Figure 6(a)) means the order of which the clack appears during the tests. It is found that the first clack appears fairly behind the theoretical Coulomb's slip line and each reinforcement material prevents the progress of the clack.

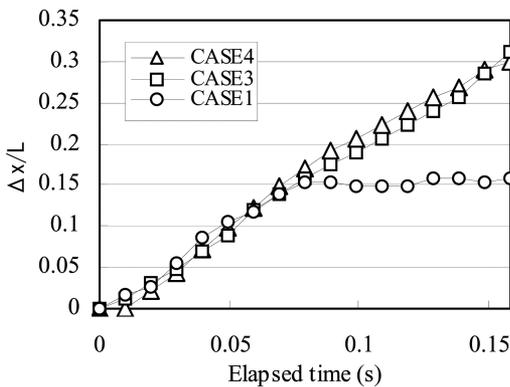
Figure 7. Normalized horizontal displacement at top of the ground against elapsed time for three cases with different embodiment length.

Figure 7 shows the horizontal displacement at the top of the ground normalized by the wall length against the elapsed time with every 0.15 seconds after the impact load is applied under the acceleration of around 14.5 m/s^2 . The typical results in Case 1, Case 3 and Case 4 are compared here. It is clear that the results in Case 3 and Case 4 have a same trend. It means that little reinforcement effect can be found in the case that the embodiment length is not sufficient. Figure 8 shows the horizontal displacements of the ground at depth of 50 mm, 100 mm and 150 mm from the bottom in the Case 1 and Case 2, paying attention to the accelerations normalized by α_0 defined in Fig. 5. It is noted that the embodiment length in Case 2 is half comparing with that in Case 1. When α/α_0 is relatively small, there is little difference of the displacement in each case. And then, when the normalized acceleration becomes larger, the displacement in Case 2 gradually becomes greater, comparing with that in Case 1. Such tendency tends to be remarkable for increasing acceleration. It is conformed that the embodiment length works well to reduce the horizontal displacement of the earth reinforcement structure when subjected to relatively large impact loads.

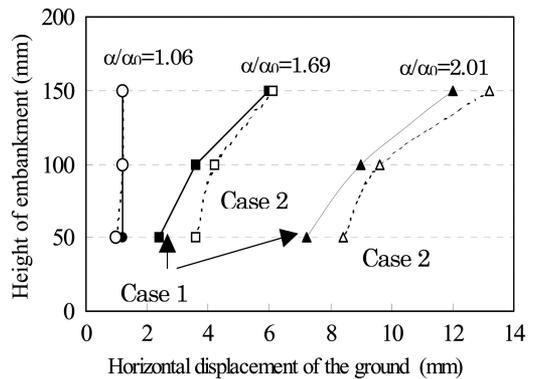
Figure 8. Comparison of horizontal displacement in Case 1 with those in Case 2 paying attention to the magnitude of the acceleration.

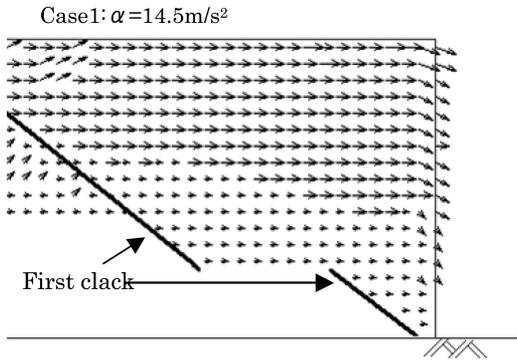
Figure 9. Typical displacement vectors of the ground in Case 1.

Figure 9 indicates the displacement vectors of the earth reinforcement ground in Case 1 in the period of 0.006 seconds from 0.05 second just after subjecting the impact load. The displacement vectors tend to increase with approaching to the upper part of the ground and also to the earth reinforcement wall. A slip surface,

which is first observed, is also depicted in this figure. It is confirmed that the soil mass inside of the slip surface mainly moves forward.
