Lessons learned from geo-electrical leaks surveys

A. L. ROLLIN, M. MARCOTTE and L. CHAPUT , Solmers Int., Quebec, Canada
F. CAQUEL, LRPC Nancy, France

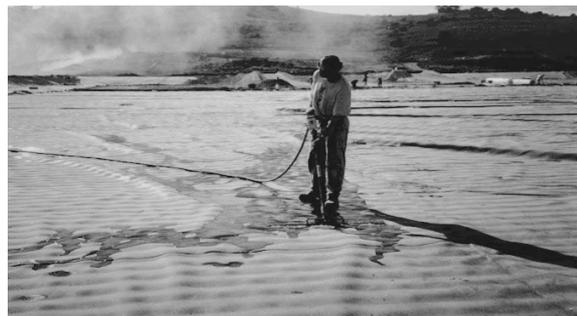
Figure 2. An electrical leak detection survey on exposed GM

Single geomembrane placed directly on soil, such as in impoundment facilities and for the secondary and primary geomembranes of a double composite lining system in landfills, in geomembrane-lined concrete and in steel tanks, can be tested using the water puddle and water lance techniques. Water is usually supplied by gravity from a tank truck parked at the top edge of the pond or landfill. For this technique to be effective, the leaking water must come into immediate contact with the electrical conducting medium to which the ground electrode of the 12 or 24 VDC supply can be connected. These techniques locate leaks independently (large damages not masking small leaks) with the possibility to detect leaks in geomembrane joints and sheets as work progressed during the construction phase.
