Parametric study of a reinforced highway slope in Thailand

Dechasakulsom, M., Sukolrat, J. & Pensomboon, G.

Bureau of Road Research and Development, Department of Highways, Thailand

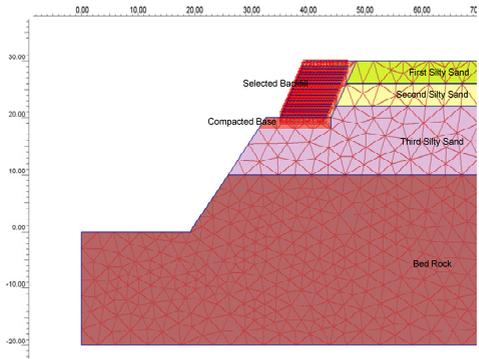
Figure 1. Finite element mesh used for the analysis.

For finite element analysis, PLAXIS 2D (Brinkgreve et al. 2006) has been used under plane strain condition of 15 node elements. The subsoil condition was simulated as indicated in Table 1 while the elastic parameters used in the analysis were adopted from the correlation of n-value proposed by Das (1990). The mesh generated from the program for the analysis is illustrated in fig. 1.

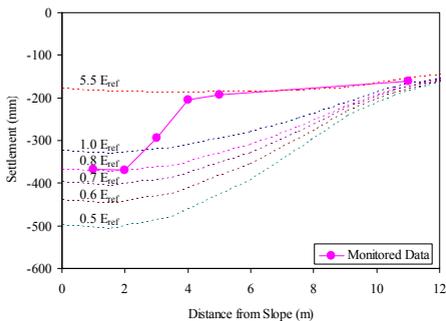
Figure. 2 Effect of stiffness of the backfill material to slope movement.

Even though, the backfill materials have met the standards, achieving the desired stiffness may encounter some technical difficulties. The parametric analysis regarding the variation in elastic stiffness of the backfills was investigated. Fig. 2 shows the effect

of variation in stiffness. It revealed that once the stiffness was reduced by 50%, the crest settlement will be increases by 200 mm or by 70% of the original value.

The FEM results were compared with the monitored settlement. It revealed that the stiffness of the constructed slope may be reduced following the decrease in soil stiffness according to stiffness nonlinearity which can be obtained from sophisticated laboratory test (Sukulrat 2007).

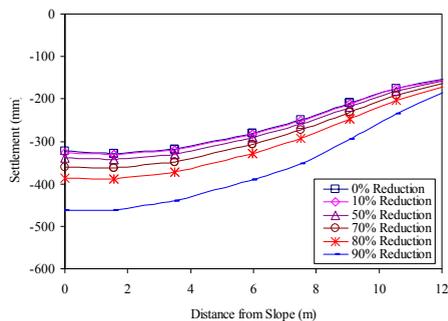
Figure 3. Effect of underlying compacted base to slope movement.

The movement of the reinforced slope also depends on the stiffness of the base. Soft base may cause high movement at the crest slope. The FEM analysis revealed the variation of the base stiffness that may affect the reinforced slope movement. The results of the investigations are shown in fig. 3. In the case that the compactive effort of the base material is not reached the designed value, the soil stiffness is then reduced. The result of the FEM simulation shows that although the base material was softened, the movement of the slope is not as much as the effect from the backfill material.

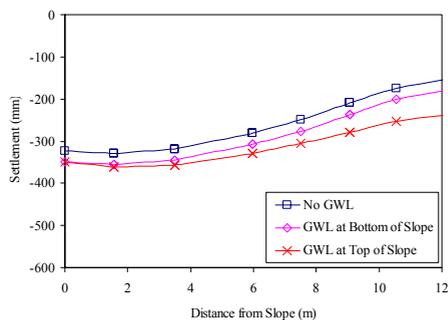
Figure 4. Effect of water level to slope movement.

Heighten ground water put an additional weight to the reinforced slope, which become less stable thus causing greater movement. In this paper, ground water variations of 3 locations were studies including (i) no effect of ground water, (i) at the bottom, (iii) on the top of the reinforced slope. Fig. 4 shows that increase of ground water has less effect on the overall settlement at the crest of the slope.

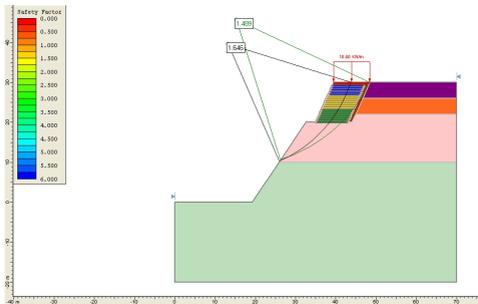
Figure 5. Slope stability analyses.

Slope stability analysis was performed using simplified Bishop Method, and slope and load configuration as shown in fig. 5. The relationships of the reduced strength parameters versus factors of safety against local and global failures were illustrated in fig. 6. The local factor of safety refers to the range of safety factor that localizes the failure plane on the geogrid-reinforced zone. On the other hand, the global factor of safety localizes the failure plane beyond the reinforcing length of the geogrid.

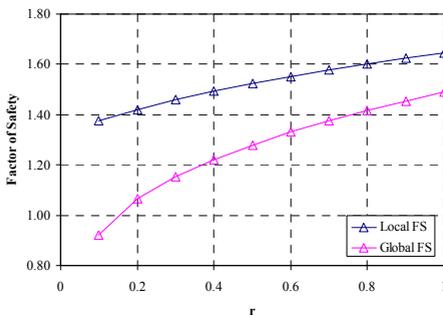
Figure 6. Factor of safety against strength reduction factor.

The result shows that the reduction of backfill strength has high influence on the global factor of safety because the material itself cannot withstand shear stress due to its own weight and the applied

traffic load. On the other hand, once the strength parameters of the backfill have been reduced, the geogrid still provide the interlock mechanism and tensile strength to the compacted backfill resisting the local failure developed by stress due to its own weight and traffic load.
