# Thermo-graph inspection for geomembrane seam evaluation

Keywords: geomembrane, heat-welding, fault detection, thermal images

**ABSTRACT:** This study attempted to develop a new method for detecting failures on welded seams between geomembrane liners. To identify the location of faulty seams, thermal images taken by a thermo graphic device were used to determine the unique temperature distribution on the faulty seam. It was shown that the real-time inspection for detecting faulty area was possible by taking thermal images of the seams while the sheets were welded by a self-propelled heat-welding machine. This method is more efficient compared to the conventional inspection method as that the seam can be examined with the welding work.

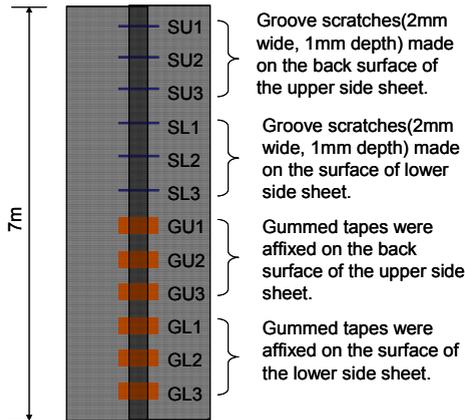
Fig. 2 Experimental sample which has faults on a seam

High-density polyethylene (HDPE) sheets were welded together by double fusion welding using a self-propelled heat-welding machine. To construct a faulty area on the seam, samples like following were made; (1) seams with groove scratches (SU1-3, SL1-3), (2) seams that a foreign object (gummed tape) was held between the sheets (GU1-3, GL1-3). Figure 2 and figure 3 shows an experimental sample which has faults on a seam.

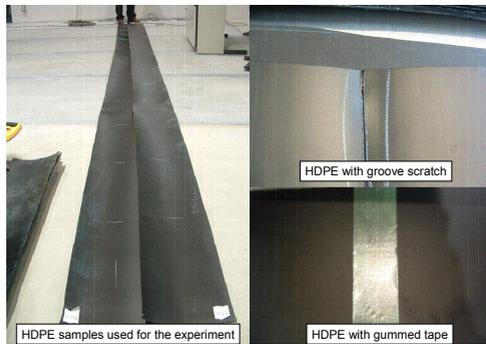
Fig. 3 Pictures of experimental samples

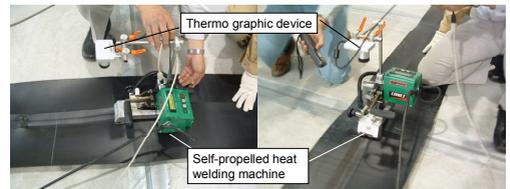
Fig. 4 A self-propelled heat welding machine with a thermo graphic device

Figure 4 shows the experimental equipment required for thermo-graph inspection. In this

experiment, 2 sheets with faulty area were welded together by self-propelled heat-welding machine. The temperature in welding was 420~500°C, and the welding speed was 1.5~1.7m/min. A thermo graphic device was fixed on the welding machine. It took images of the surface temperature and saved it as video files, with the sheets were welded by the welding machine.

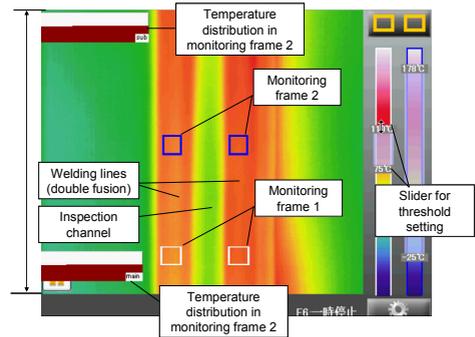
Fig. 5 A view of the faulty seam detection software

Figure 5 shows a view of a faulty seam detection software which was developed in this study. This software has 2 functions. The first function is the continuous recording of the temperature on the welded seam. The temperature of the area surrounded in the squares, which are named “monitoring frame” in Figure 5, was recorded as a csv file. A monitoring frame is composed of 9 cells,

and the temperature of each cell can be recorded at 1 second interval. The second function of the software is faulty seam detection. Users of the software can set the range of the temperature of normal seam as threshold temperature. When the temperature in the monitoring frames become higher or lower than the normal range, the area is detected as a faulty seam.

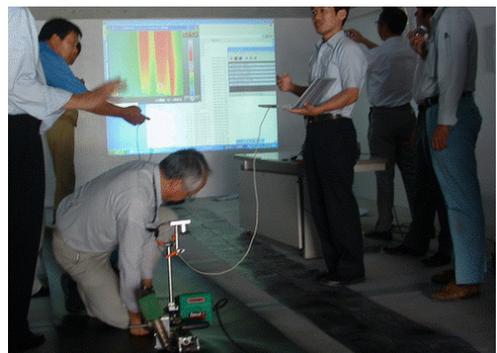
Fig.6 A scene of the experiment

The experiment was conducted indoors in an environment where both the ambient and sheet temperatures were approximately 23 °C. A scene of the experiment is shown in Figure 6.

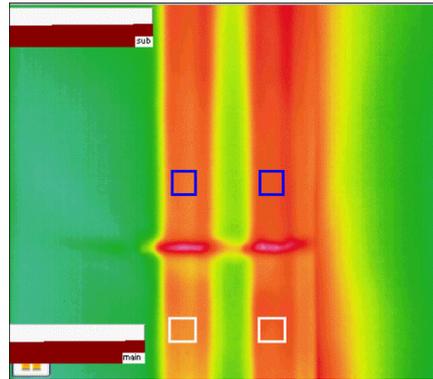
Fig.7 Thermal image of a seam with scratches

Figure 7 and Figure 8 are the thermal images that were taken when the sheets, which have groove scratch and gummied tape respectively, were welded together. On those images, the welding machine welded sheets from the top to bottom of the image. In figure 7, the temperature of the faulty area, where a groove scratch of 2mm width and 1mm depth was made on the upper sheet, was apparently higher than the normal area. Figure 8 shows a thermal image of faulty seams caused by affixed gummied tape. Unlike the case of the faulty seam with scratch, temperature in the faulty area was lower than the normal area, since the heat capacity of the part where the gummied tape located increased, and the heat transfer in boundary surface decreased.

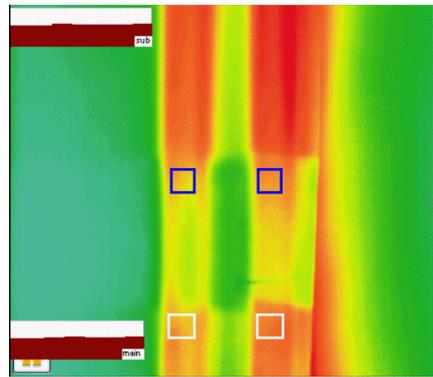
Fig.8 Thermal image of a seam with gummied tape

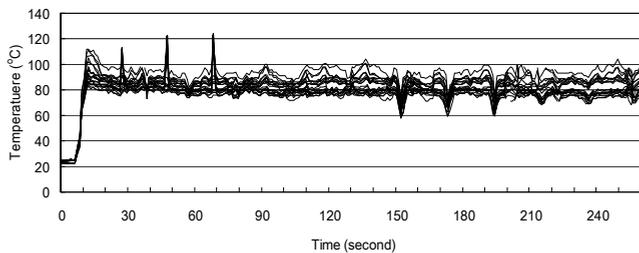
Fig.9 Surface temperature on the welded seam recorded at pixels in the monitoring frames

Figure 9 shows the surface temperature on the welded seam recorded in the monitoring frames and figure 10 shows the highest and the lowest values of the recorded surface temperature. Arrows in figure 10 indicate the location of the faulty area on the seam. Apparent peaks can be seen on the highest surface temperature at SU1-SU3 where

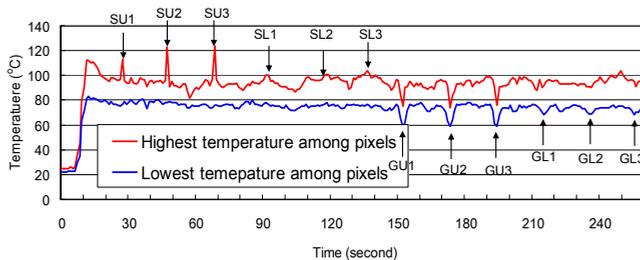
Fig.10 Highest and lowest surface temperature among the pixels in the monitoring frames

groove scratches were made on the upper sheets. Temperature at SL1-SL3 where scratches were made on the lower sheets did not change so much. The lowest temperature in figure 10 sharply decreased at GU1-GU3 where the gummed tapes were affixed on the upper sheet, and it slightly decreased at GL1-GL3 where the gummed tapes were affixed on the lower sheet.
