LEVILLAIN, J.-P., Laboratoire Régional de l'Equipement, Les Ponts de Cé, France

GEOTEXTILES IN BANK PROTECTION: AN EXPERIENCE OF THREE YEARS IN LOIRE GEOTEXTILIEN IM UFERSCHUTZ: DREIJÄHRIGE ERFAHRUNGEN AN DER LOIRE LES GEOTEXTILES EN PROTECTION DE BERGE: TROIS ANS D'EXPERIENCE EN LOIRE

Third International Conference on Geotextiles, 1986, Vienna, Austria

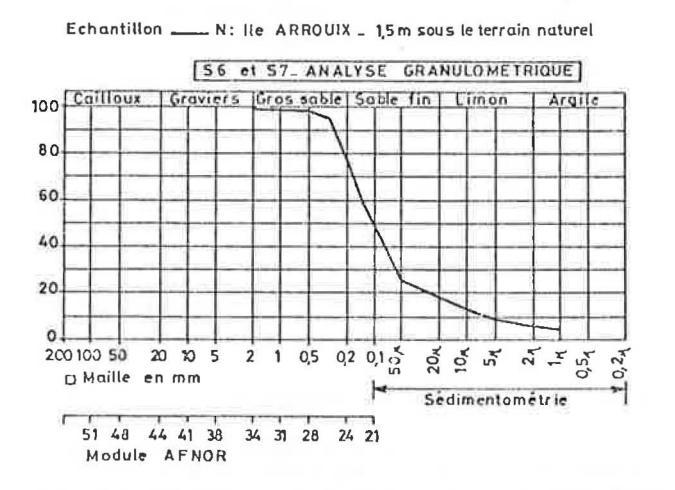
On the river la Loire, we observe a tide of 4 or 6 meters near NANTES at 45 km of the sea. The bank of the river are constitute of sand. Figure 1.

Figure 1 - Sand of the bank.

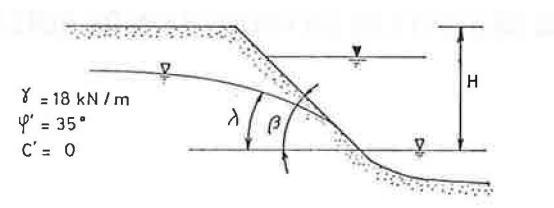
The embakement is made with a sand : $\Psi' = 35^{\circ}$, cohésion = 0. The stability is study with the variation of λ , slope of the flow in the embakement. Figure 4.

Figure 4 - Slope of the flow in the embakement.

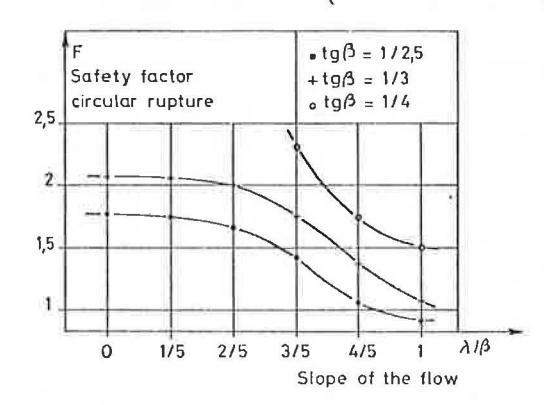
Figure 5 give the security of the sand slope when we have variation of $\boldsymbol{\lambda}$ and $\boldsymbol{\beta}$.

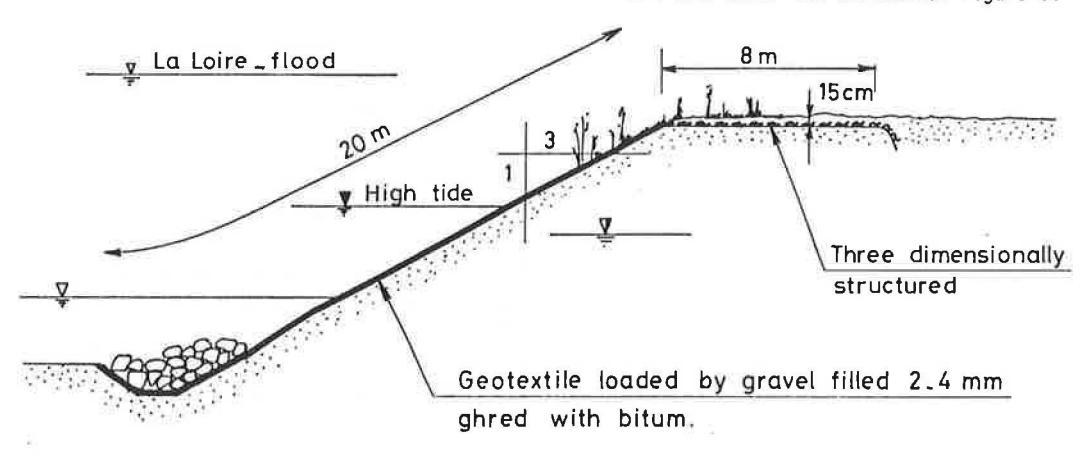
For protected this embakement we have put a lining of a gravel filled geotextile. It is a structured nylon-based mat with as much as 90 % being filling space. A gravel filled 2-4 mm glued with asphalt is put on 20 mm thickness and a wearing filter made in polypropylere is fixed under the structure. Figure 6.

Figure 6 - Slope protection by lining.

In the high of the bank, the structured nylonbased mat contributes to the recovery of nature.

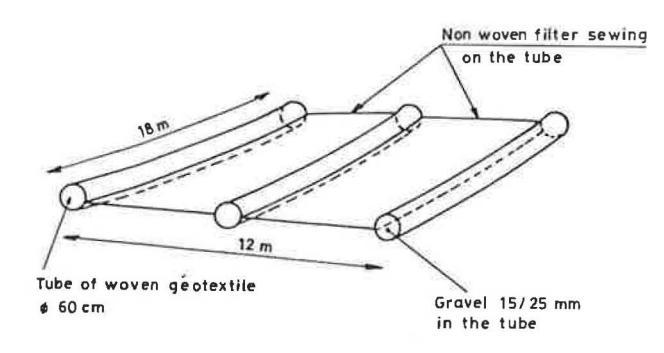
For a protection near the abutmont of a great bridge on the Loire, we have put a geotextile filter under the boulders.

The slope of the sandy bank is 3/2 (2 of high) and his heigh is 15 meters under the low tide.

All six meters. Figure 7. The non woven filter was sewned to a woven geotextile tube of 60 cm diameter.

Figure 7 - Filter under the boulders on the bank.

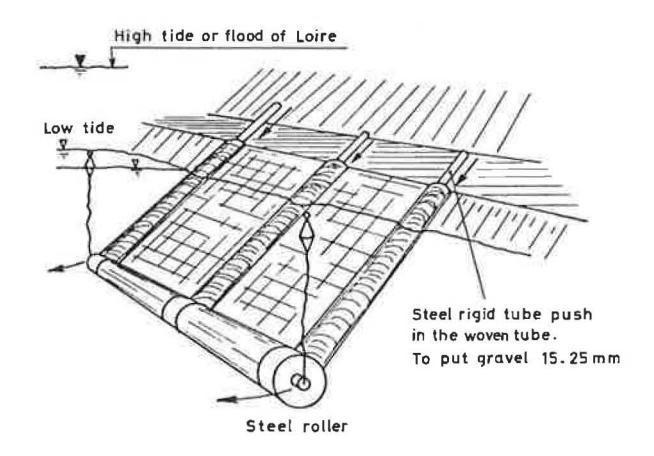
During the low tide, the mat was unrolling on the slope. In the woven geotextile tube, an over steel rigid tube is push and a gravel 15-25 mm is deposit. The rigid tube is pull out when the woven tube is full. Figure 8.

Figure 8 - Laying of filter geotextile on the bank.

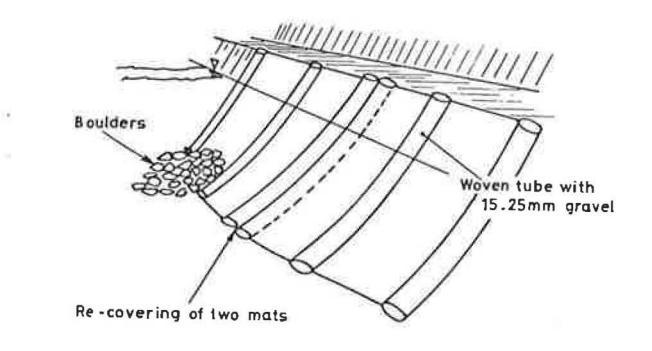
The second mat recover the last woven tube. Figure 9. When all the bank is cover we put the boulders 15-300 kg.

Figure 9 - Geotextile mat on the bank.

Since three years this protection is effective and the stability of the bank is sure.
