Underwater installation of a waterproofing geomembrane at Lost Creek arch dam

A.M. Scuero, G.L. Vaschetti Carpi Tech S.A., Chiasso, Switzerland

3 APPLICATION OF THE NEW UNDERWATER TECHNIQUE TO REDUCE REHABILITATION COSTS: THE LOST CREEK DAM PROJECT

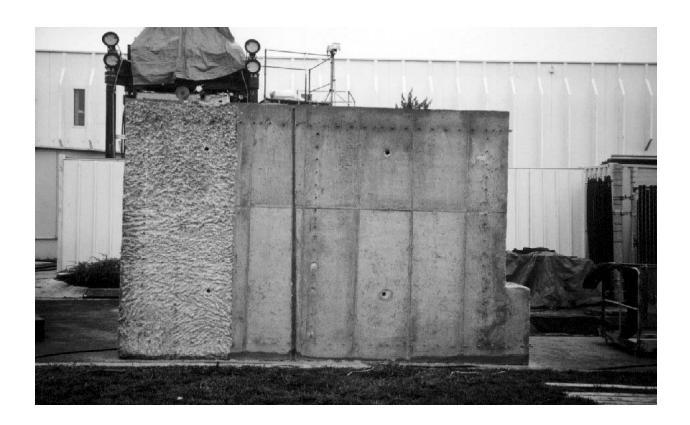
Figure 1. The "L" shaped, reinforced concrete wall constructed for the second phase of the research for the US Army Corps of Engineers. The wall incorporates rough and smooth parts, fissures, joints, corners, protrusions and depressions, to replicate as much as possible all features to be encountered in an underwater installation. Approximate dimensions of the longer side of the wall are 4.8 m x 3 m height, of the shorter side 1.5 m x 3 m height

In the second phase of the project, the solution developed in the first phase was further refined to produce a geomembrane system to be tested for underwater constructibility. A reinforced concrete

structure was built for this purpose, and the constructibility and efficiency of the designed system was verified by its complete underwater installation on the test structure. Underwater installation was successfully performed under the supervision of the US Army Corps of Engineers (Christensen et al. 1996).

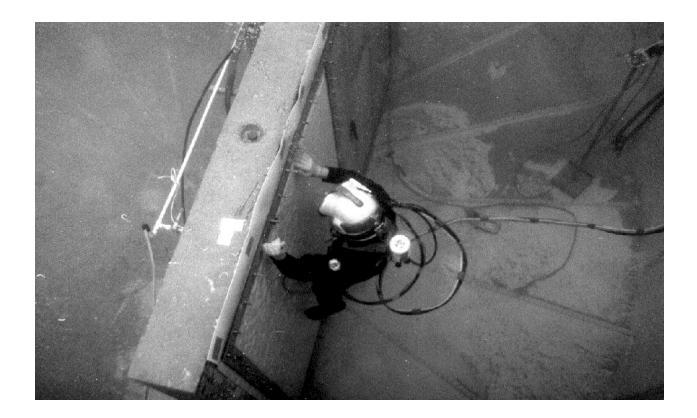
Figure 2. The wall was lowered in a tank, at a depth of 6 m, and the designed system was installed underwater. After underwater installation, a suction corresponding to 8.4 m of hydrostatic head was applied to the back of the liner. The geocomposite liner conformed to the subgrade, and no leaks were detected, demonstrating that an effective seal had been achieved. The Army Corps project demonstrated the feasibility of underwater installation, and allowed to refine design of the various components of the system, and of underwater installation procedures.

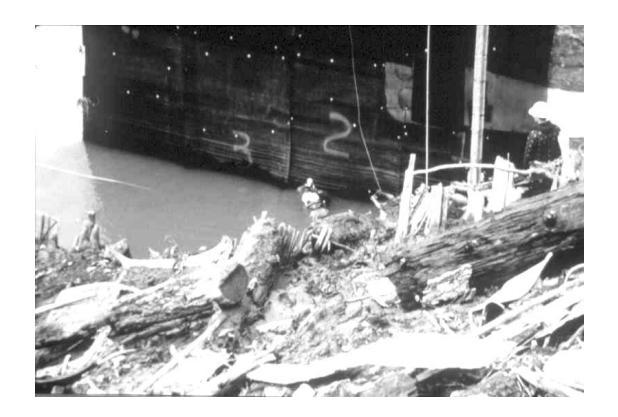
Figure 3. The drainage layer consists of a geonet with cross-diagonal grid pattern, anchored to the dam face by impact anchors. 3 ventilation holes at crest enhance water flow to bottom collection. Along the bottom perimeter of the lined area, an additional layer of geonet facilitates conveyance of water towards the bottom discharge system.

The system is a drained system, to intercept and discharge immediately and continuously water seeping from foundation, rain and snowmelt from the crest, and condensation water migrating from the colder dam body towards the warmer upstream face. The geocomposite is installed over a drainage geonet, to facilitate the flow of drained water to bottom collection. Bottom collection is made by an additional band of drainage geonet. Discharge is made through a pipe drilled to the downstream face of the dam at lowest elevation of the lined area. To enhance water transmission, the drainage layer is ventilated at 3 different points at crest.

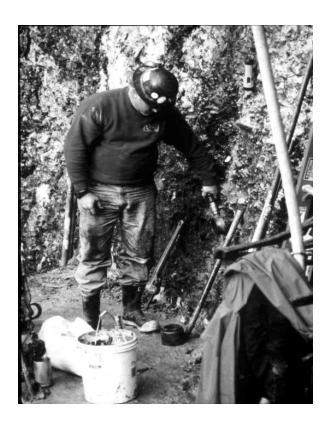
Figure 4. The bottom discharge consists of a transverse pipe inserted into a hole drilled through the dam body.

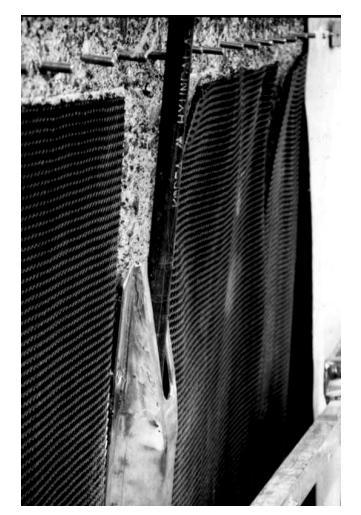
Figure 5. To monitor the efficiency of the system, a water level indicator is installed in one of the vertical profiles assemblies.

The efficiency of the system is monitored by a water level indicator, positioned inside the vertical profile assembly left of the bottom outlet. The measurement of drained water flow, associated to the measurement of water standing behind the geocomposite if any, allow to ascertain if the geocomposite liner, and its associated drainage system, are performing correctly.

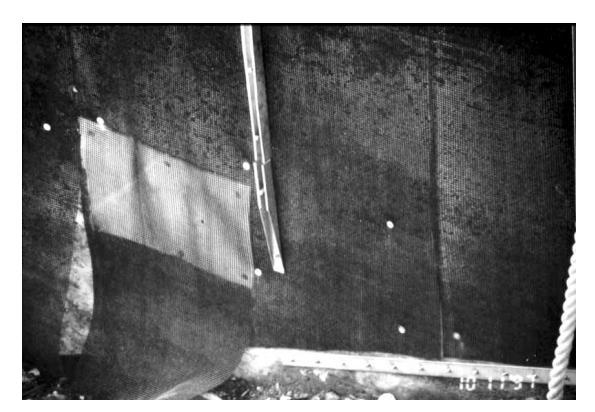
Figure 6. The geocomposite liner is mechanically anchored to the dam face along vertical lines, and along the perimeter. Perimeter anchorage is resistant to water in pressure at bottom and spillway, to rain and snowmelt at crest. To optimise installation underwater, standard 2.05 meters wide PVC geocomposite sheets were assembled to prefabricate wider panels. This allowed increasing standard interaxis between vertical anchorage assemblies from 1.80 meters to approximately 7.8 meters, reducing the amount of hardware and of underwater work necessary to secure the membrane on the dam face. Pictured are one of the vertical anchorage profiles and the batten strip that is part of the bottom seal. All anchorage lines are made with stainless steel.

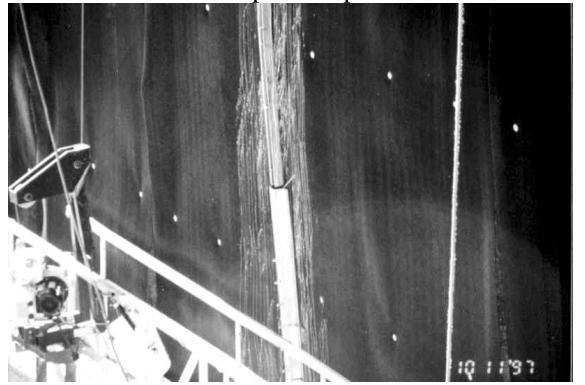
Figure 7. The dry vertical anchorage assembly (patented system illustrated in ICOLD Bulletin 78 on waterproofing geomembranes) consists of one "internal" profile, which is positioned on top of the drainage geonet, and of one "external" profile, which is placed over the geocomposite. The connection between the two profiles secures the geocomposite to the dam face, and tensions it to assure that no slack or folds form.

The geocomposite is secured to the dam face by vertical stainless steel assemblies. In the part where installation was performed in the dry, the two profiles constituting the assembly are of the same type described by the International Commission on Large Dams Bulletin 78 on the state of the art of waterproofing geomembranes for dams (Corda et al. 1991). In the underwater part, the two profiles were adapted so that installation and joining of geocomposite panels could be executed mechanically, with no need for heat-welding.

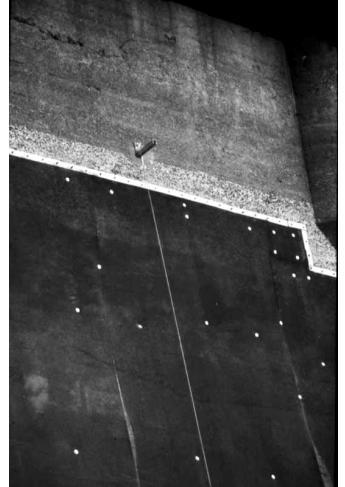
Figure 8. At top, the batten strip for perimeter anchorage at crest. The vertical line is one of the guide wires that were installed to assure proper alignment of the geocomposite panels, especially underwater, where turbidity limited visibility from nil to less than 1 m.

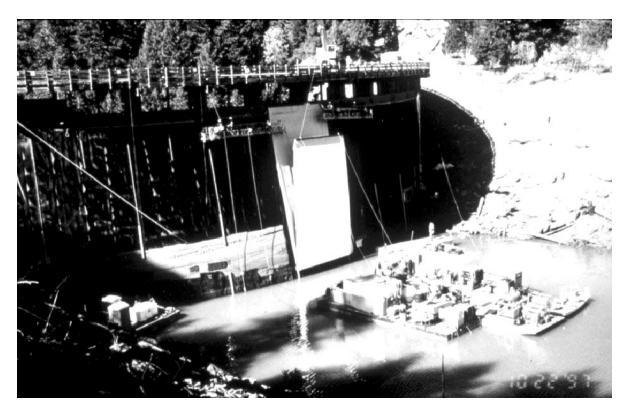
Figure 9. The geocomposite was prefabricated in 8 m wide panels, to optimise construction schedule while accommodating the need of underwater work. The panels were lowered from the dam crest into the water, to cover the entire face with no transverse junctions. Adjoining panels overlapped at the vertical anchorage profiles. In the dry, overlapping panels were heat-welded. Seventeen panels were necessary to cover the 2800 m^2 face of the dam.

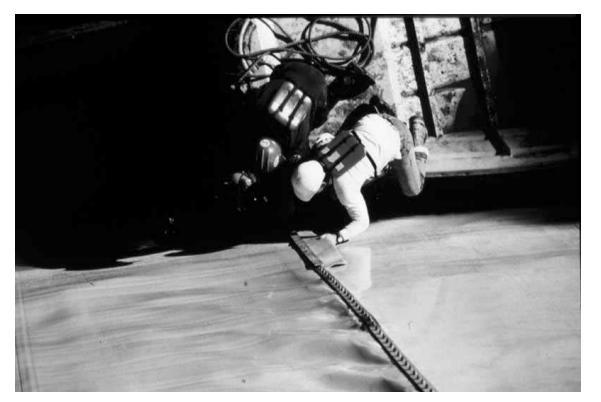
Figure 10. Underwater, the joining of adjacent panels was made by the vertical anchorage assemblies, which have a special design conceived for underwater installation.

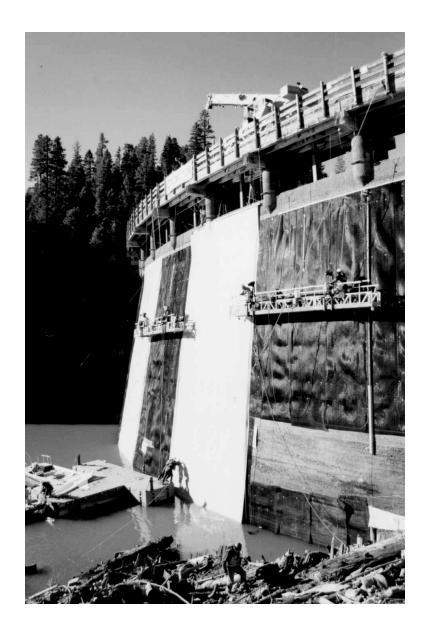
Figure 11. Dry and underwater installation proceeded at separate locations for security reasons. As workers install the geonet in the dry, from suspended platforms, the divers are securing the panels at bottom.

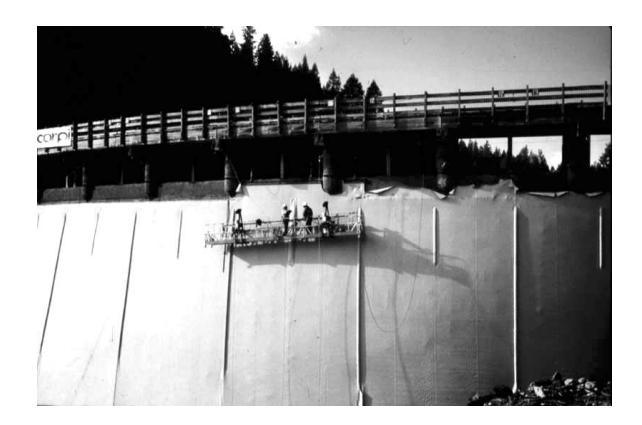
Figure 12. The vertical profile assemblies are all watertight. In the dry, to avoid that water seeps along the threads of the set screw/hex coupler assembly coupling the profiles, PVC cover strips are welded over the profiles. Underwater, the external profiles are connected to the internal ones by a watertight connection obtained by compression. At spillway, the upper seal is executed below the bottom of the concrete piers supporting the bridge deck.

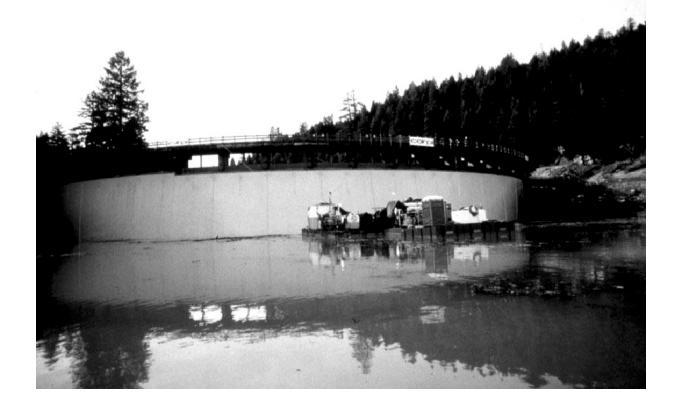
Figure 13. The installation was completed in Autumn 1997, in less than 3 months for a total lined area of 2800 m^2 . The whole project was completed safely, without a single reportable or Lost Time Accident. Up to date, total documented seepage is less than 0.063 l/s, and there is no water standing behind the membrane.

Seepage control: the monitored flow, after some initial fluctuations due to higher initial dehydration of dam body, has stabilised to less than 0,0631 l/s with reservoir at spillway level. The readings of water level indicator show that there is no water standing behind the geocomposite in the drainage system.
