Geosynthetics Applications at Boussiaba Dam in Algeria

Boussiaba is a 51 m high Rolled Compacted Concrete (RCC) dam under construction in Algeria. Owned by ANBT (Agence National des Barrages et Transfers), the dam will increase water supply to Beni Haroun Transfer and to the people of El Milia region. EDF – CIH (Centre for Hydraulic Engineering of Electricité de France) are the designers. The dam, of the low cementitious content type, has an upstream exposed drained geomembrane system to provide watertightness. The barrier system includes an impervious PVC geocomposite and a drainage geonet. The drainage system is divided in six compartments that will allow monitoring the behaviour of the impervious PVC geocomposite. The paper describes the details of the system selected by ANBT, the results of the tests performed at CESI on the impervious geocomposite, and the phases of installation that have been completed by the waterproofing contractor Carpi Tech at the time of preparation of the paper.

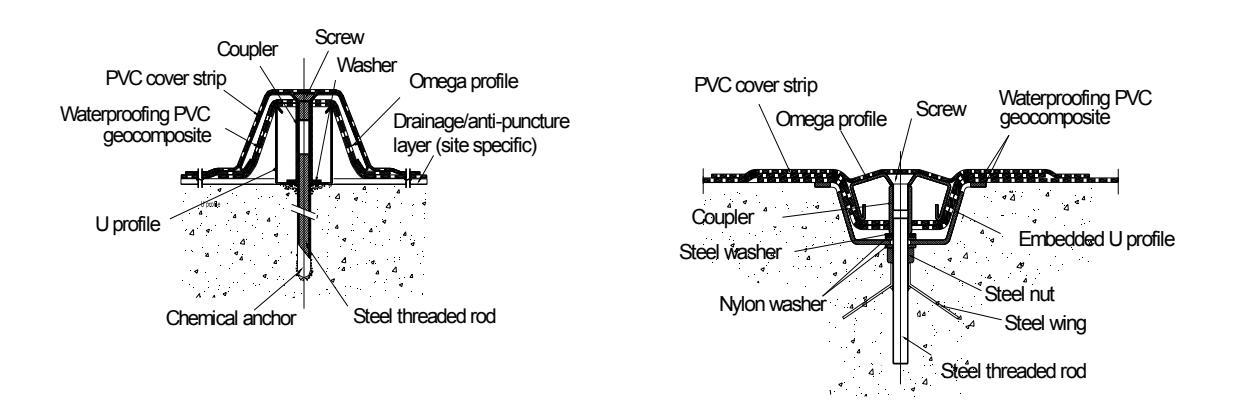
In RCC dams, there are two possible configurations for the U profile that is fastened to the upstream face: the profile can be can be installed when the upstream face has been completed (external U profile, as pictured at left in Figure 1), or it can be embedded by the main contractor in the dam face as it is being constructed (embedded U profile, at right in Figure 1).

Figure 1. The two possible configurations of the tensioning system in RCC dams.

The configuration with external U profiles (see left part of Figure 1) was selected for Boussiaba. The spacing between adjacent lines of profiles, calculated based on foreseen local conditions, is 5.7m.

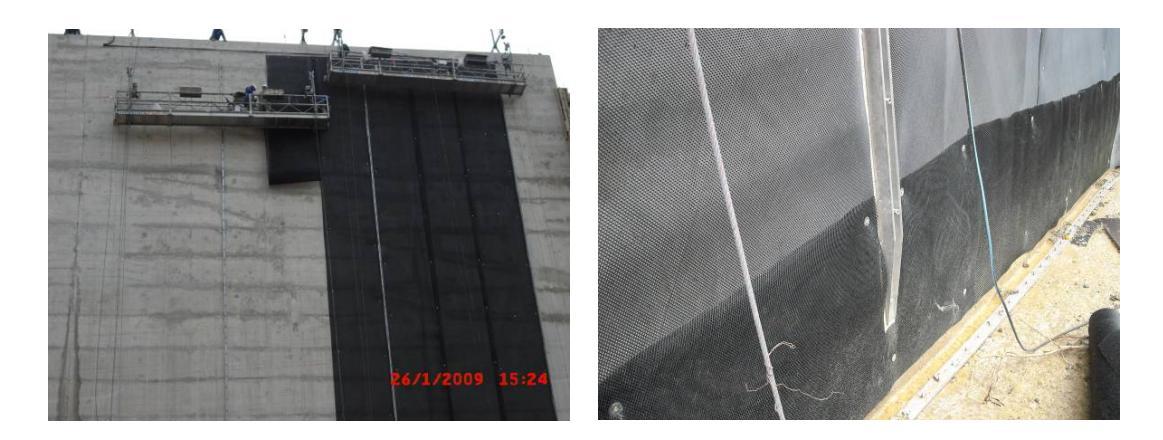
Figures 2 and 3. Placement of the geonet on the upstream face between adjacent anchorage profiles, and the additional band of drainage geonet acting as longitudinal collector at heel.

After drilling the holes and positioning the pipes for drainage discharge, the crews have placed the U profiles that form the vertical drains on the face of the dam, the geonet in the space between the profiles, and the additional band of geonet as longitudinal collector at the heel of the dam.

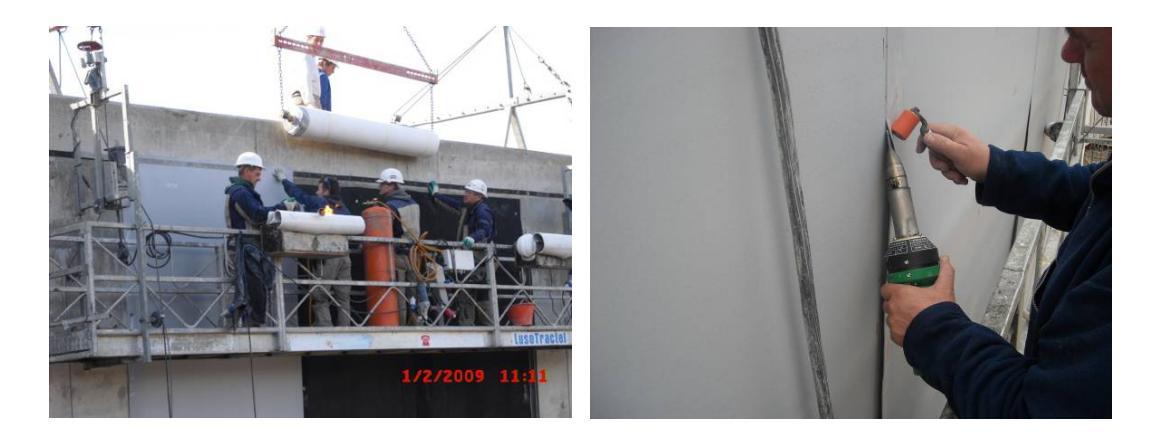
Figures 4 and 5. Placement and welding of the geocomposite sheets.

Joining of adjacent sheets has been made by watertight heat welding, with manual one track welding machines. All welds exposed to the water have been checked on their entire length according to the mechanical point stressing method of ASTM standard D 4437.

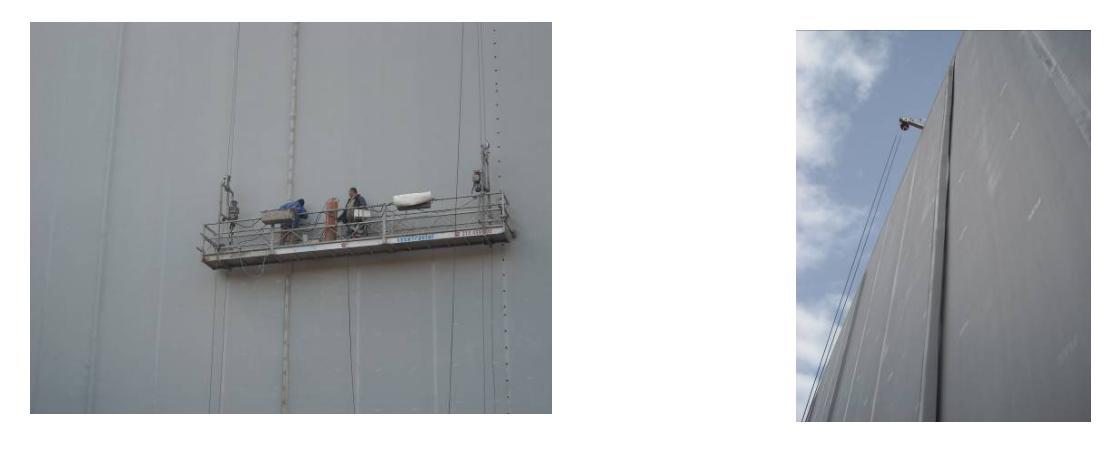
Figures 6 and 7. Placement of the Ω profiles on the punctured PVC geocomposite, and the PVC geomembrane cover strip waterproofing the profiles.

The PVC geocomposite has been punctured over the threaded rods anchoring the U profile, to expose the rods and allow coupling the tensioning profiles. The Ω profiles. have been placed over the punctured holes, and the connection with the U profiles has been made. Lastly, the Ω profiles have been waterproofed with PVC geomembrane cover strips.

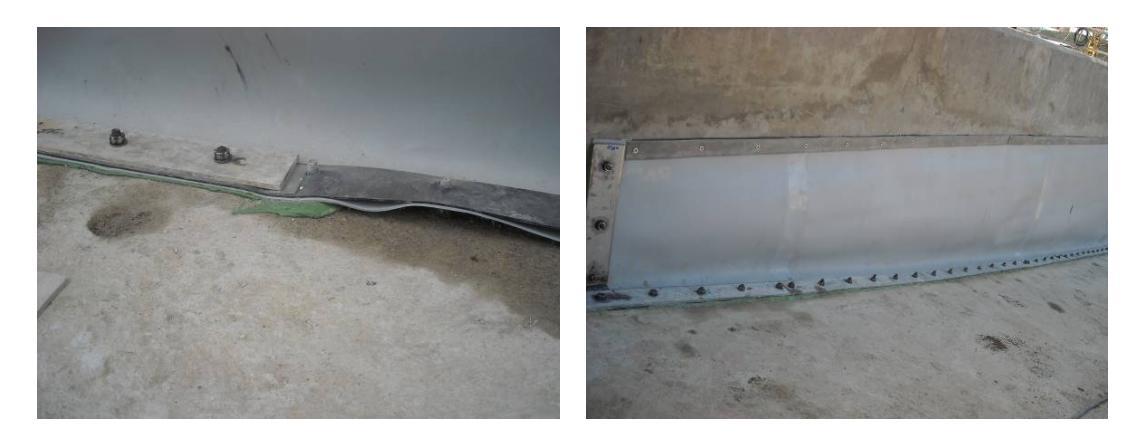
Figures 8 and 9. At left, the components of the watertight seals: bedding resin, PVC geocomposite, rubber gasket, stainless steel splice plate, stainless steel batten strip. At right, the watertight bottom an side sea, and the top seal, at the end of the left abutment.

Watertight perimeter seal is made at the boundaries of the lined area, to impede water infiltration behind the waterproofing liner. At the boundaries that can be submerged, that is along the plinth, the spillway, and at the sides of the intake tower, the seal is watertight against water in pressure and is made by stainless steel flat batten strips, 80 x 8mm, fastened to the concrete by stainless steel anchor rods embedded in chemical anchors placed at 0.15m spacing. Bedding resin mortar, rubber gaskets and splice plates provide the adequate distribution of stresses that is necessary to achieve watertightness.

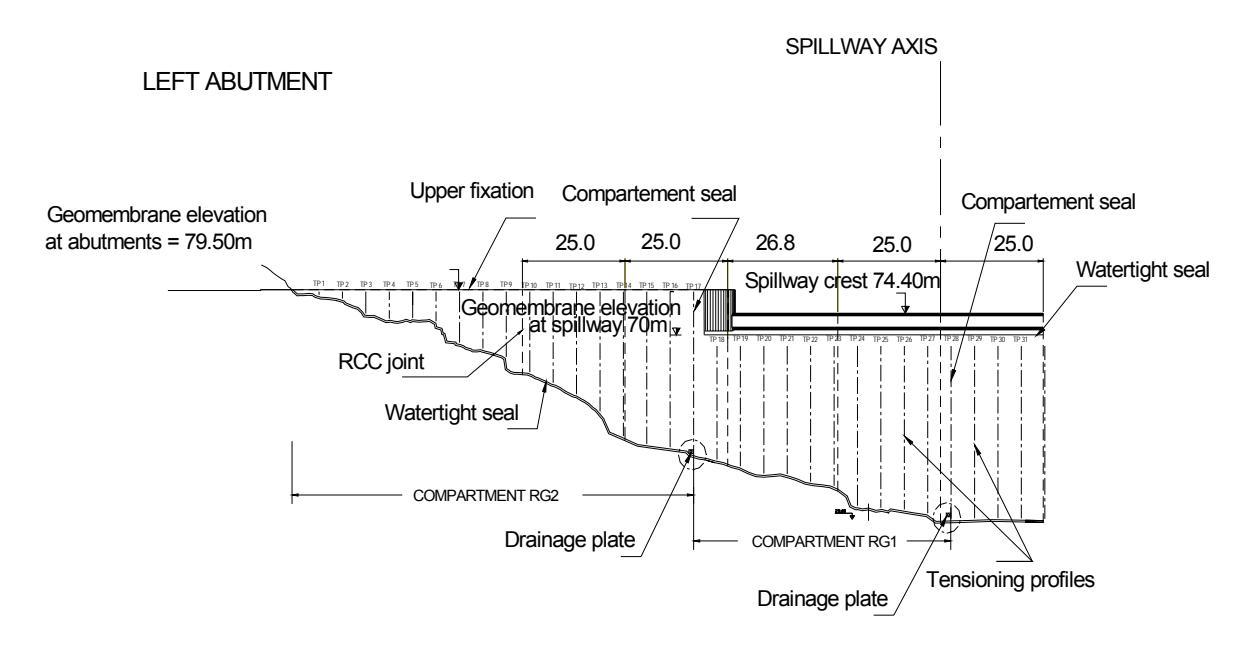
Figure 10. At the time of preparation of the paper the waterproofing system has been installed from the end of the left abutment to profile 17 (compartment seal at left of spillway).

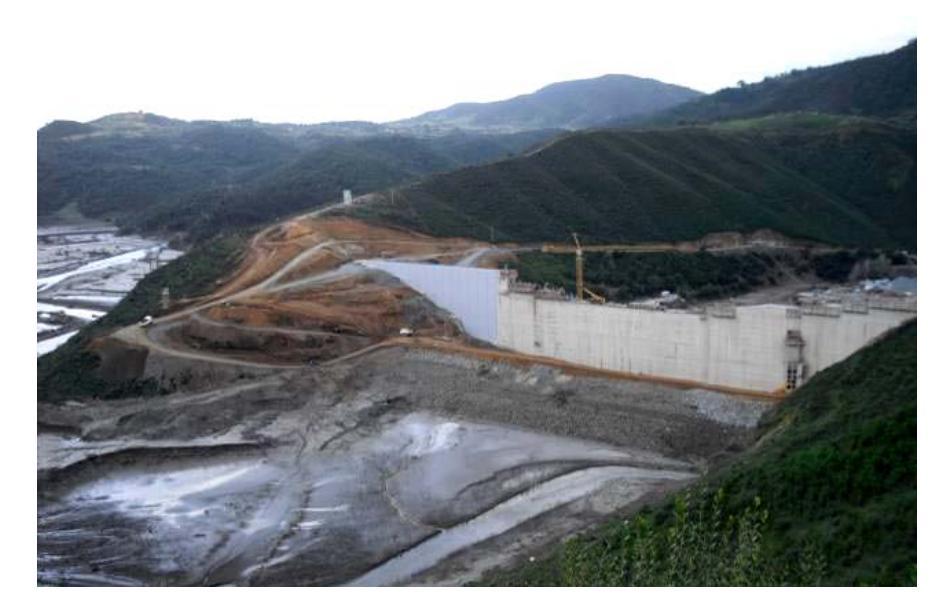
Figure 11. Boussiaba dam at completion of waterproofing works on the left abutment, while construction is ongoing at spillway.
