## *EuroGeo4 Paper number 226* INSTALLATION AND ULTRAVIOLET EXPOSURE DAMAGE OF GEOTEXTILES

# Benjamim, C.V.S<sup>1</sup>, Bueno, B.S.<sup>2</sup> Lodi, P.C<sup>3</sup>. & Zornberg, J.G.<sup>4</sup>

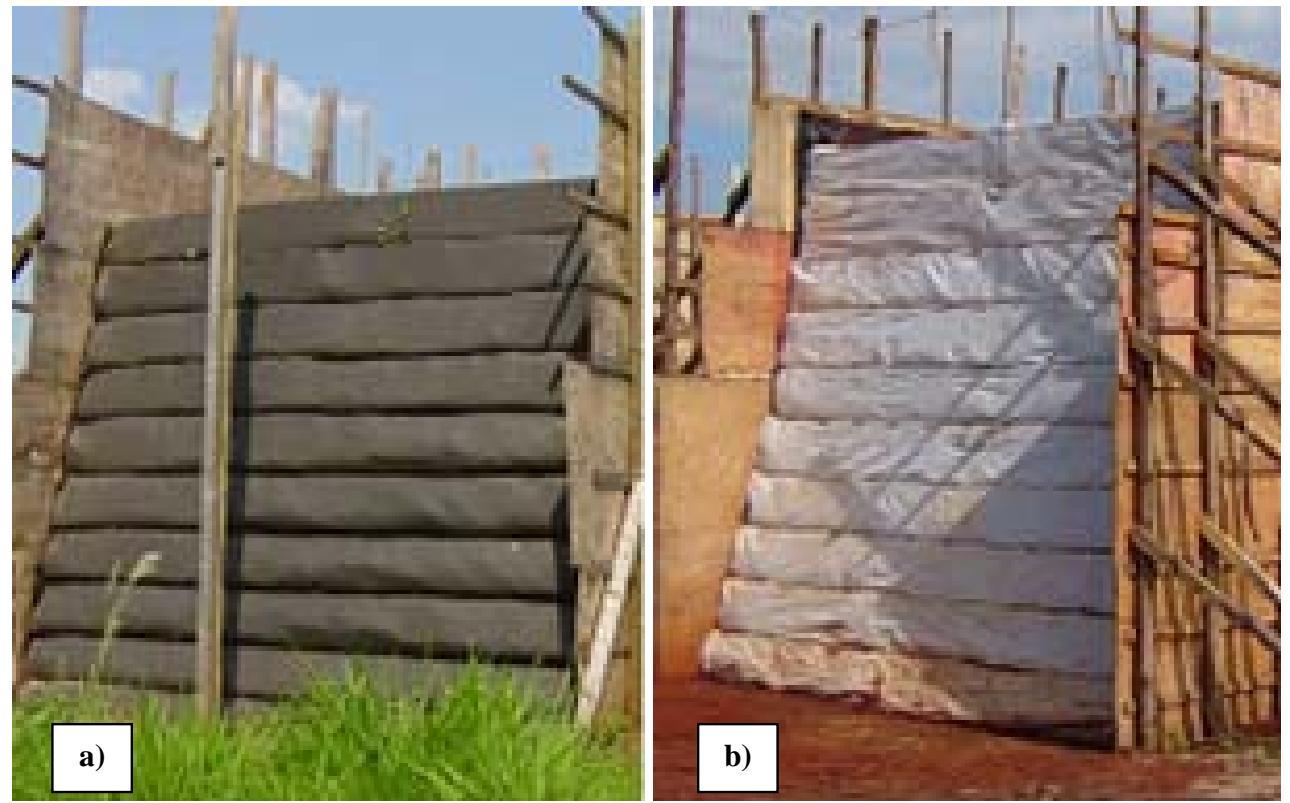
Figure 1. Front view of the prototypes: a) nonwoven geotextile (PET) and b) woven geotextile (PP).

In order to improve the knowledge on the geotextile-reinforced soil retaining walls, it was constructed and instrumented 8 retaining walls, 4.0 m high each, and reinforced with woven (PP) and nonwoven (PET) geotextiles. Because the experimental character, the structures constructed in this research didn't have any facing system protection, being exposed to evaluate the UV degradation. After the behavior evaluation of the prototypes 1 and 8, geotextile specimens were retrieved within the backfill soil, in order to evaluate the mechanical damages, as well as specimens of the facing that had been exposed for evaluation of the UV (Figures 1a and 1b).

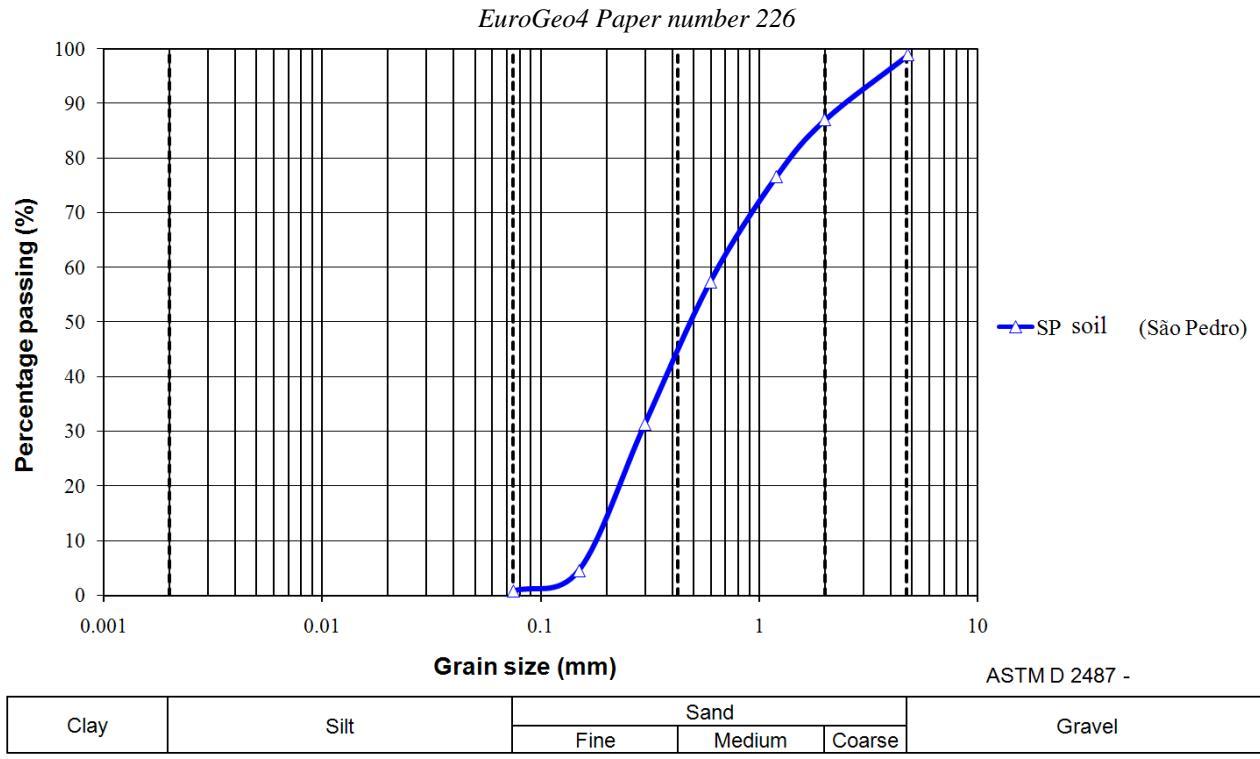
Figure 2. Grain size distribution.

Three different soils were used in this research, among them, two with cohesive behavior and one with granular behavior. The soil used in the construction of prototypes 1 and 8 was a poorly graded sand (Figure 2).

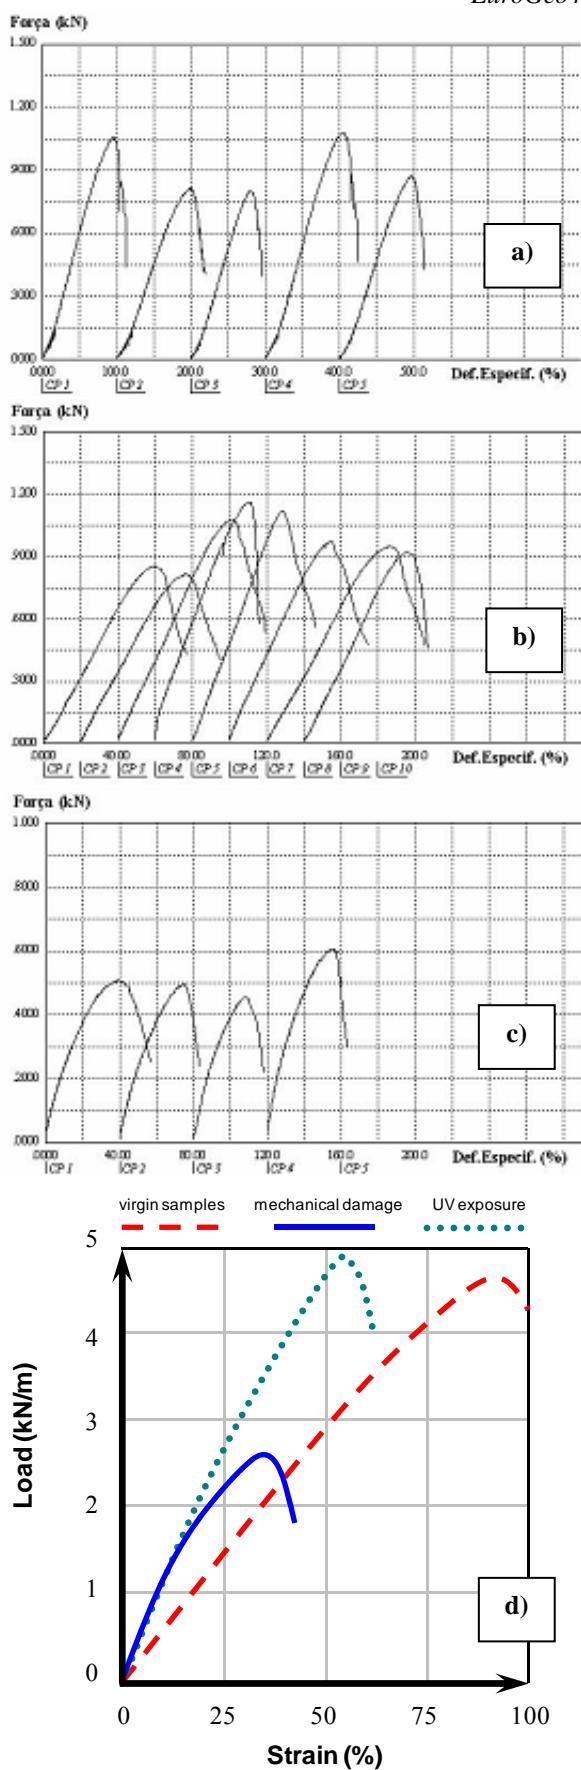
Figure 3. Tensile strength tests conducted in the machine direction (MD) with the nonwoven geotextile: a) virgin samples, b) mechanical damaged samples, c) UV exposed samples d) comparison between the medium results of each tests.

Figures 3, 4, 5 and 6 present the curves load x strain of all the tests, simultaneously with the average values obtained for each type of damaged sample. Tables 3, 4, 5 and 6 present the results obtained for the geotextiles (ultimate tensile strength, strain at the failure and coefficients of variation).

The ultimate tensile strength of the retrieved specimens of nonwoven geotextile did not suffer significant variation with compaction, varying less than 2.0% in both machine directions (Figures 3 and 4). This implies in reduction factors for the installation next to one. Since the nonwoven geotextile used in this research has a mass per unit area relatively low, the geotextiles with larger mass per unit area may present more favorable reduction factors.

On the other hand, the samples presented an increase in the stiffness, which is beneficial for this type of application, with a strain at failure close to 55% in both machine directions (considerably smaller than the 95% registered in the virgin specimens).

The nonwoven geotextiles, manufactured with PET fibers, presented a reduction in the ultimate tensile load equal to 44% in MD and 38% in CMD, after an exposition of approximately 200 days. The stiffness modulus presented and increase of 60% in MD and 90% in CMD. The woven geotextile, manufactured with PP, presented a high discrepancy comparing the two machine directions. In the MD, the reduction in the ultimate tensile load was, after approximately 1000 days, 33%, while in the CMD, the reduction was 84%. A small increase in the stiffness modulus on the exposed specimens, when compared with virgin specimens, was verified, reaching 37% in MD and 21% in CMD. when compared with the virgin samples.

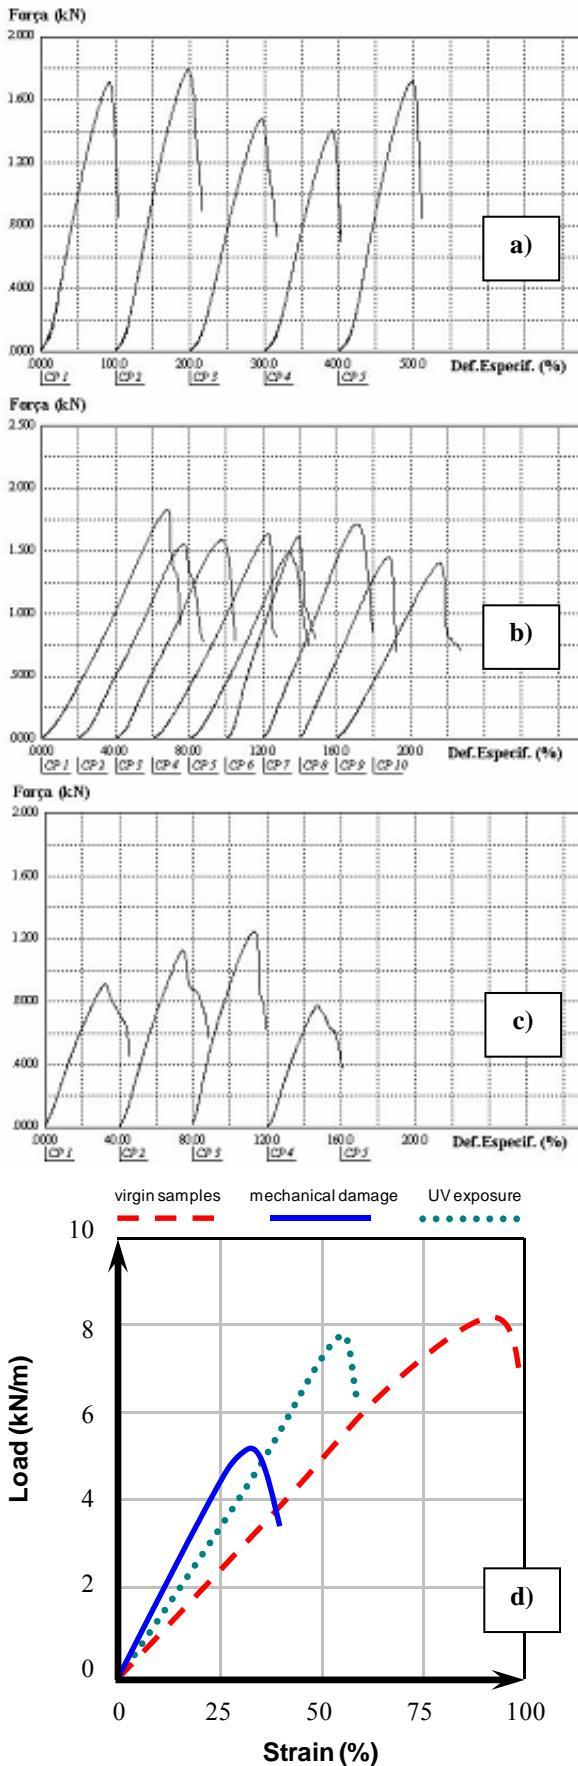
Figure 4. Tensile strength tests conducted in the cross machine direction (CMD) with the nonwoven geotextile: a) virgin samples, b) mechanical damaged samples, c) UV exposed samples d) comparison between the medium results of each tests.

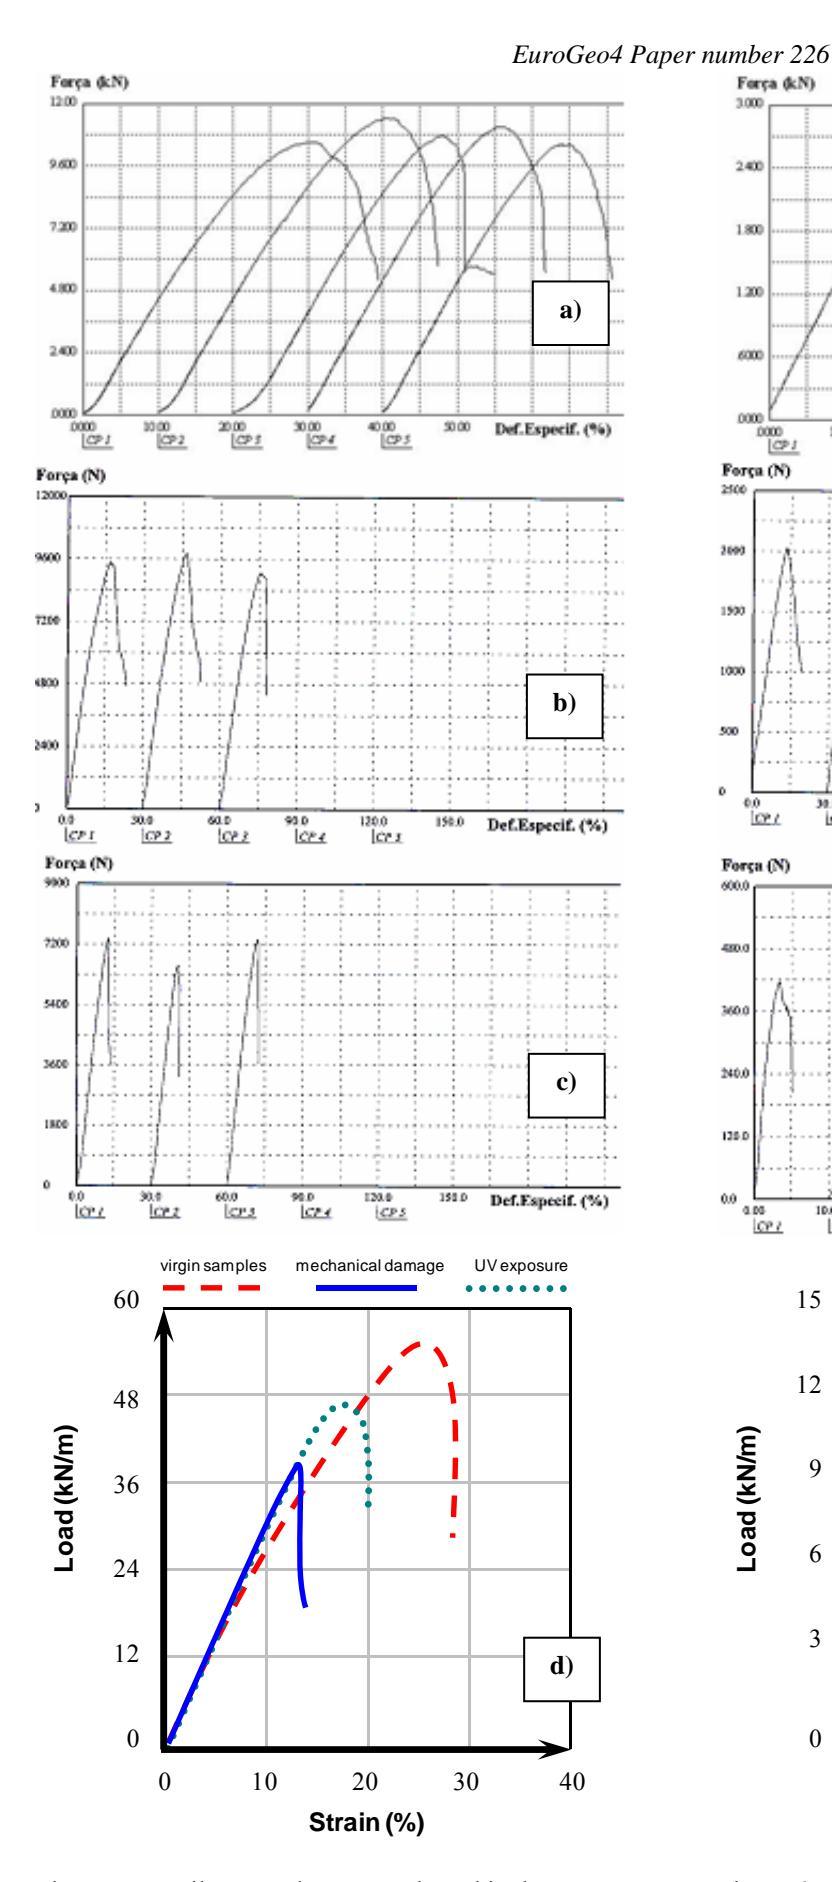
Figure 5. Tensile strength tests conducted in the machine direction (MD) with the woven geotextile: a) virgin samples, b) mechanical damaged samples, c) UV exposed samples d) comparison between the medium results of each tests.

Regarding the woven geotextile, the decrease registered in the ultimate tensile strength, due to compaction and installation damage, was more accentuated. In machine direction (MD), the decrease in the ultimate tensile strength, compared with the virgin specimens, was approximately 10%, while in the crossmachine direction (CMD) this decrease was 26%.

These values imply in reduction factors for installation, for the woven geotextile, equal to 1.1 (MD) and 1.4 (CMD). However, as generally does not exist in project distinction for the directions, the largest value will have to be adopted. These values are similar to the ones recommended by Elias et al. (2001), where the author recommends, for woven geotextiles, reduction factors for installation between 1.1 and 1.4, for soils with the  $D_{15}$  close to 0.7 mm and maximum size of the grains equal to 2 mm, very similar to the soil used in this research project.

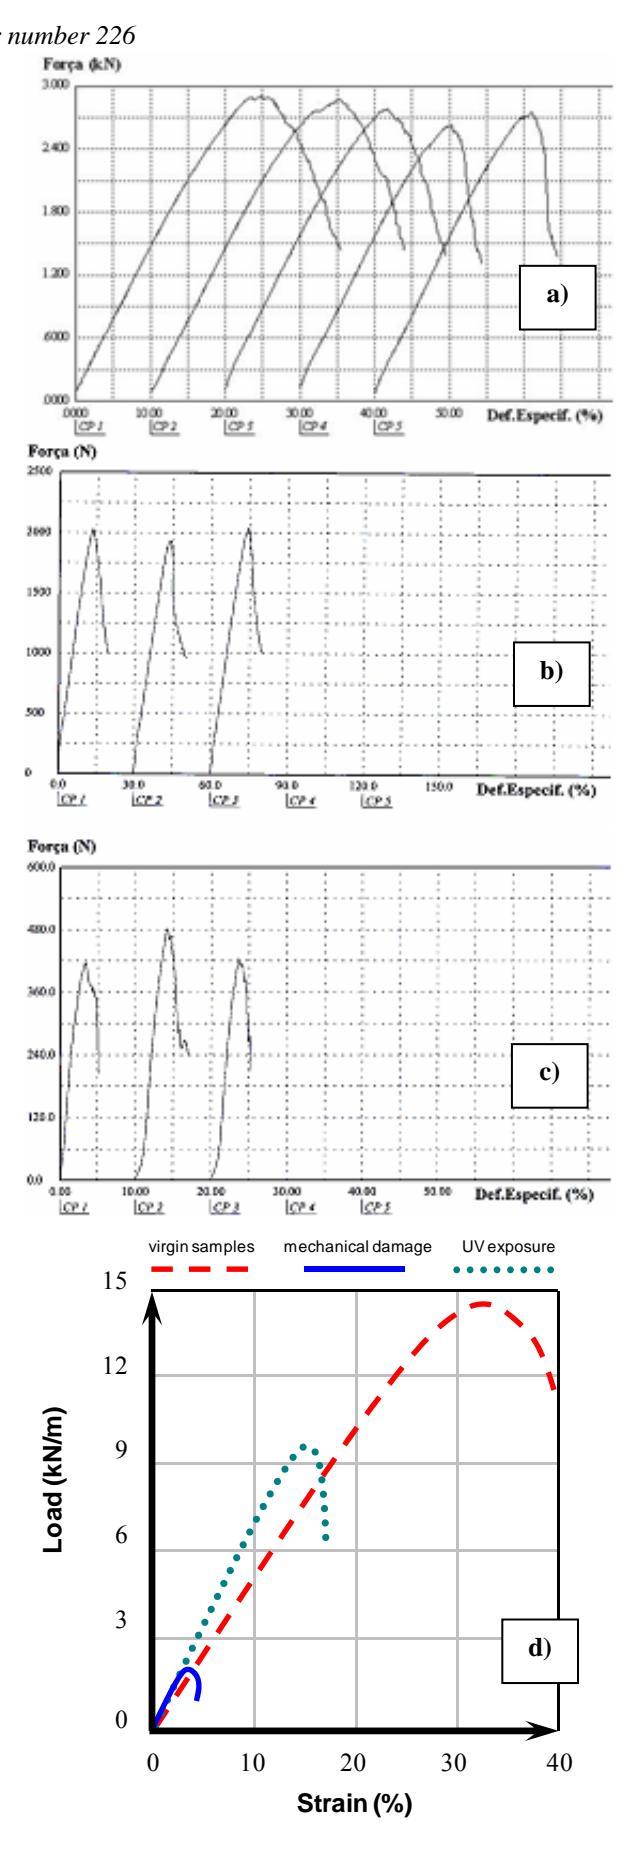
Figure 6. Tensile strength tests conducted in the cross machine direction (CMD) with the woven geotextile: a) virgin samples, b) mechanical damaged samples, c) UV exposed samples d) comparison between the medium results of each tests.
