# Selecting the most important parameters in geosynthetic reinforcement applications

Troskie, M.M. Kaytech Engineered Fabrics, Johannesburg, South Africa

ABSTRACT: Geogrids have different mechanical properties, depending on the end-use. The ideal geogrid for each application will be the most suitable and economical. These properties and characteristics will be illustrated in two case studies:

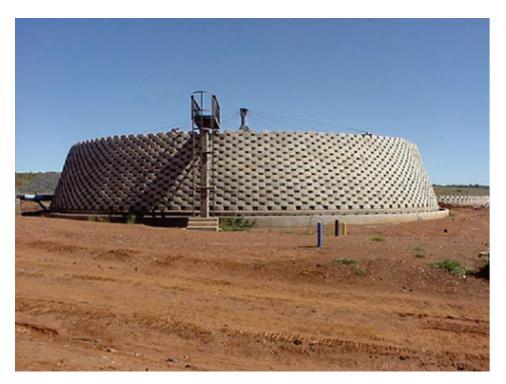
The conventional solid concrete perimeter retaining walls can be replaced with geosynthetic reinforced concrete blocks. Concrete blocks are stacked in an open structure allowing additional oxygen flow between the stones. Manual labour can be used to place the blocks. This creates excellent opportunities for the contractor to use local labour from the surrounding settlements.

Figure 1. Concrete block trickling filter.

The geosynthetic reinforcement is installed at predetermined levels between the concrete blocks. The height and face angle of the structure determine the tieback length and strength of the geogrid in trickling filters. Tieback lengths required range between 0.7 and 0.8 times the height of the structure. Geogrids are positioned at the required level on top of the blocks and stone bed. It is important to level the stone bed with the top of block before the reinforcing layer is laid down. Movement of the front face can occur if the reinforcing is not installed in one plane. The geogrid is placed right to the front to ensure maximum clamping between the facing unit and the reinforcing material. The geogrid is installed in the machine direction perpendicular to the wall face. The next layer of concrete blocks is installed before more stone is placed. Damage to the geogrid can occur if proper construction practices are not followed when placing the stone.

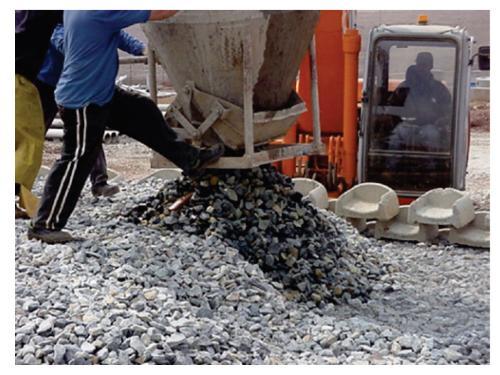
It is good practice to tension the geogrid before the stone is placed. This is to mobilise the tensile stresses in the geogrid preventing lateral movement at the front face.

Figure 2. Placing of stone.

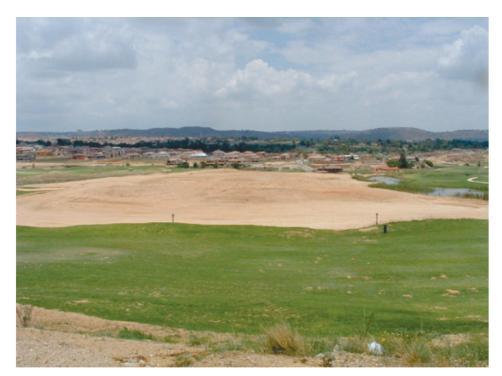
Figure 3. Eagle canyon driving range.

The property has since been developed into a golf estate called Eagle Canyon Golf Estate. The site was reshaped according to the golf course design and a driving range constructed over the tailings dam.

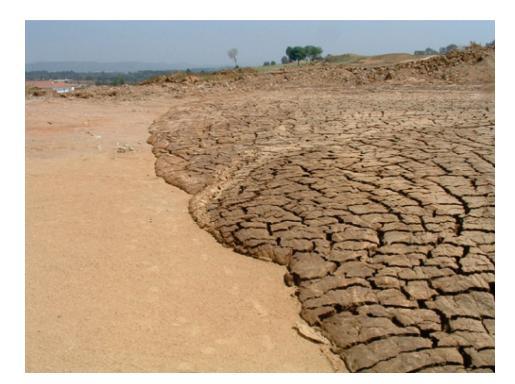
Unknowingly the original dam-wall and a section of the toe were used as a source of borrow-pit material. This material was taken up-stream to cover the tailings and to reshape the required area of the driving range. Heavy earth-moving equipment continuously drove over this area during the reshaping and levelling process. The additional load from the cover material and dynamic action from the earth moving equipment generated additional earth pressure. As a result of the removal of the material from the original tailings dam-wall, the contained tailings, which were still

Figure 4. Tailings "flowed" over cover material.

saturated, "flowed" out filling the borrow-pit that had been created downstream of the dam-wall.

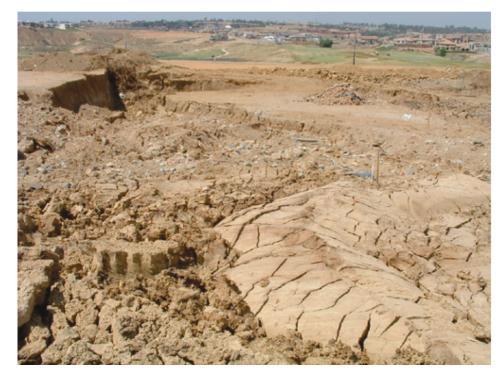
Earth moving equipment was immediately evacuated from the borrow-pit and the driving range section as the borrow-pit rapidly filled up to the natural ground level. The depth of the borrow-pit varies between 7 m and 9 m and had an area of approximately 5 000 m<sup>2</sup>. As the tailings flowed towards the borrowpit the driving range capping material sheared. In some sections the tailings flowed out from beneath the capping causing settlement in the layer works. During failure these areas of subsidence were filled and covered with tailings from up-stream.

Figure 5. Cover material sheared.

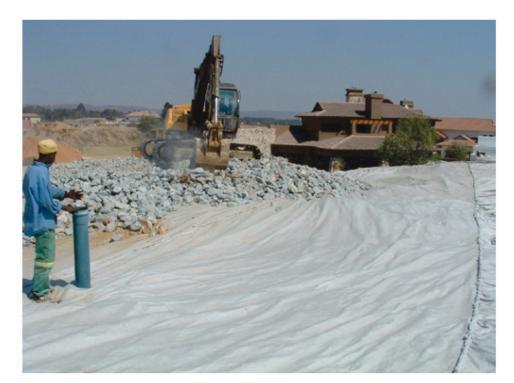
A composite, reinforcing geotextile was placed over the filled borrow-pit. The 5.2 m wide panels were stitched together using 1 mm thick binding wire. A continuous reinforcement and separation blanket was thus formed with the composite geotextile. A 600 mm thick dump-rock layer was placed over this blanket layer. The purposes of the composite geotextile were to act as a reinforcement, separation and drainage layer. This layer prevented the dump-rock from punching through into the soft, saturated tailings, thereby controlling the dump-rock volumes used. Furthermore, it prevented tailings contaminating the dump-rock. The composite geotextile layer allows water to pass through but prevents fines entering the drainage path that the dump-rock layer provided, thereby accelerating the consolidation process. This drainage path was connected to the 3 m deep subsurface drain via solid 160 mm diameter PVC pipes at 10 m spacing. The nonwoven geotextile component provided protection to the high-tenacity, polyester. reinforcement yarns when the dump-rock was placed.

Figure 6. Placement of dump-rock.

Differential movement occurred when the dumprock was placed and compacted. This mobilised the tensile force in the composite geotextile layer that was trapped between the two different materials. The composite geotextile and the dump-rock layer formed a stiff but flexible layer after the compaction effort was complete. A low-elongation reinforcement product was critical in this application to ensure that high tensile forces were generated during the dump-rock placement period. The dump-rock was covered with a compacted layer of suitable backfill material that was tied in with the starter berm.

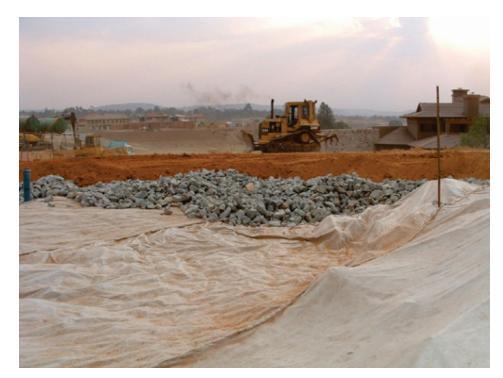
Figure 7. Preparation of final levels.
