Damage of geotextile due to impact of stones

Adam Bezuijen

ABSTRACT: Impact tests of stones on a geotextile have been performed. The geotextile was mounted on a concrete cylinder of 0.8 m diameter filled with dry sand with a constant porosity. Tests were performed on woven and non-woven geotextiles and on composites. Drop tests were performed with concrete blocks of different shapes weighing all around 40 kg. The falling heights varied between 0.5 to 5.5 m.

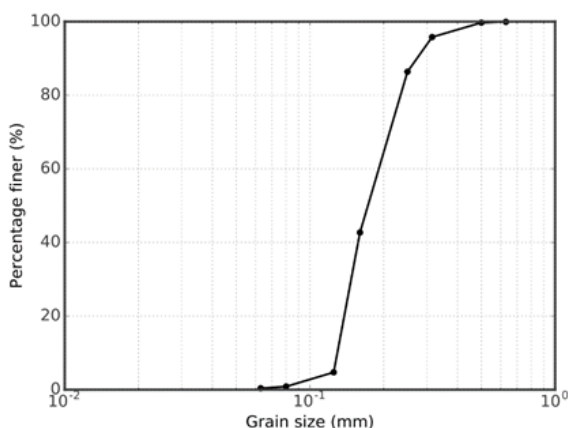
Figure 2. Grain size distribution of the sand

A concrete cylinder of 0.8m diameter and 0.9 m high was filled with dry Mol sand. The grain size distribution is shown in Figure 2. Before each test the upper layer of the sand was loosened, see Figure 3, to avoid that ongoing densification of the sand during the tests would influence the results.

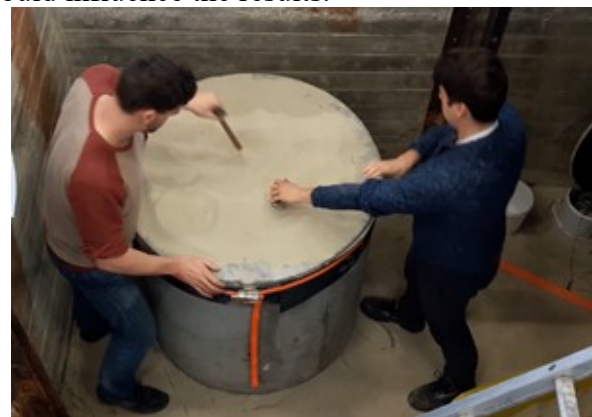
Figure 3. Loosening of the sand before an impact test by turning around wooden sticks.

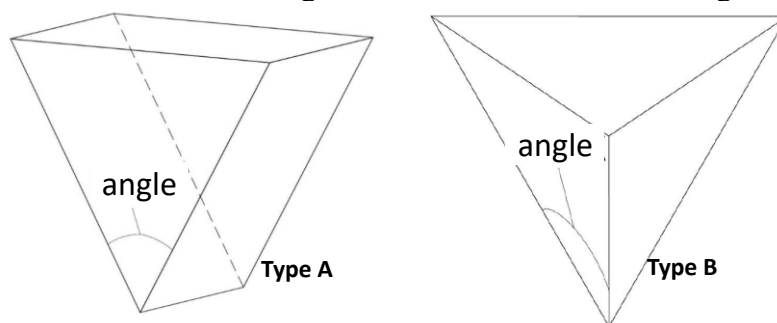
Figure 7. Definition of the angle β for Type A and Type B blocks. (De Strijcker and Decraene, 2017)

Blocks of different dimensions were used. In all cases the weight was around 40kg. As mentioned before, the angle between the surfaces differed. See Figure 7 for the definition of the angle for different block types.
