Lining of mine residue storage facilities

ABSTRACT: The lining systems used for mine residue (or tailings) storage facilities are not dissimilar to those used for single lined solid waste landfills, although there are currently less regulations driving the specific liner materials used. The logistics of installing lining systems in storage facilities in remote mining locations means that forward planning is required and extra care is needed to avoid damage to the liner due to climatic effects, such as wind and rain. The QA/QC practices are similar to those used for solid waste landfills. In addition, there is the challenge of keeping material and installation costs to a minimum in line with mining practices. This paper discusses a number of experiences of lining large mine residue storage facilities, especially under tropical conditions, and presents considerations for future lining of mine residue storage facilities.

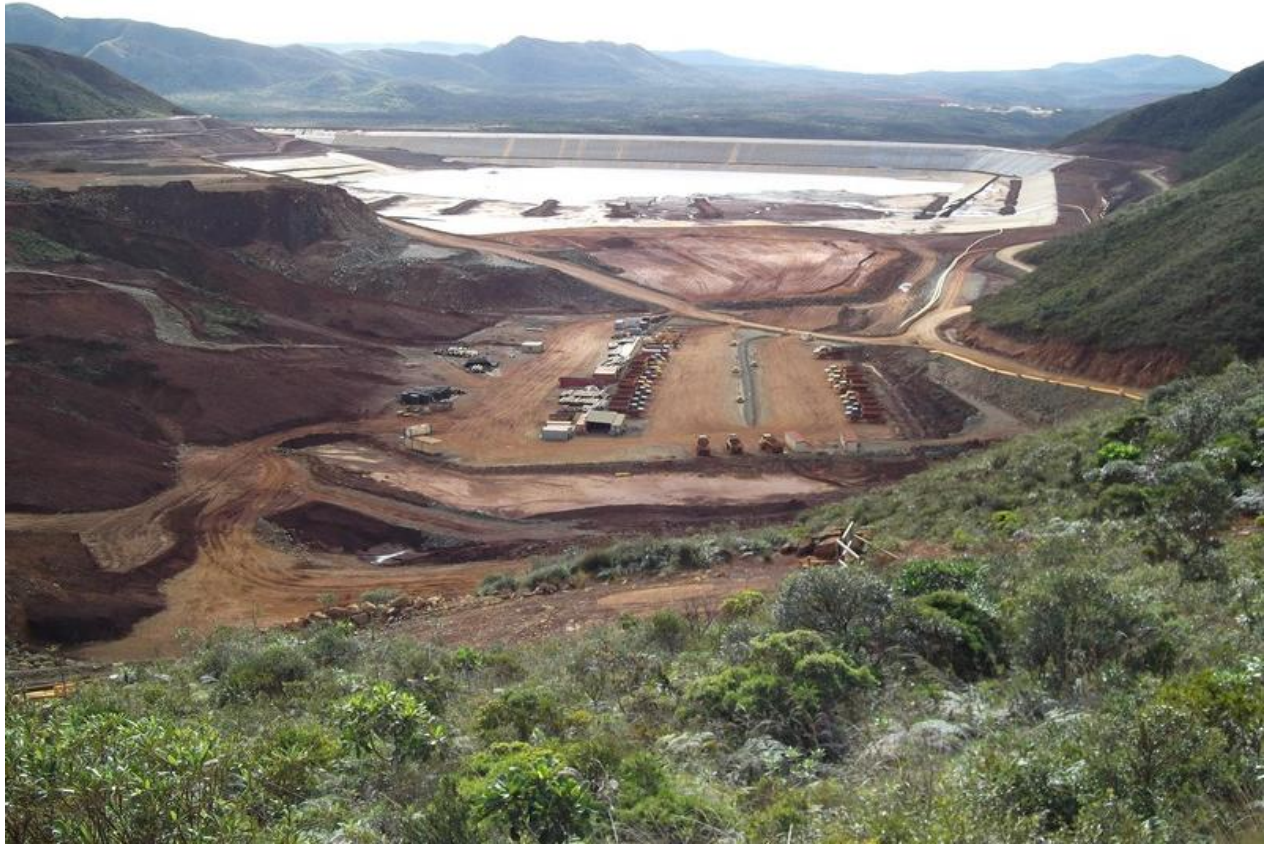
Figure 1 A large tailings dam in the tropics with a geomembrane liner where many issues associated with wind and stormwater were addressed.

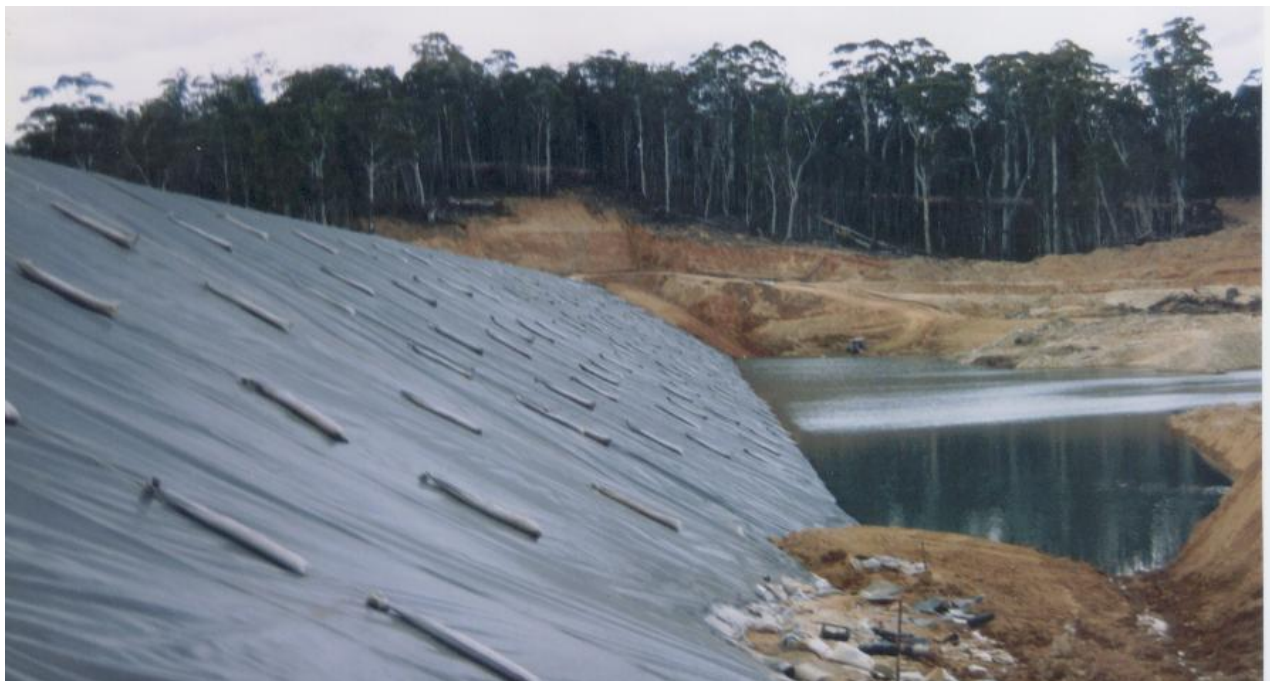
Figure 2 A lined upstream face of an embankment of a tailings dam with sand filled ballast tubes suspended on the slope

Due to the high expected wind speeds from passing cyclones, a regular ballast system was installed to hold the liner in place until it was covered by the mine residue. The local soils were utilized for ballast, and these materials were fully enveloped in erosion resistant materials to reduce the loss of material (and hence ballast load) during severe rainfall events. The white strips in Figure 5 along the slope toe are soil ballast mounds fully wrapped in thick geotextile. Some of the geotextile that was exposed to the weather for extended periods showed significant degradation. During the later stages of the works, the ballast was wrapped in thin geomembrane to provide increased durability against ultra violet degradation of the ballast wrapping within the storage. The high design wind velocity at the site required a large amount of ballast to manage the load from wind uplift on the liner.

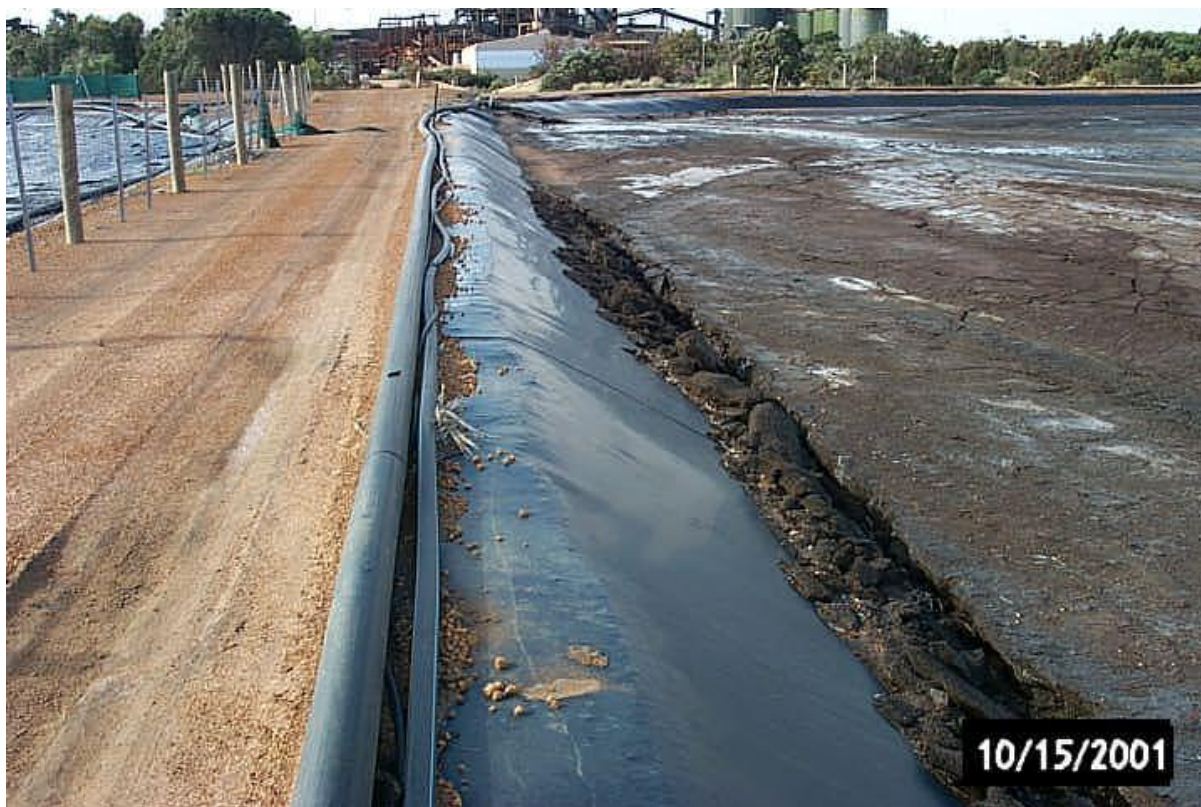
Figure 3 A lined tailings dam where the tailings have dried and settled leading to down-drag on the liner

- The lining system needs to consider the effects of drag down loads on the liner when the residue settles due to consolidation and drying.

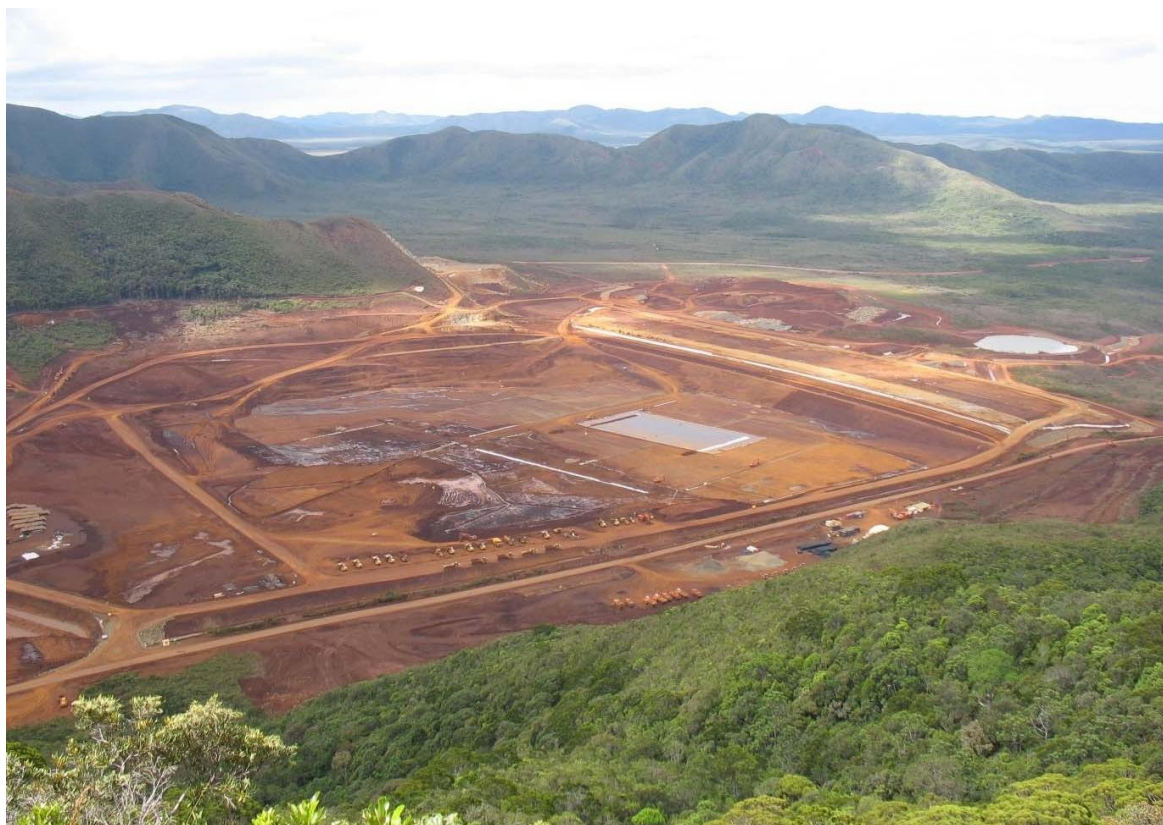
The figure below shows the initial stage of the works, with the embankment on the right and the basin in the middle, with the first stage of geomembrane liner on the floor of the basin.

Figure 4. Early stage of construction.

The storage basin liner comprised a clayey silt subgrade overlain by a 1.5 mm thick linear low density polyethylene (LLDPE) geomembrane. The embankment was lined with a 2 mm thick LLDPE geomembrane liner generally placed on a slope of 2H in 1V. The embankment includes a number of intermediate benches, nominally at a 10 m vertical spacing, to facilitate the staged construction of the geomembrane liner on the slope. The total lined area of approximately 1.3 million m² was installed in stages to suit the earthworks construction of the embankment and preparation of the side slopes of the storage.

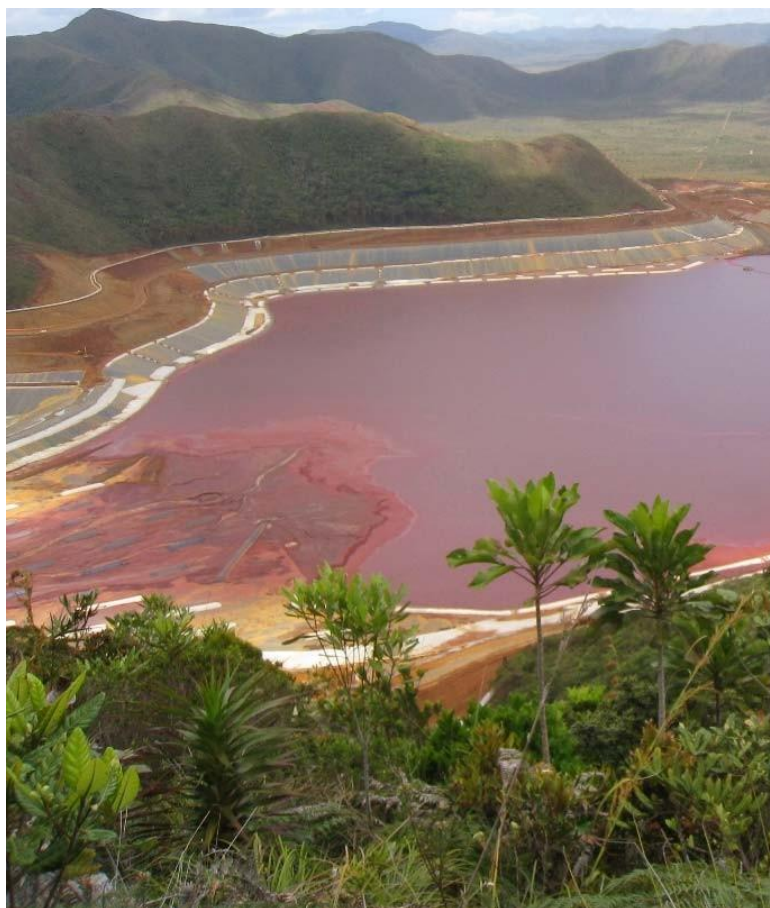
Figure 5. Ballast along slope toe. Storm Water Drainage

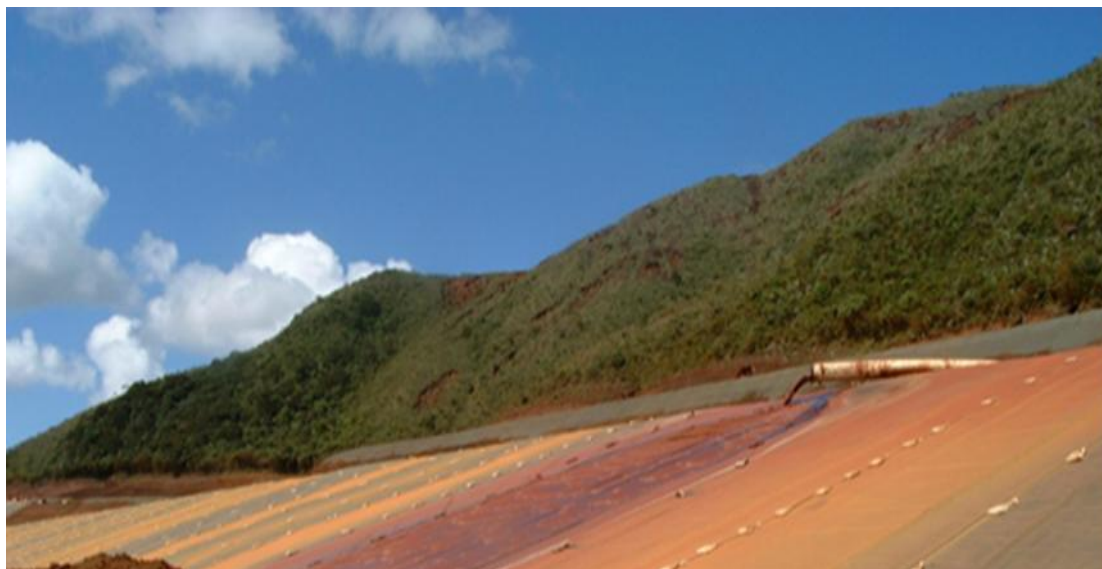
Figure 6. A pipe discharging hot slurry directly on to a liner

On some sites the residue or tailings is pumped into these facilities as a warm slurry. The slurry often comprises rock flour and crushed particles with high abrasion potential. These features can be damaging as it impacts on the liner. Sometimes an additional layer of geomembrane or rock erosion protection layer is used as protection of the liner or a modified inlet pipe is used so that the incoming slurry does not impact on the liner.

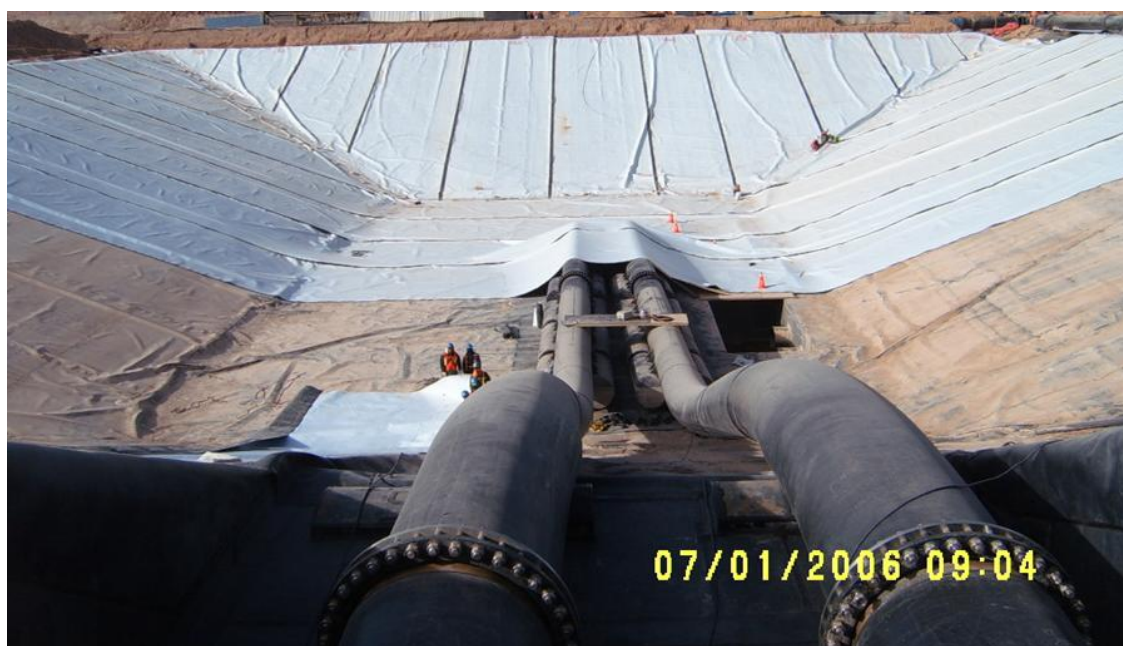
Figure 7. HDPE pipes with floats so that discharge is away from liner. These pipes are shown entering the facility beneath a cover, and the floating exits of the pipes are well above the liner.

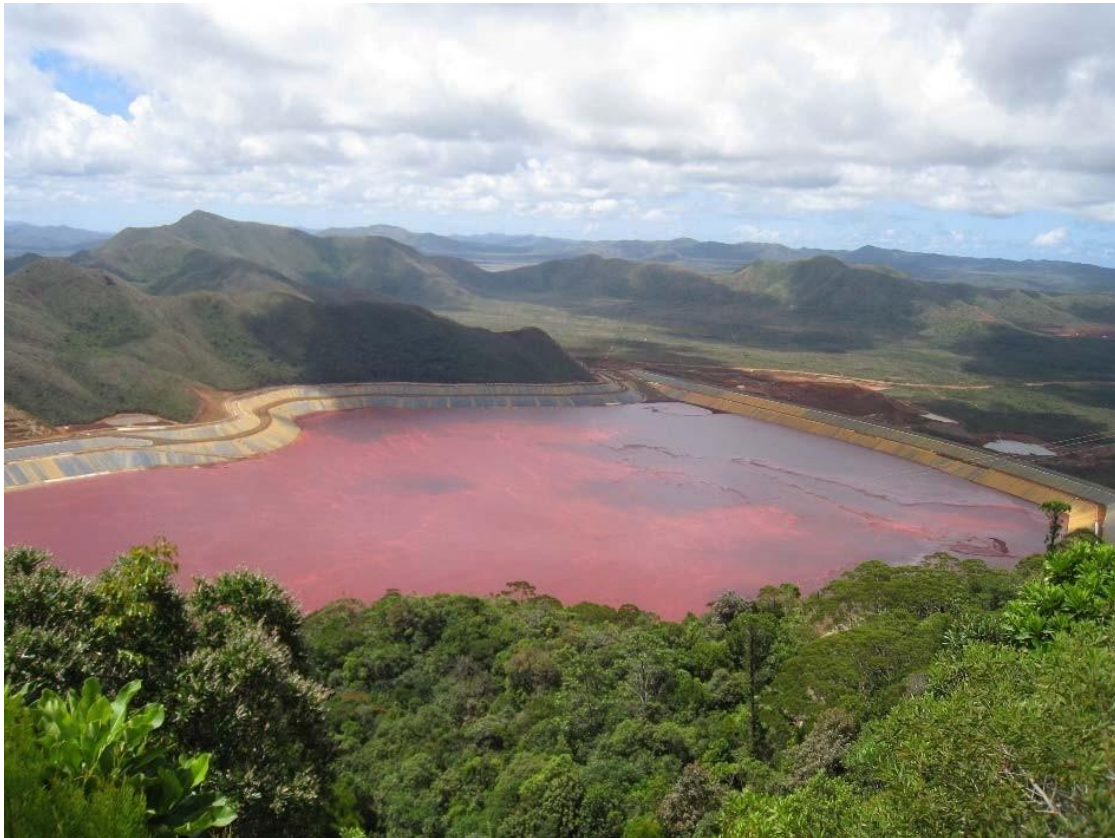
The lining of the residue storage facility was completed in December 2016, and Figure 8 shows the storage facility at that time. The level of stored liquid shown in the figure is about 20 m below the crest of the containment embankment.

Figure 8. Completed residue storage facility.
