Ageing HDPE geomembranes exposed to different climate conditions for 12 years

ABSTRACT: High density polyethylene (HDPE) geomembranes are used in many geotechnical engineering applications, remaining sometimes exposed to climatological conditions for a long time. They are expected to experience degradation due to that exposure, leading to a decrease in their engineering properties. To study the degradation in the properties of field exposed geomembranes, a research program has been in progress at *Laboratório Nacional de Engenharia Civil*, since 1999. This paper addresses the degradation in the properties of HDPE geomembranes, installed at eight different locations, after 12 years of exposure. Another goal of this work is to compare the properties of exposed geomembranes with the minimum requirements currently recommended by the Geosynthetic Research Institute (GRI), in order to verify that they still meet those requirements. Samples were exhumed from different sites located all over Portugal and the properties of the geomembranes were tested in laboratory. The properties studied were: density, melt flow index, tensile properties, carbon black content, and oxidative induction time

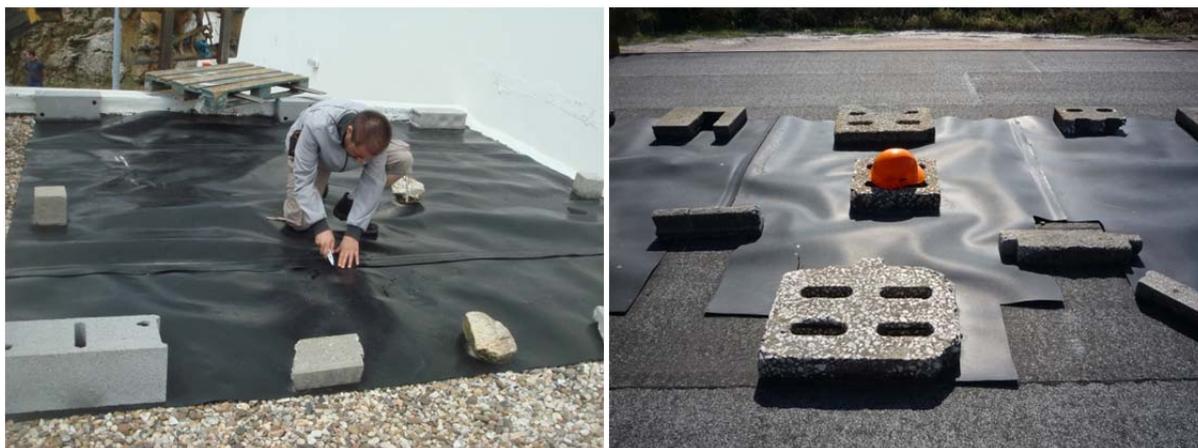
Figure 1: Examples of geomembrane samples exposed to climatic conditions

The samples were either placed on easily accessible slopes or on building roofs (Figure 1), where they were exposed to climate conditions. They were installed at eight different locations in Portugal, as depicted in Figure 2.

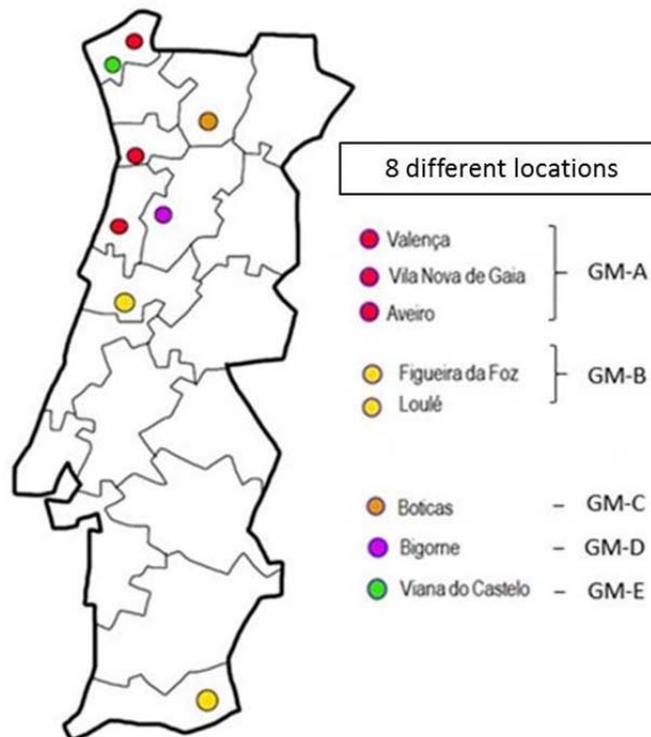
Figure 2: Location of geomembrane samples in Portugal

GM-C, GM-D and GM-E. As Figure 2 shows, GM-A was simultaneously exposed in three different locations and GM-B was exposed in two locations.

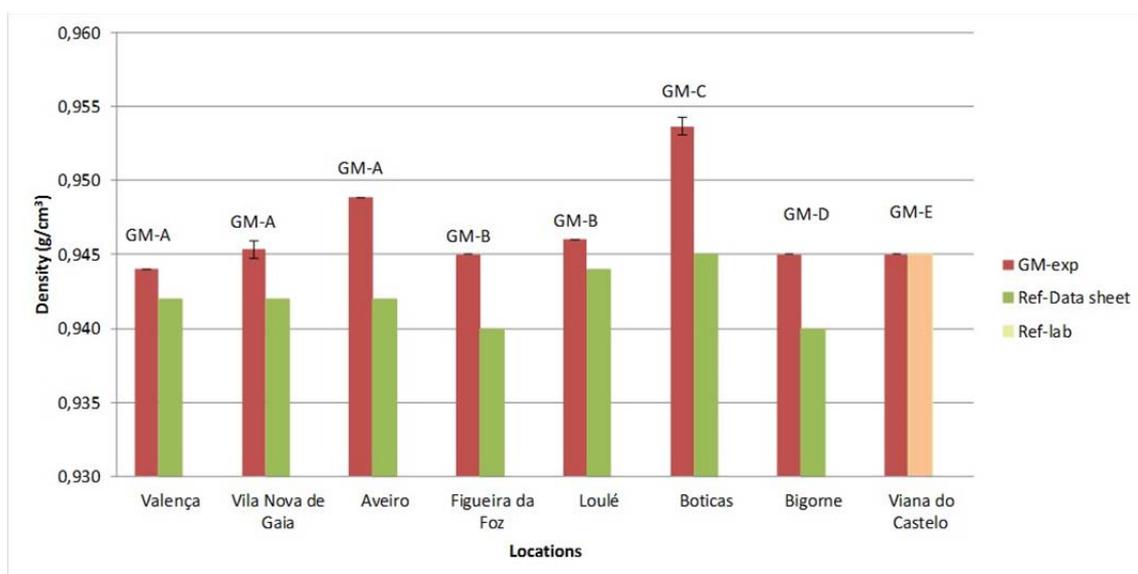
Figure 3: Comparison of the density of GM-exp with the reference values

As regards density, exposed geomembranes showed higher values than the reference values, except for GM-E, of which the values were identical, as can be seen in Figure 3. The increase in density can be related to changes in the polymer structure due to geomembrane degradation. As discussed by Rowe and Ewais (2015), geomembrane degradation can be caused by a change in the morphological structure (physical degradation), which may result in increased geomembrane crystallinity as the polymer tends to become more brittle.

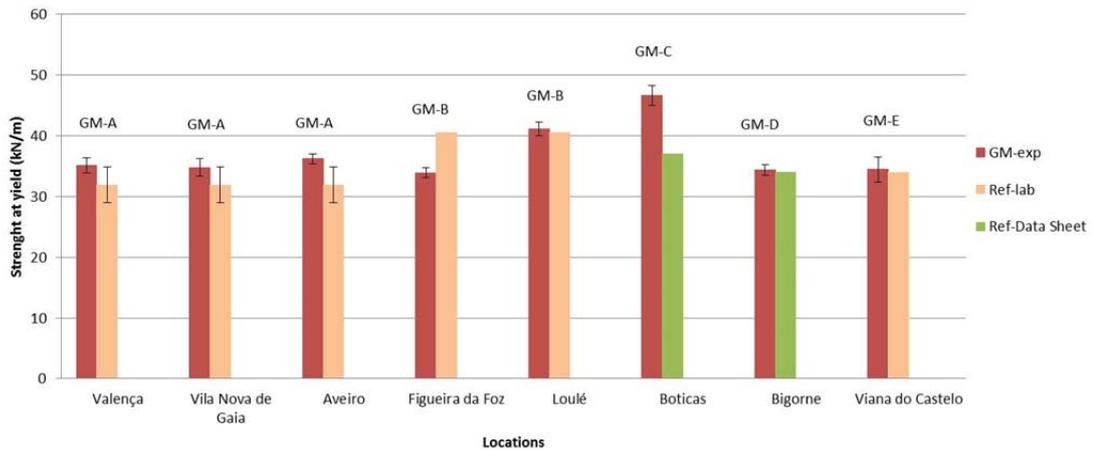
Figure 4: Comparison of the strength at yield of GM-exp with the reference values

Density has an impact on mechanical properties of the geomembrane (Handbook of Plastic Films, 2003). For example, increasing the density will increase the yield strength. This theory is consistent with the results obtained in the present study and depicted in Figures 4 and 5. In general, the yield strength values were higher for the aged geomembranes (GM-exp) than the reference values. Similar results were reported by Rowe et al. (2009) for a geomembrane exposed in air, at different temperatures, during 115 months. According to these authors, the increase in yield strength can be attributed to the physical ageing deriving from the increase in crystallinity.

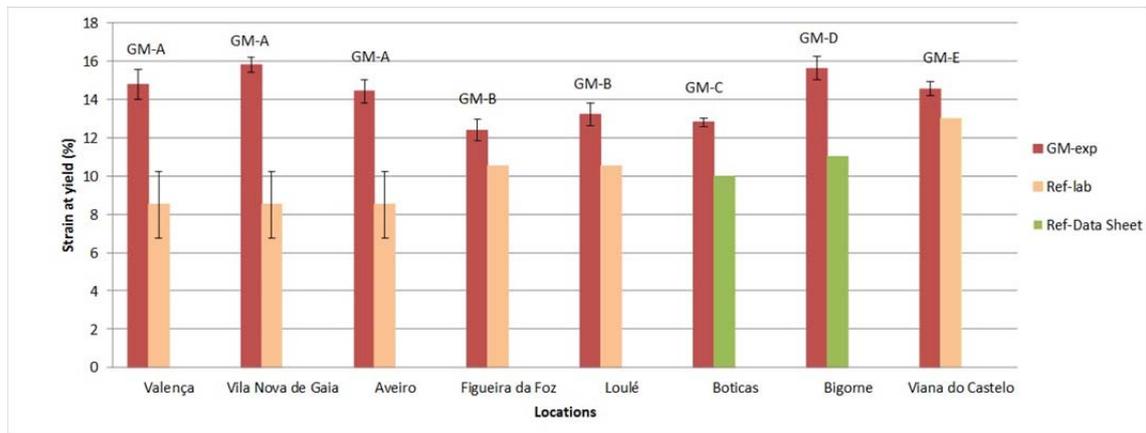
Figure 5: Comparison of the strain at yield of GM-exp with the reference values

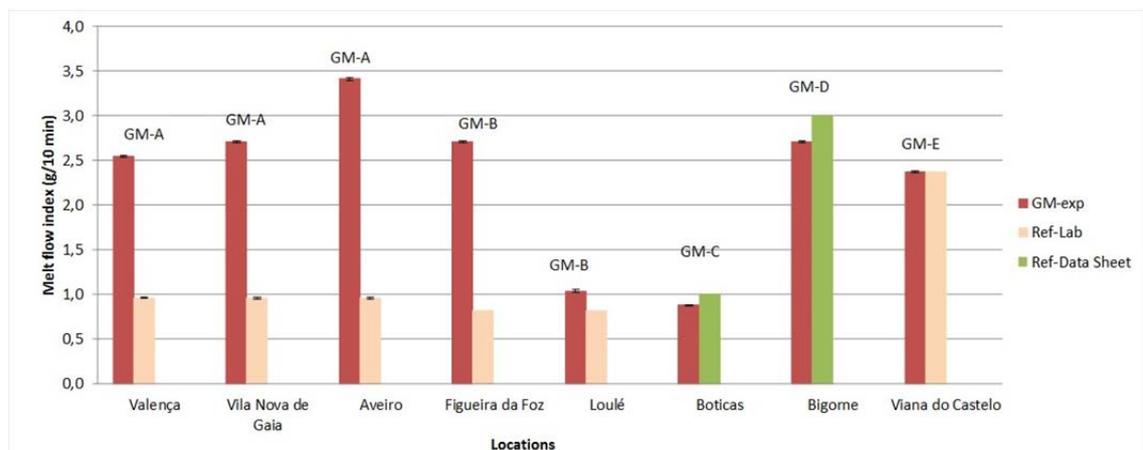
Figure 6: Comparison of the melt flow index of GM-exp with the reference values

For the melt flow index (Figure 6), results obtained for exposed geomembranes (GM-exp), are higher than the reference values for GM-A and GM-B and less than the reference values for GM-C, GM-D and GM-E.

Results obtained for GM-A and GM-B differ from what was expected beforehand, since both the tensile strength and the melt flow index have increased. These results are similar to the results obtained by Lodi et al. (2007). The reason for this unexpected behavior has not yet been fully understood. It seems that further research on this topic is needed before some general trends can be established.

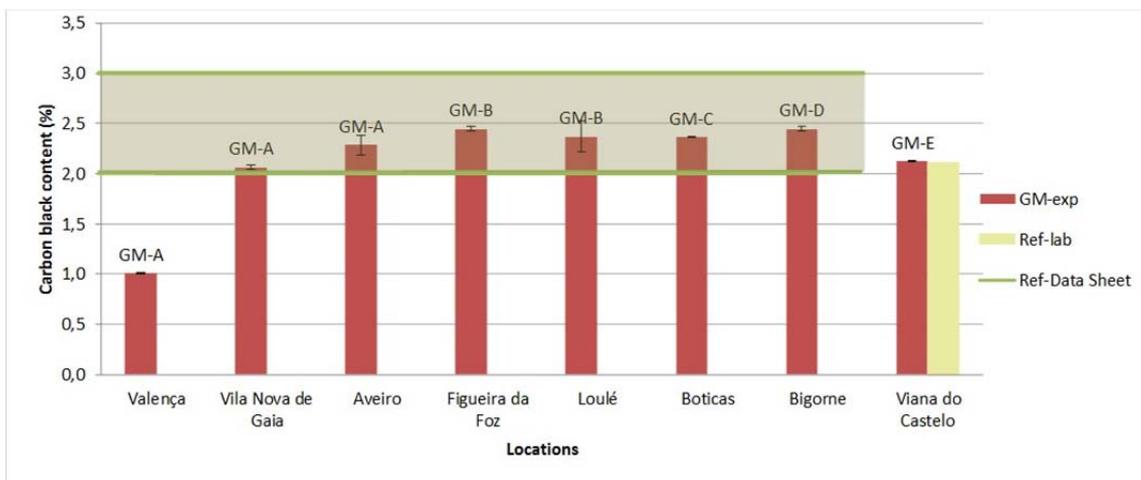
Figure 7: Comparison of the carbon black content of GM-exp with the reference values

For the carbon black content (Figure 7), as the initial values of the original material at the time of sample preparation were not available, the reference values were based on the data sheet, corresponding thus to a range between 2 and 3%, which makes it rather difficult to do comparisons. Hence, the results can be considered as inconclusive.

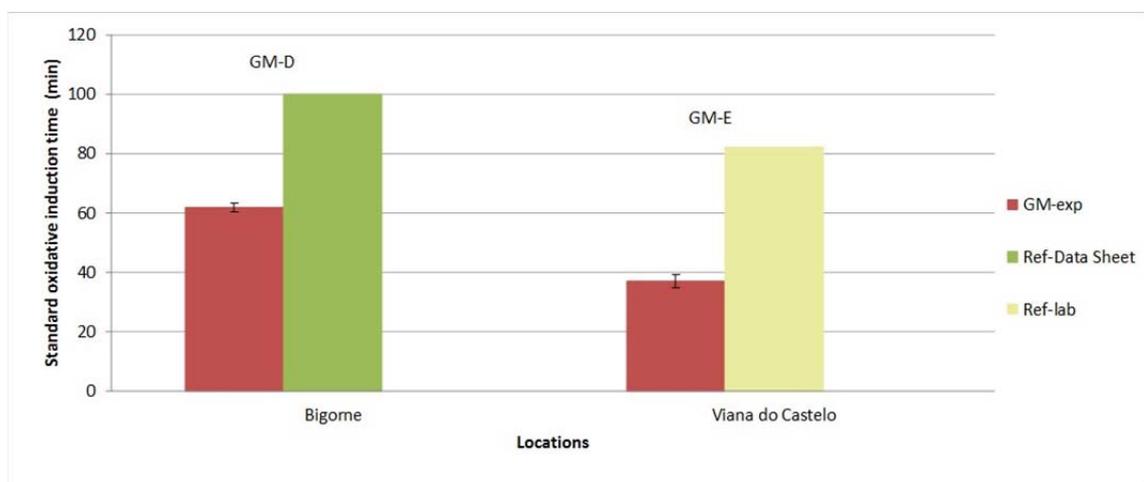
Figure 8: Comparison of the standard oxidative induction time of GM-exp with the reference values

For the oxidative induction time, comparisons are only possible for GM-D and GM-E (Bigorne and Viana do Castelo) since for the remaining samples the initial values were not available. As can be seen in Figure 8, the OIT values were less for the aged geomembranes (GM-exp) than the reference values, suggesting that consumption of antioxidants occurred due to sample exposure to climatic conditions. This seems to give supporting evidence that climatic conditions have had an impact on geomembranes exposed for 12 years in Portugal.

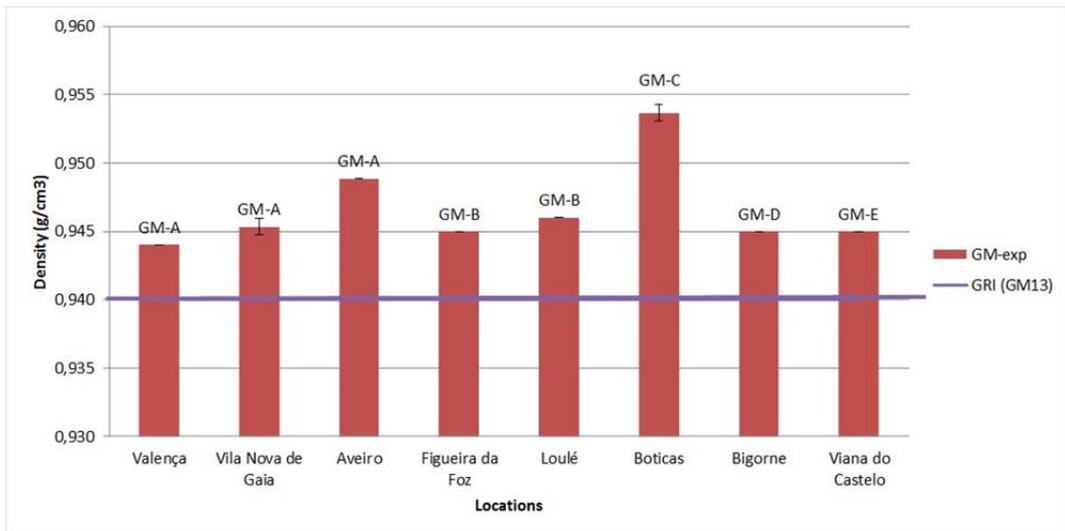
Figure 9: Comparison of the density of GM-exp with GRI-GM13

For density (Figure 9), tensile strength at yield (Figure 10) and strain at yield (Figure 11), exposed geomembranes at eight different sites in Portugal, for 12 years, still met the minimum requirements established by GRI-GM13.

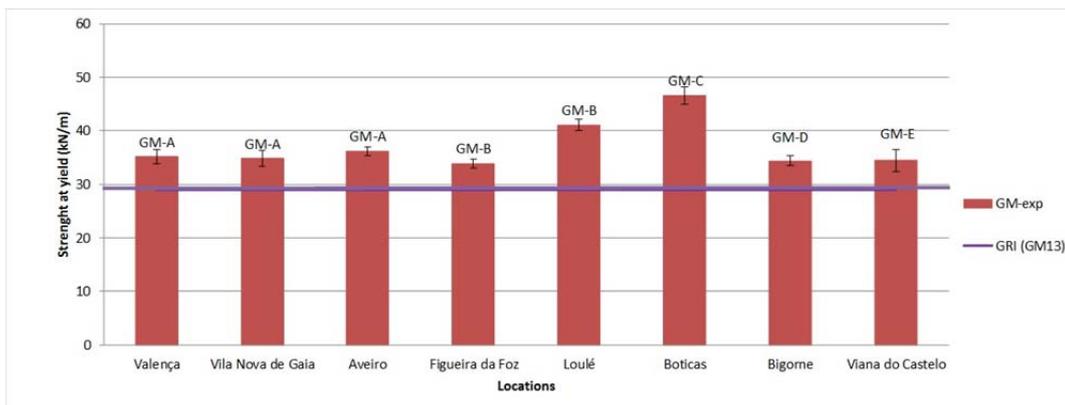
Figure 10: Comparison of the strength at yield of GM-exp with GRI-GM13

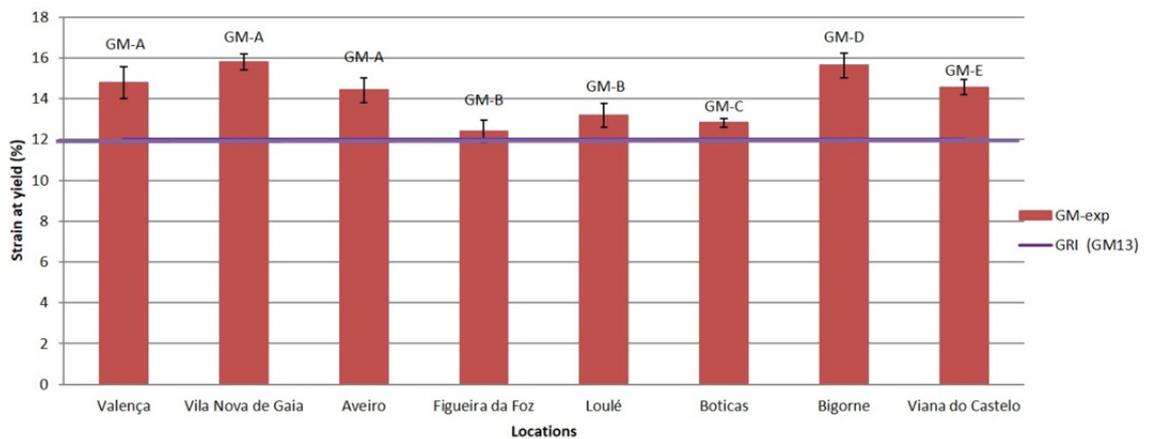
Figure 11: Comparison of the strain at yield of GM-exp with GRI-GM13

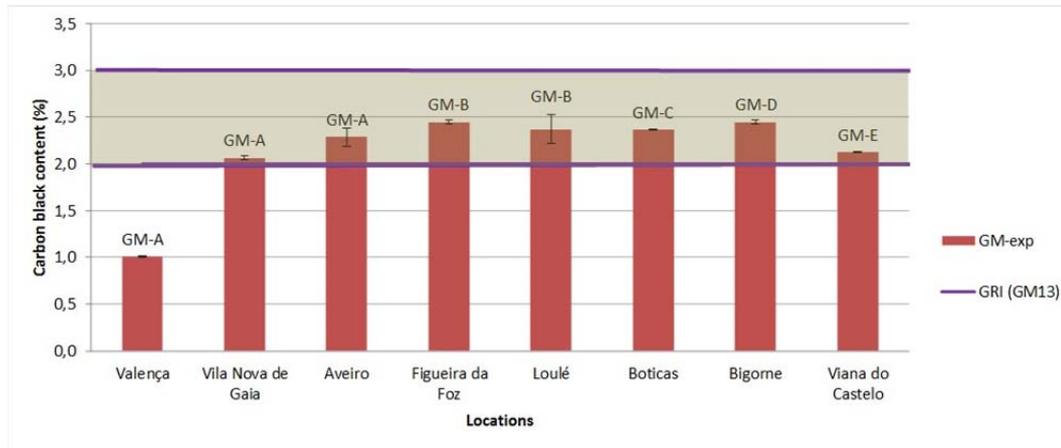
Figure 12: Comparison of the carbon black content of GM-exp with GRI-GM13

For carbon black content (Figure 12), aged geomembranes also met the minimum requirements recommended by GRI - GM13, except for the sample exposed in Valencia.

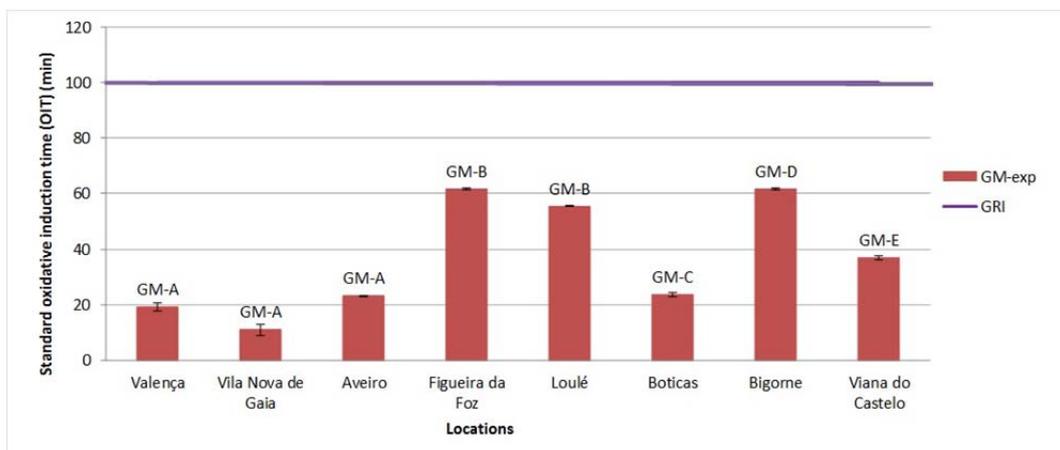
Figure 13: Comparison of the standard oxidative induction time of GM-exp with GRI-GM13

For the oxidative induction time (Figure 13), none of the exhumed geomembrane samples met the minimum requirements indicated by GRI-GM13, although there was no total depletion of antioxidants.
