Bituminous geomembrane in extremely cold conditions

Installing bituminous geomembranes in Arctic conditions: Construction of three retention ponds at the Diavik Diamond Mine.

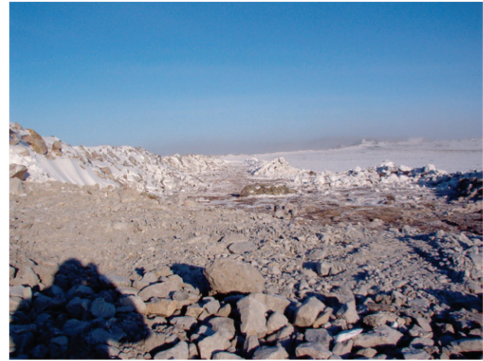
Photo 1. April 18, 2005.

4.1 Photos of natural ground conditions

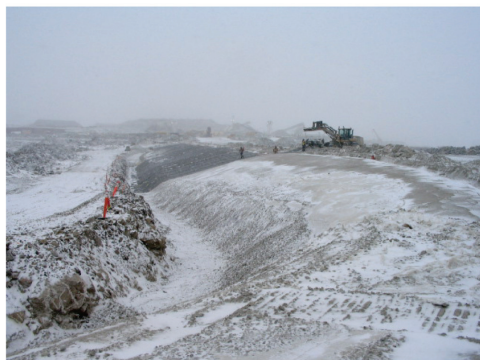
Photo 3. Bottom of trench.

- The geomembrane had to be completely anchored in a trench at the toe of the dike to assure the continuity of the watertightness.
- Because of the permafrost, the trench required blasting. To protect the geomembrane at the transition between the slope and the bottom of the trench, some material was put in the trench to smooth and round the support.

A bentonite-modified soil was used in the trench, which was excavated approximately two metres into the permafrost:

- To provide increased protection for the geomembrane at the bottom of the toe trench; and
- To improve the watertightness at the junction of the permafrost and the geomembrane.

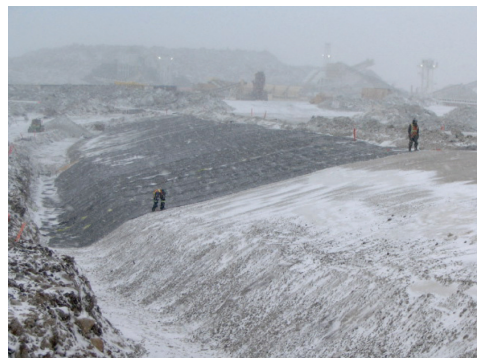
Photo 4. Liner installation.

It takes the same amount of manpower to install a bituminous liner in harsh conditions as it does for an HDPE membrane if using a manual beam.

- A hydraulic beam was used for ponds 2 and 14 and only two workers were needed to unroll the geomembrane.
- Two welders were needed to weld the joints and one assistant to roll and seal after welding.
- One worker was needed to visually inspect the quality of the seam and finish the joint.

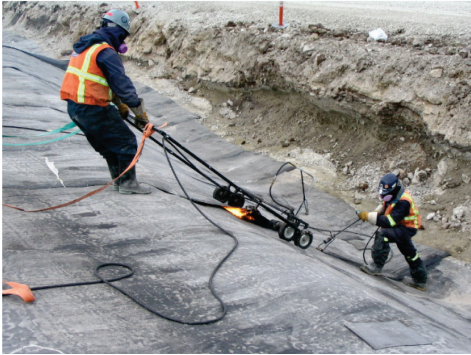
Photo 5. Torching.

The installation could have been improved with more stringent preparation prior to the start of the installation work. This problem was minimized due to the contractor's experience in installing other types of geomembranes.

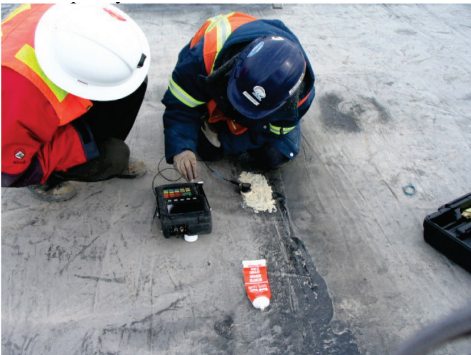
Photo 6. Testing.

There was a manual ultrasound device on site to check the quality of the seams.

There was a vacuum bell on site for testing particular points.
