MECHANICAL PERFORMANCE OF HDPE GEOMEMBRANES SEAMS AFTER SUNLIGHT EXPOSURE

ABSTRACT: Geosynthetic materials are increasingly used in solid waste landfills, but geosynthetic mechanical properties can change when exposed to sunlight. The experience with the evolution of mechanical performance due to UV radiation is not yet consolidated. Presently, at *Laboratório Nacional de Engenharia Civil* (LNEC) a research program concerning the evolution of the mechanical properties of HDPE geomembranes dual hot wedge seams exposed to sunlight during 12 years (expected service life of most Portuguese solid waste landfills) is under study. This paper presents the results of shear and peel tests in HDPE geomembranes dual hot wedge seams after 2, 3 and 5 years to sunlight exposure. The results are compared, on one hand, with those of the same specimens exposed to sunlight but covered by geotextile, and on the other hand, with those of the same specimens not exposed to sunlight. The change of tensile properties of covering geotextiles, after 3 years of sunlight exposure, is also presented. The analysis of the obtained results showed that the mechanical properties of the geomembrane seams were not af

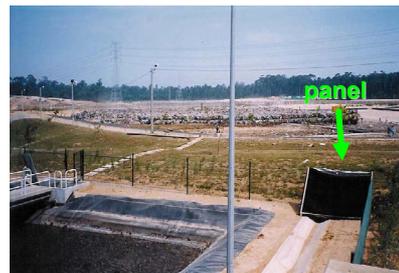
Figure 1 Example of a panel with a geomembrane sample exposed to weathering (waste landfill 3)

The study was carried out on two phases. The first one consisted in the accomplishment of the natural aging of the geosynthetics to the sunlight exposure. With this purpose, during the construction of eight solid waste landfills (1998-1999), panels with the applied geosynthetics were built (see figure 1) and exposed to weathering. Figure 2 shows the distribution of these panels and waste landfills over the country. At the second phase, after 2, 3 and 5 years to sunlight exposure, samples (with a field seam at the middle) were cut from the exposed materials (on the eight panels) for testing the evolution of mechanical performance of geomembrane seams.

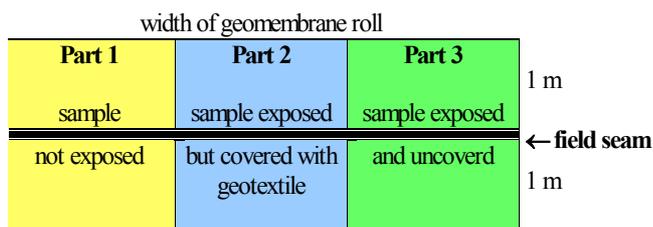
(see figure 3): part 1 was unexposed, part 2 was exposed to sunlight but covered with a geotextile and part 3 was exposed directly to sunlight. Three different types of geotextiles with photostabilizers were used.

Figure 3 Different parts of the sample

During the construction of the different waste landfills, geomembrane samples (with a field dual-bonded lap seam in the middle) were collected and divided in three parts

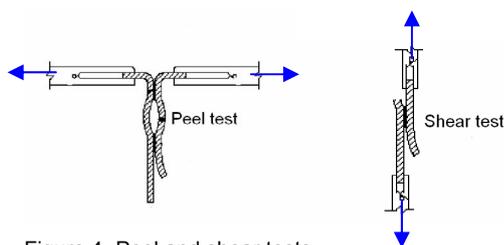
Figure 4 Peel and shear tests

Seam strength was determined by testing, in shear and peel modes (see figure 4), the specimens cut from the field samples and from the samples not exposed to sunlight. Determination of seam strength in shear and peel modes was performed based on ASTM D4437 "Standard practice for determining the integrity of field seams used in joining flexible polymeric sheet geomembranes". A strip specimen with a 25,4 mm wide and 152,4 mm long was used. Initial grip separation was approximately 25,4 mm for peel mode and 101,2 mm for shear mode. Rate of grip separation was 51 mm/min. Due to the limitation of available material only three peel and three shear specimens were tested for each seam sample.

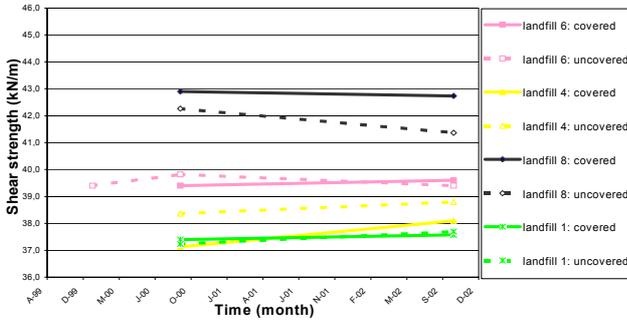
The mean values of shear strength evolution for covered and uncovered geomembrane seams, exposed to sunlight during 2, 3 and 5 years, are presented in figure 6.

From figure 6 we can observe that the maximum variation of the shear strength among covered and uncovered geomembranes seams was 1,3 kN/m (landfill 8).

Notice that all the measured values are higher than 30kN/m.

Figure 6 Evolution of shear strength for covered and uncovered geomembranes

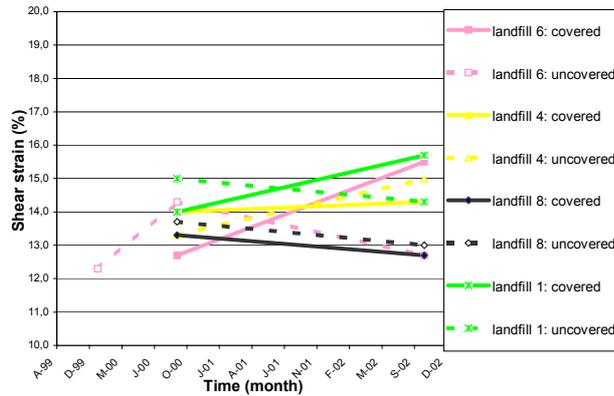
The mean values of shear strain evolution for covered and uncovered geomembrane seams, exposed to sunlight during 2, 3 and 5 years, are presented in figure 7.

Figure 7 Evolution of shear strain for covered and uncovered geomembranes

From figure 7 we can observe that the maximum variation of the shear strain among covered and uncovered geomembranes seams was 2,8 % (landfill 6).

Notice that all specimens had shear strain values higher than 10%.

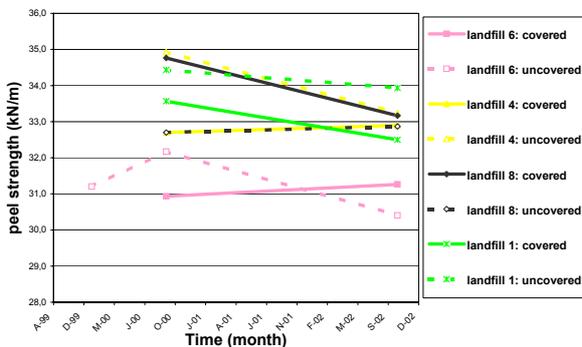
The mean values of peel strength evolution for covered and uncovered geomembrane seams, exposed to sunlight during 2, 3 and 5 years, are presented in figure 8.

Figure 8 Evolution of peel strength for covered and uncovered geomembranes

From figure 8 we can observe that the maximum variation of the peel strength among covered and uncovered geomembranes seams was 2,1 kN/m (landfill 4).

Notice that all the measured values are higher than 23 kN/m.

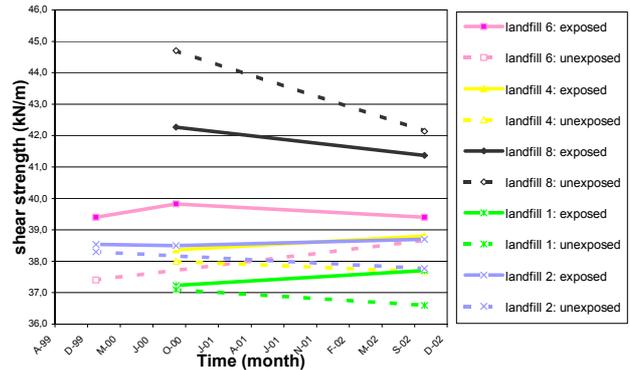
The mean values of shear strength evolution for exposed and unexposed geomembrane seams to sunlight during 2, 3 and 5 years, are presented in figure 9.

Figure 9 Evolution of shear strength for exposed and not exposed geomembranes

From figure 9 we can observe that the maximum variation of the shear strength among exposed and unexposed geomembranes seams was 2,4 kN/m (landfill 8).

After five years of sunlight exposure, the maximum variation of the shear strength was 0,9 kN/m (landfill 8).

Notice that all the measured values are higher than 30kN/m.

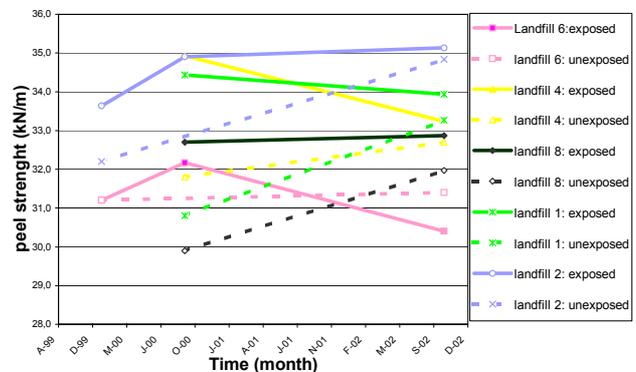
The mean values of seam strength evolution for exposed and unexposed geomembrane seams to sunlight during 2, 3 and 5 years, are presented in figure 10.

Figure 10 Evolution of peel strength for exposed and unexposed geomembranes

From figure 10 we can observe that the maximum variation of the peel strength among exposed and unexposed geomembranes seams was 3,1 kN/m (landfill 4).

Notice that all the measured values are higher than 23 kN/m.

After 5 years of sunlight exposure, the maximum variation of the peel strength was 1,8 kN/m (landfill 6).
