The successful design and construction of a floating cover molasses storage reservoir for the TSB Malelane Mill in South Africa

ABSTRACT: Although the storage of molasses in floating cover reservoirs is cost-effective, a number of problems are associated with such storage, including gas generation, foaming, rainwater removal and cover drag. This paper describes the design and construction of a new 14 800m³ floating cover molasses storage reservoir at the Transvaal Suiker Beperk Malelane Sugar Mill in South Africa, taking these design issues into consideration.

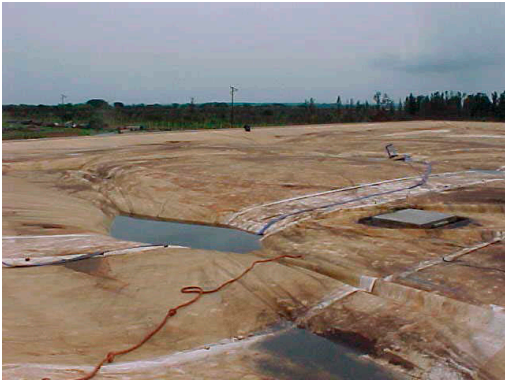
Plate 1: Rainwater puddles on cover

Rainwater removal from floating cover reservoirs must be addressed for any product stored, which is complicated by the variable level of the cover. Because water is lighter than molasses, a low point must be created within the cover from which rainwater can be pumped. This is accomplished by placing weights on the cover. Where possible, the distance that rainwater has to travel on the cover should be minimized, so that this is not complicated by any gas bubbles.

Issues of concern during the operation have included the breeding of mosquitoes in puddles on the cover, and frogs accessing the cover, and not being able to get off. The site is situated within a malaria area, so breeding of mosquitoes is a serious concern. These issues are being addressed by the client.

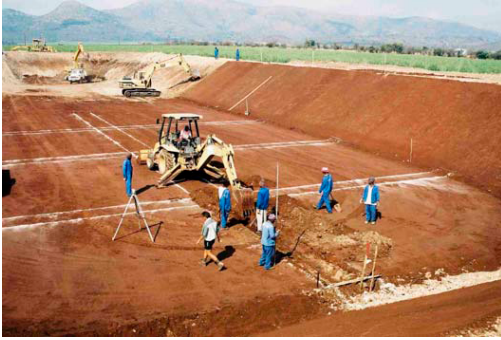
Plate 2: Bulk earthworks

The reservoir was constructed by four contractors. The bulk earthworks were undertaken first, and the imported clay protection layer was constructed by the same contractor.

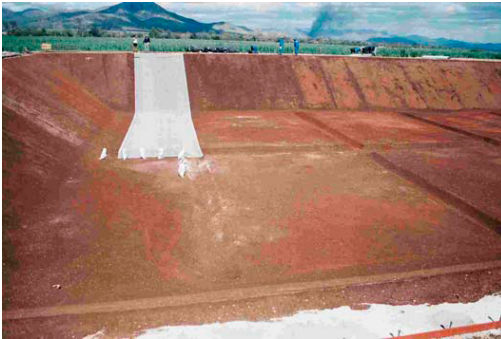
Plate 3: First installation of GCL on clay protection layer

The reservoir is lined with a GCL (Bentomat ST) and a 1.5mm thick HDPE geomembrane, while the cover comprises 1.14mm thick reinforced polypropylene (R-fPP). Given that the reservoir was constructed in weathered rock, it was necessary to place a 75mm thick imported clay layer to obtain the required finish for lining.

The GCL and HDPE liners were laid as the earthworks were completed. The pipe work and structural work were programmed in so that the pipes were laid between the liners & cover, and so that the concrete anchor ring was completed in time to use as an anchor. The outlet sump was completed once the pipes were in place, and was backfilled to allow the liners and the cover placement to be completed.

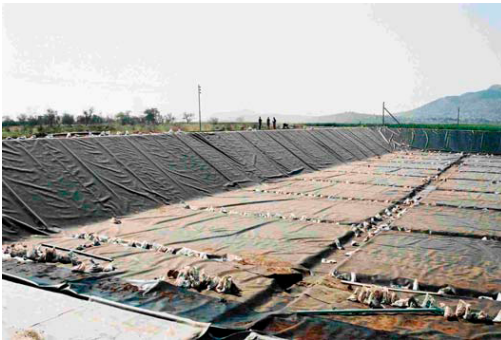
Plate 4: Installation of HDPE liner

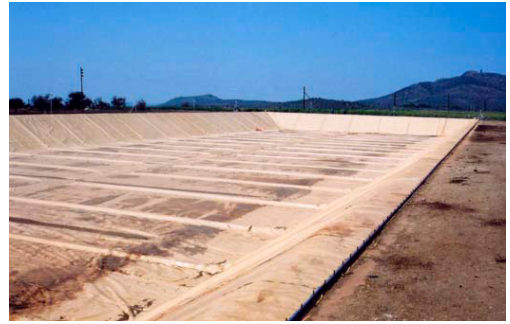
Plate 5: Installation of fPP-R cover

The liners and cover are anchored to a concrete anchor ring beam. The inlet to the dam is between the liner and the cover, so that no penetration of the liners was necessary for the inlet, limiting the risk of leakage. The reservoir is linked to a large sump, which is coated to protect concrete from attack by the molasses. The sump is used as the outlet, and molasses is pumped from it. The sump also acts as an additional inlet, as road tankers can discharge directly in to the sump.

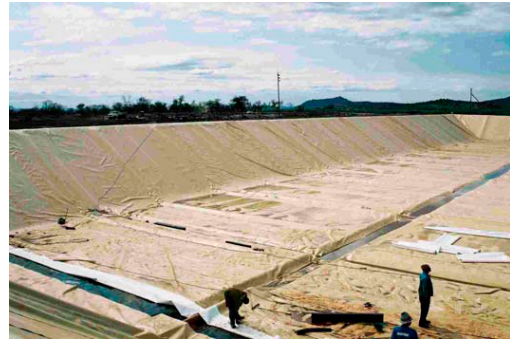
Plate 6: The molasses reservoir during commissioning

First filling of the dam was undertaken slowly, to allow the trenches to be filled gradually, and for the molasses to spread across the floor and raise the cover evenly. This was undertaken in order to avoid generating tensile stresses in the cover. First filling required careful monitoring, but did not prove a problem at all.

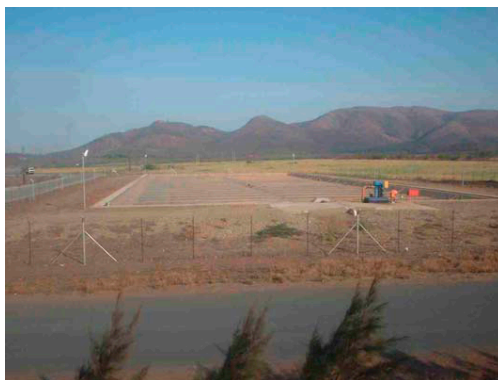
Plate 7: The reservoir in use

The reservoir has been in operation for just over a year at the time of writing, and is performing in accordance with design brief. Within two months of commissioning, the reservoir was filled to slightly above capacity, which was retained within the freeboard. This, however affected the gas removal system, as minor gas bubbles formed below the cover. These dissipated once the molasses level was lowered.
