Reinforced very steep wall 23 meters high built on a river bank in an industrial settlement in Lumezzane (Italy)

ABSTRACT: The paper presents a case-history of a high reinforced steep wall with inclination angle of 80° built in order to enlarge the settlement of a new industrial area in Lumezzane, Brescia, Italy. The area on top of the retaining reinforced structure will be used as a vehicle manoeuvring zone and will also serve as a car park. The toe of the steep reinforced slope lies directly on the top of big cemented boulders bank of a mountain torrent. Due to the presence of water springs coming from the backfill, these first foundation layers had to be filled with gravel in order to have a good draining behaviour and fully wrapped with a high permeability filter geotextile. A number of drainage pipes have been installed through the bank in order to discharge the water coming from the drainage foundation mattress into the torrent. The use of a steep reinforced slope as retaining structure allowed to follow the shape of the mountain torrent with good aesthetic results minimizing environmental impact proving once again the flexibility of this system for this kind of applications

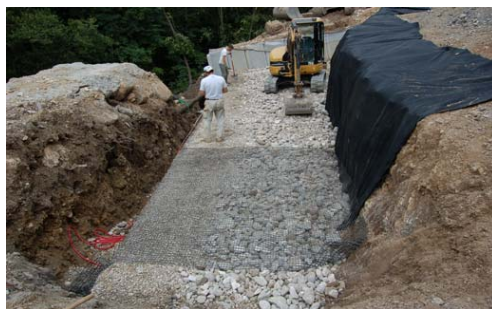
Figure 3. Bottom foundation layer filled with rounded cobblestone wrapped with woven filter.

Also for the foundation block the wrap-around reinforced soil system has been chosen with 5 layers geogrids of 200 kN/m tensile strength, spacing 0,60 m for a total height of 3,00 m. Due to the presence of water springs coming from the backfill, these first foundation layers had to be filled with rounded cobblestones in order to have a good draining performance.(Figure 3).

These layers were fully wrapped with a high permeability filter geotextile with an optimum opening size for preventing clogging and blocking of the filter with hydraulic mechanical properties. (Table 1).

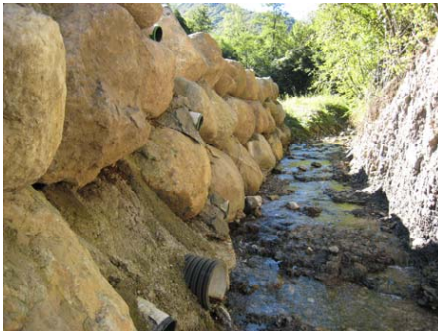
Figure 4. Drainage tubes passing through the boulders bank of torrent.

In order to collect and discharge the water coming from the slope inside the drainage foundation mattress and to prevent increasing of pore water pressure, a drainage system with network of draining tubes have been laid on the bottom, on the back part of the trench and connected with sub-horizontal tube passing through the boulders bank into the torrent. (Figure 4).

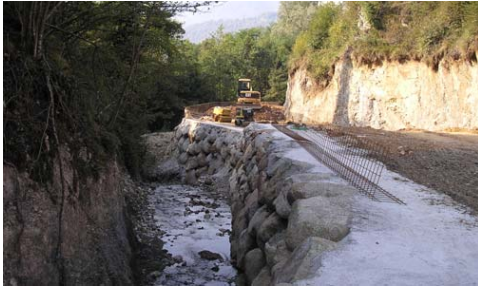
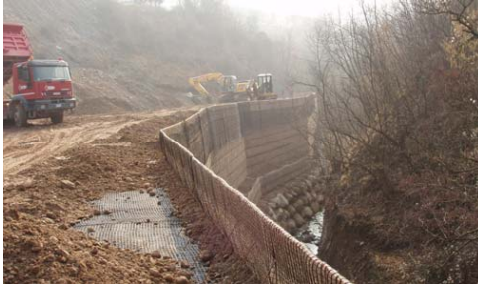
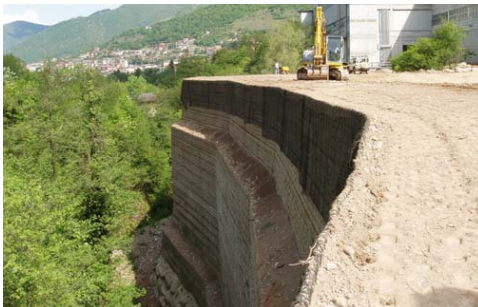
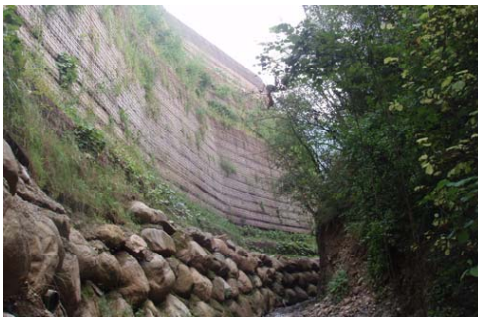
Figure 6. Construction phases

The flexibility of the reinforced soil system allowed to follow the squared shape of the tube laterally and on top keeping the tube in position without any problem and damage to the structure with a pleasant aesthetic effect.

Various phases of the installation of the geogrids and the impressive view of the wall after completion are shown in Figure 6.
