# The use of geosynthetics in a sea port reclaimed area in Southern Brazil

**ABSTRACT:** This paper presents a well known solution, however put into practice in a unique situation. A Southern Brazilian sea port, Antonina, Paraná, prepared a relatively huge area, called back port, for disposing of the dredged material from the port entrance canal. Although taking into account the very poor geotechnical quality, due to its liquid state and erratic placement, the reclaimed area from the sea formed by the sedimentation of such heterogeneous mud fill, was devised as part of the increase in available space. A geotechnical design was then carried out to make this idea come true, and this paper describes the situation and procedures for the objective. Soil reinforcement with geosynthetic materials, fill monitoring with time and local experimental site are included in the project, herein reported.

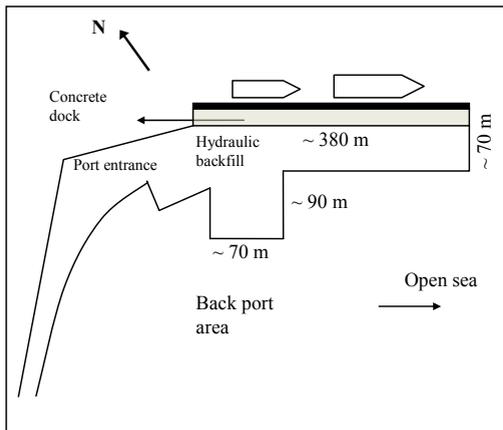
Antonina is an important sea port in Southern Brazil, that along with Paranaguá contributes a great deal of for Brazilian goods exported to the whole world. Both ports are located in Paraná, at the Paranaguá Bay. Antonina’s actual ship dock was constructed about ten years ago, by means of heavy precast driven piles anchored in hydraulic fill. The basic port lay-out is about 380 meters long and 70 meters wide with a concrete structure along the sea line, plus the parallel backfill, including an extra rectangular area of 90 x 70 meters (Figure 1).

Figure 1. Basic lay-out of the Antonina Port (not to scale).

- The water flow in the pond, oriented from the dock line to the back port area (Figure 1), was forced due to the placement of the dredging pipes by the limits of the existing hydraulic fill;

As far as the approach for the construction operation is concerned, the authors suggested that a small area between the port entrance and the first building in the hydraulic fill, was tested first (Figure 1). After a few weeks under loading and with constant monitoring, also depending on the obtained results, other areas should then be added similarly. Unfortunately, such procedure was not materialized so far and the real data from the field behavior is still today not yet available.

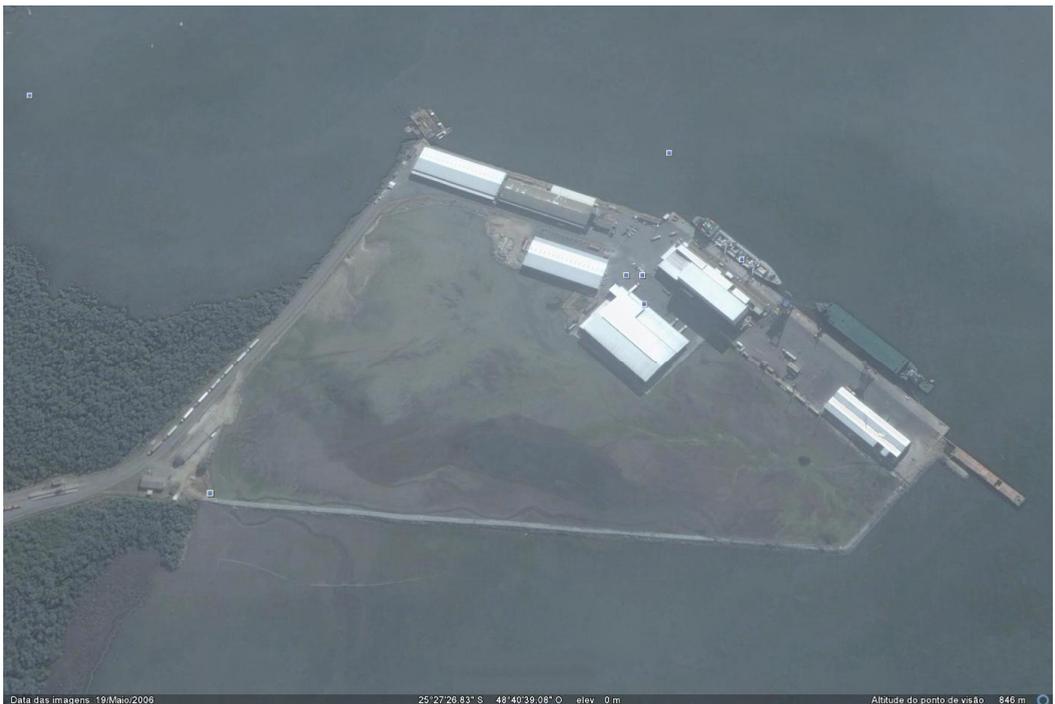
Having these aspects of the problem in mind, the port authorities decided to make solution out of a big problem: a levee was built in the back port blocking the sea water in a huge pond, and the dredged material was then pumped from the canal to this pond (Figure 2). As the hydraulic fill advanced, the water was being slowly expelled from the pond and a highly compressive and weak kind of very soft “soil” took place. The dredged heterogeneous material, or

Figure 2. Antonina port area (photo – Google Earth).

It is interesting to mention that the confinement of the pond, defining approximately a triangular shape for the proposed back port, was built around one year before the studies reported in this paper started. For the levee no specific evaluation of soils and foundation was made, and according to informations given by the owner, basically soils and boulders were dumped by earth moving equipment, with occasional points reinforced by geosynthetics. A general inspection of this linear structure done by the authors indicated that, even after considerable settlement had occurred, its main objective had been achieved, that was to block the sea water from the pond and to retain the pumped material inside (Figure 2).

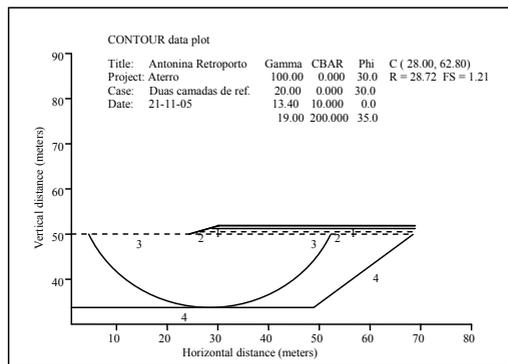
Slope stability analysis was performed to evaluate the effect of the surcharge due to additional landfill and containers to be applied over the hydraulic landfill material. Parametric analysis was made with cohesion  $c = 10$  kPa (minimum value for soft soil) and friction angle  $\phi = 0^\circ$ . Surcharge applied was 25 kPa (half of total surcharge that will be applied by containers). For this situation the safety factor obtained was 1.21, with a circle of rupture tangential to the resistant material below (Figure 4).

Figure 4. Analysis with  $c = 10$  kPa and  $\phi = 0^\circ$ , for soft soil.

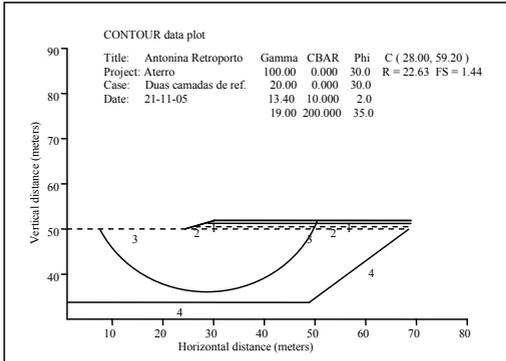
With a small friction angle ( $\phi = 2^\circ$ ) for the soft soil (since this material contains some fraction of sand), the coefficient of safety reaches 1.44, with a circle of rupture above the resistant soil below (Figure 5). It should be noted however that this result was obtained for half of the planned containers surcharge, which implies the need of additional consolidation in order to the shearing resistance of the soft soil to increase, until it is possible to apply the final design surcharge.

Figure 5. Analysis with  $c = 10 \text{ kPa}$  and  $\phi = 2^\circ$ , for soft soil.

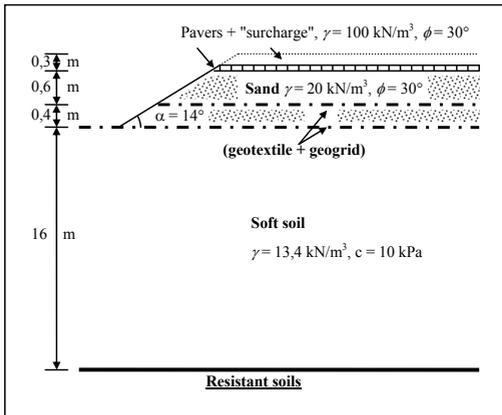
Figure 6 shows a construction detail of the pavement structure to be placed on the hydraulic landfill. The top layer simulates the surcharge of the pavement with half of the containers on it. The authors recommended caution for both the construction period and the initial loading, with careful settlements monitoring, to minimize problems and allow for increase in the number of containers along time. In other words, the whole process can be called trial an error.

Figure 6. Transversal section of the landfill (not to scale).

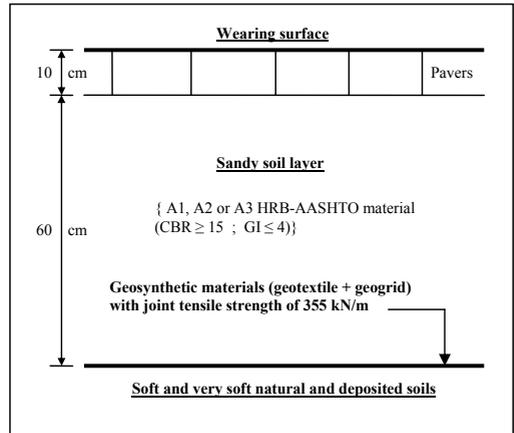
The results from the mentioned considerations led to a design (Figure 7) that specified geotextile and geogrid over the dredged material after some consolidation had occurred, with a granular soil on top plus the wearing surface defined by precast concrete blocks – pavers (Peltier, apud de Senço, 1974). Under these circumstances, no failure was to be expected, however a great deal of settlements will occur with time. Evaluation based on Terzaghi's consolidation theory showed numbers between 75 and 200 cm, for a compressible soil layer of 600 to 1600 cm. The time associated to such vertical compression ranged from 14,5 to over 100 years.

Figure 7. Pavement structure proposed for the dredged material in the back port area (not to scale).
